# Denitrification in a Rotoehu Stream, 2nd installation

# Additional results from 2008/2009 samplings

Landcare Research Contract Report: LC0809/149

DATE: May 2009

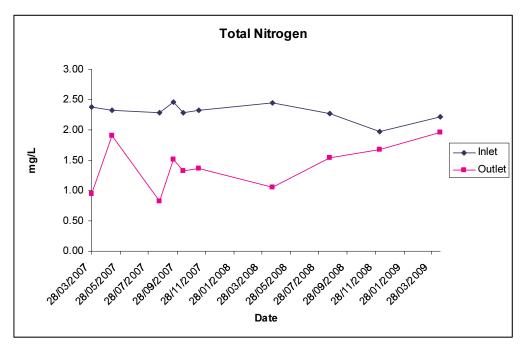
Fig. 2 Total Nitrogen levels entering and leaving the denitrification bed

Total nitrogen levels in the stream at entry to the bed appear to be dropping marginally over time and, as noted in the previous report, nitrogen is largely in NOx (nitrate and nitrite) form. The nitrate removal efficiency of the bed (as a function of percentage removal of N from the inflow to the outflow) has deteriorated over time, but it is important to note that flow rate through the bed has dramatically increased over the past two sampling dates. The bed continues to remove some nitrate from the inflow even at the highest rate of flow encountered. Unfortunately the assessments of flows are very much estimates as we did not have the gear on hand to measure over multiple points; however, using averages of the approximations yields:

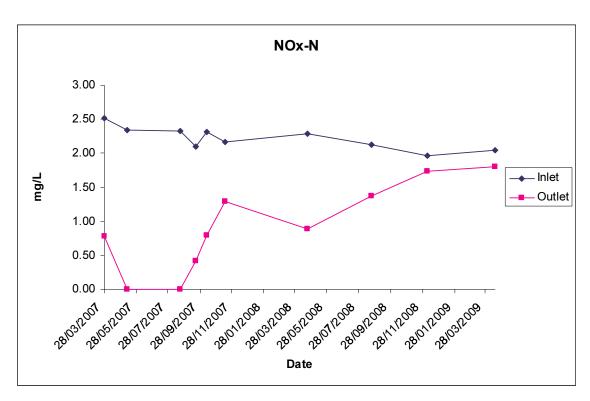
Fig. 3 Nitrate and nitrite (NOx-N) levels entering and leaving the denitrification bed

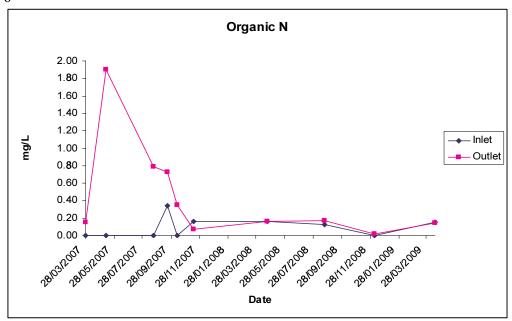
Fig. 4 Organic Nitrogen levels entering and leaving the denitrification bed
