**ASSESSMENT OF SOUTHERN CATCHMENT, WAITANGI BAY
LAKE TARAWERA**

A report prepared for
Environment Bay of Plenty

Norm Ngapo

Waiora Soil Conservation Limited
10 October 2006

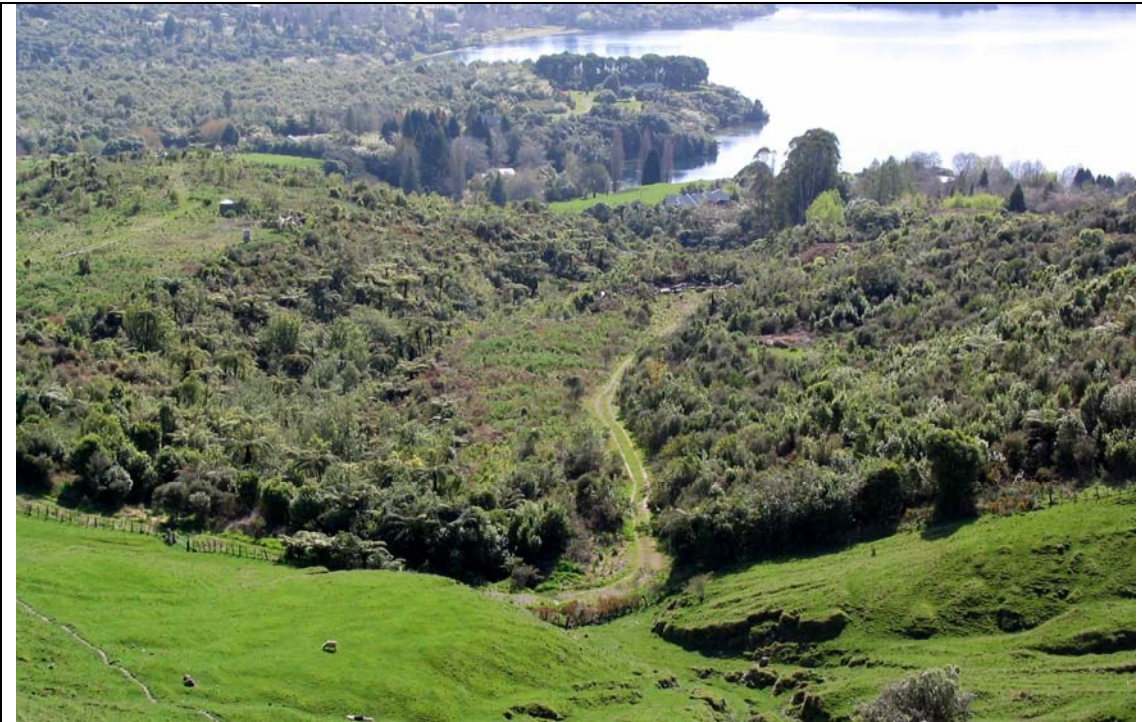
Photo1: Southern Waitangi Bay catchment: Looking from Playnes property down the catchment to Waitangi Forest property and Waitangi Lodge Estates property in the lower valley.

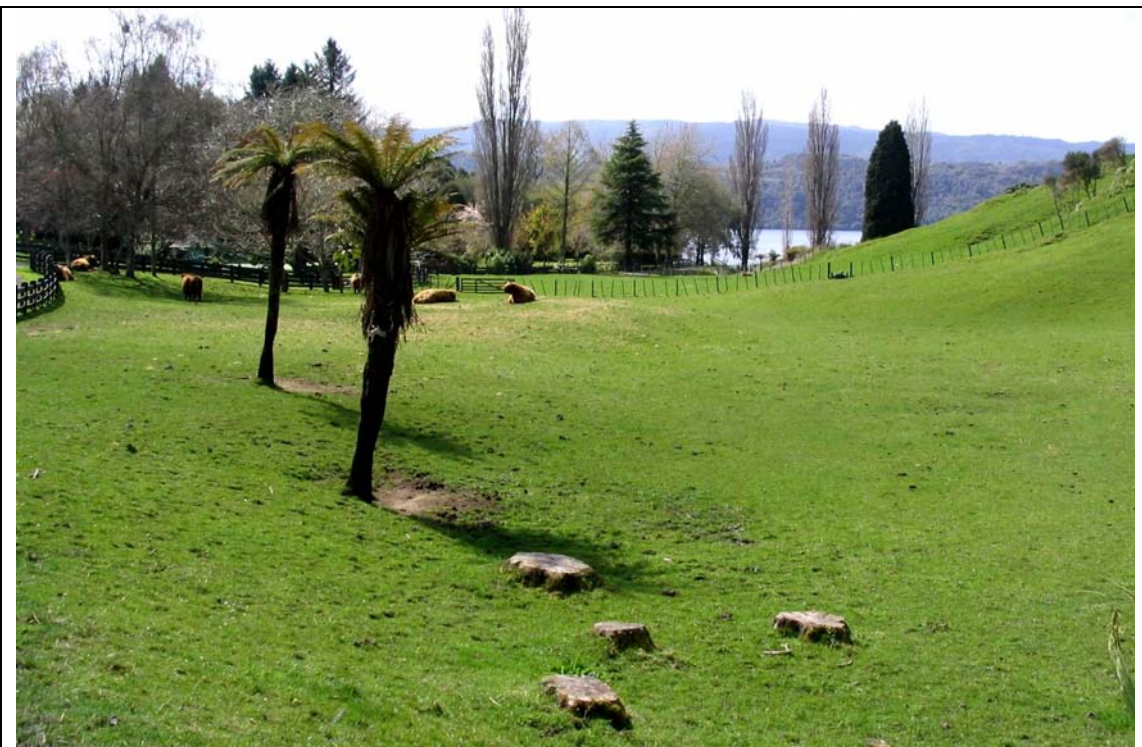
Photo 2: Southern Waitangi Bay catchment: Looking from Spencer Road down the ephemeral valley on the property of Waitangi Lodge Estates. Lake Tarawera in the background.

- That the owners of Waitangi Lodge Estates ensure that the capacity of the ephemeral flowpath through their property is of sufficient size to ensure that stormwater runoff from the catchment following extreme rainfall events does not flood buildings or other capital assets. In addition, the ephemeral flowpath should be sufficiently robust to prevent scour from high velocity floodwaters. The flowpath should be capable of handling the 50 year flood event, and should allow for water surge and super elevation of stormwater as it flows around bends.

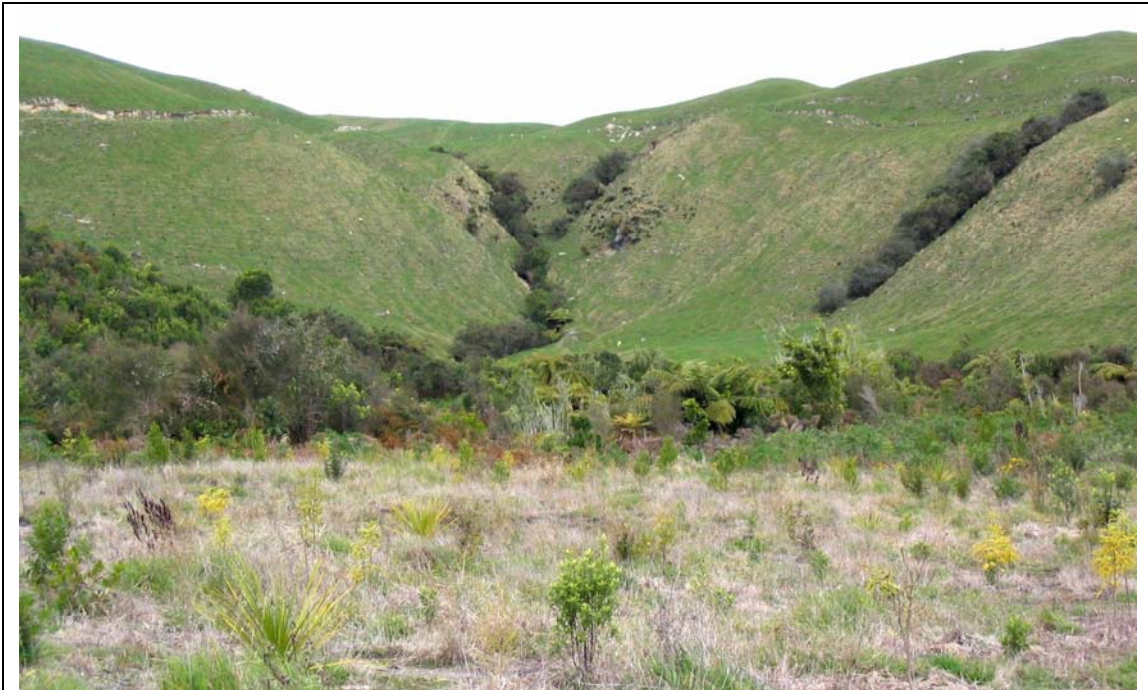
Photo 3: Looking from Waitangi Forests property southwards into the steep upper catchment on Playnes property

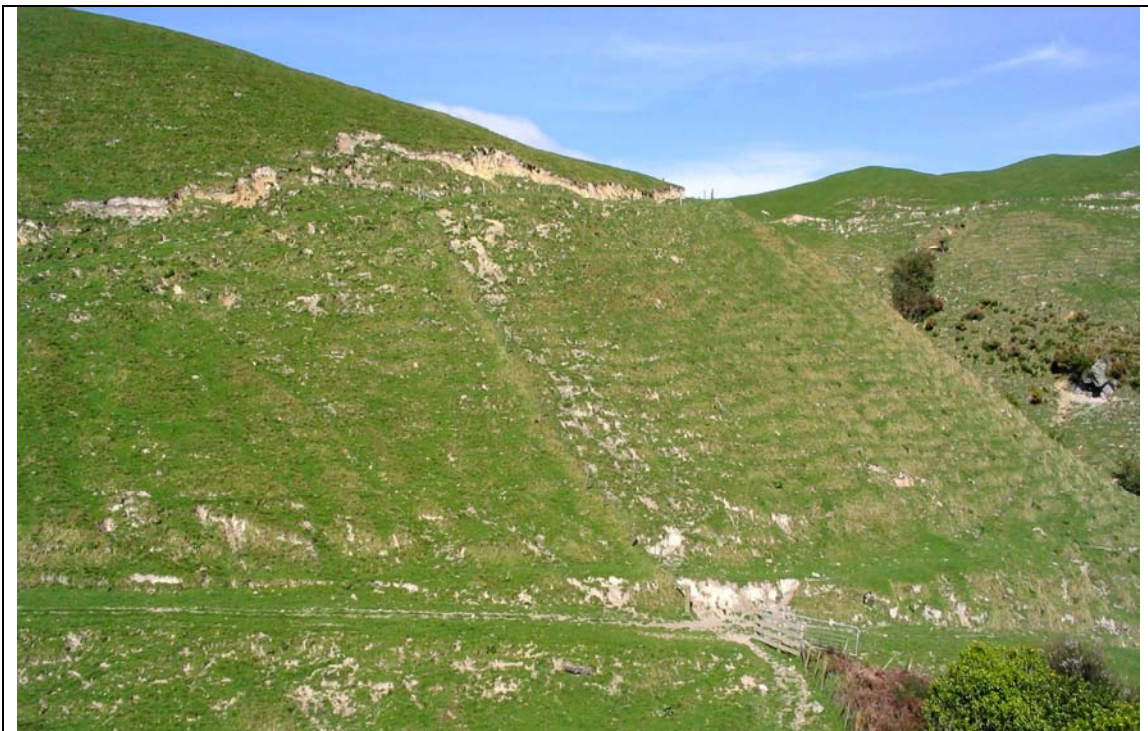
Inspection of the catchment confirmed that the steep pastoral faces in the upper catchment are subject to sheet erosion, and the steep ephemeral gully systems show signs of both historical and active gully erosion.

Photo 4: Steep pastoral land on the Playne property. Sheet erosion on steep Rotomahana soils.

- That the owners of the Playne property consider alternative land use options for the steep pastoral land draining into the Waitangi Forest property that would reduce peak flood flows and control sheet and gully erosion. When considering alternative land uses, plantation forestry may not be a viable option unless the area is established in long term rotation species and the ephemeral gullies are planted into long term protection vegetation (such as native shrubs), not production species.

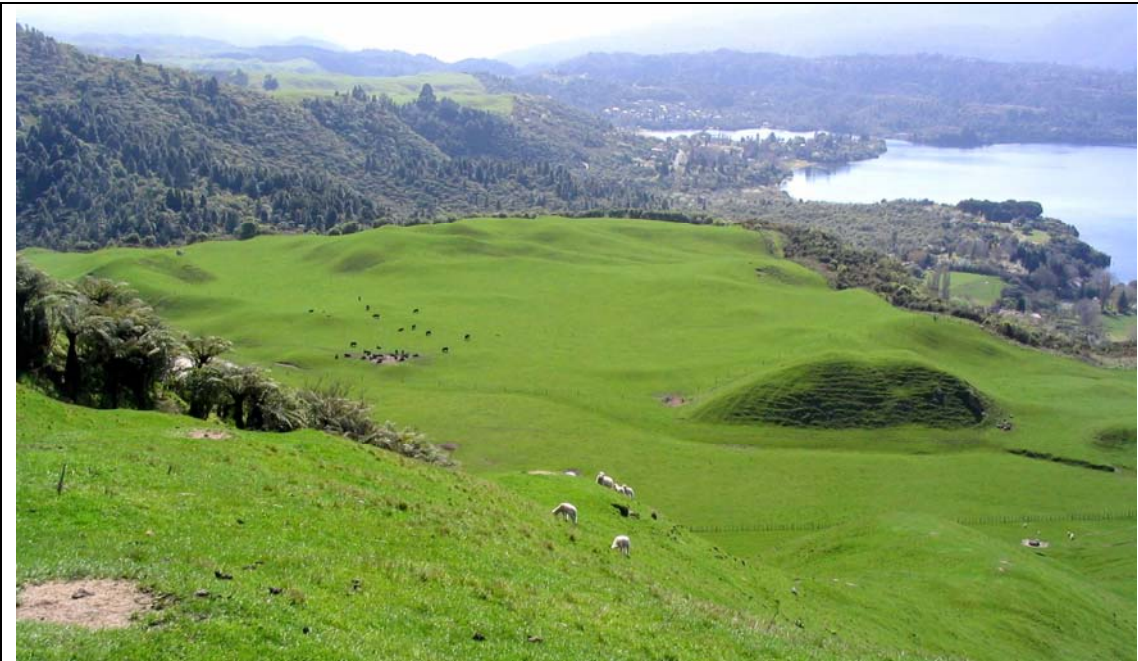
There is a plateau area of approximately 20 ha in the north eastern part of the upper catchment that is relatively flat and holds has a small ponding area. This plateau appears to have been historically part of the Lake Okareka catchment. However, at some time in the past, a small bank (approximately 1 metre high) has been installed to prevent water flowing back towards Lake Okareka, and a drainage swale formed to divert stormwater into the Waitangi Bay catchment and then into Lake Tarawera. The area is very flat, and a small change in flow patterns has been sufficient to divert the stormwater towards Lake Tarawera. Note that even if the historical flow path towards Lake Okareka was to be reinstated, the flow would be directed over an old gully head, and then picked up by the controlled outlet channel from Lake Okareka to the Waitangi Stream. This would then divert the flow back to Lake Tarawera via the Waitangi Stream.

Photo 5: Looking into the flat plateau area encompassing the 20 ha of 'pond catchment' on Playnes property. Runoff from this plateau drains via the grassed drain/swale in the middle of the photo towards the right and then down into Waitangi Bay. It is recommended that a low detention bund be installed towards the right hand end of the grassed swale to detain peak runoff from the plateau area, and drain slowly via a small pipe through the base of the detention bund.

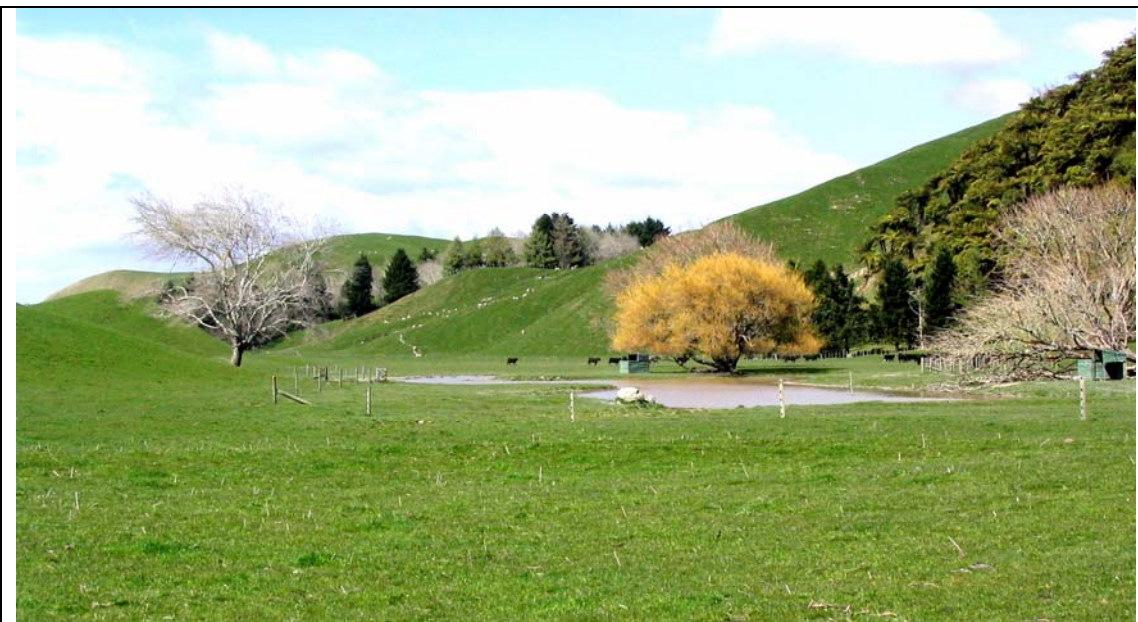
Photo 6: Looking towards the south east at the pond on the plateau area on Playnes property. The pond now drains away from the viewer towards Waitangi Bay. In the foreground, a low bund has been constructed. This prevents runoff from draining towards the viewer and then into the Lake Okareka catchment.
