## **The ecological condition of the Rotorua Lakes using LakeSPI - 2010**

**NIWA Client Report: HAM2010-047  
May 2010**

**Environment Bay of Plenty**

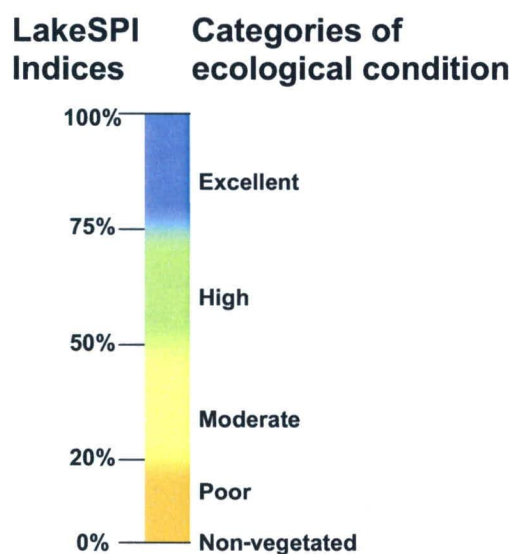
**Figure 2:** LakeSPI indices categorise lakes into five lake condition groups.

Note: These categories are imposed on a continuum scale of scores; therefore we recognise some flexibility in the placement of lakes with scores close to the transition between categories. Lake placement in these cases will be made using expert opinion based on the current status of the lake and the pressures exerted on it.

For the purposes of ranking and discussing results, lakes have been categorised into five main groups based on the LakeSPI Index. Lakes are grouped as being in an ‘excellent’, ‘high’, ‘moderate’, ‘poor’, or ‘non-vegetated’ condition (Figure 2). These new lake groupings support an MfE initiative to ensure national consistency in terminology and reporting and allow for better comparisons of lakes nationally and regionally.

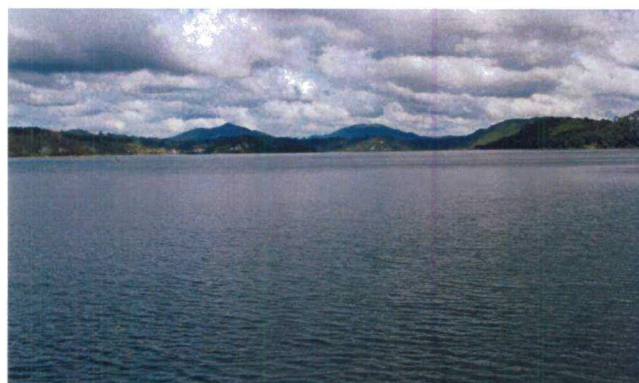
Lake condition: High

Stability: Declining

Lake Rotomahana, whilst still the highest ranked lake in the Rotorua region, is declining in condition as indicated by the most recent LakeSPI assessment. This is due to the recent invasion by two of New Zealand's worst aquatic plant species, *Egeria densa* and *Ceratophyllum demersum* (hornwort). Discovered for the first time in April 2007, egeria was found to be established in two areas of the lake, at the north-eastern end and in the southern embayment, while hornwort fragments were found growing amongst native plants in the southern embayment (Clayton & de Winton, 2007; Scholes and Bloxham, 2008). Since then both species have continued to spread, with egeria now present at 3 of the 5 LakeSPI baseline sites (1 site more than 2008) and forming bands of weed growth down to a depth of 9.7 m. The maximum depth of aquatic plant growth at these 3 sites is around 11 m. As both egeria and hornwort continue to have an impact on the diversity and quality of indigenous plant communities in Lake Rotomahana we can expect to see the Native Condition Index decline while the 'Invasive Impact Index' will continue to increase.

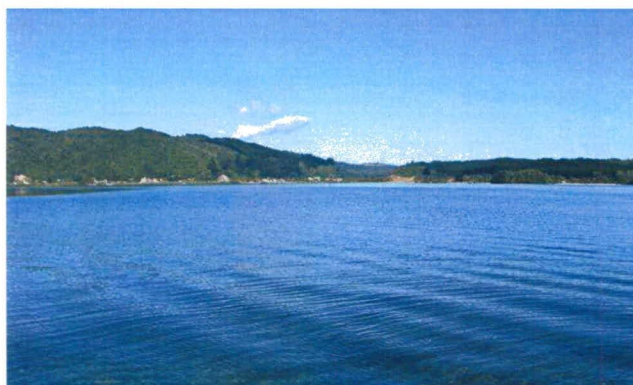
Lake condition: High

Stability: Declining

In 1973 Lake Rotoma had a high LakeSPI score, which reflected the early stage of lagarosiphon invasion and the extensive high cover charophyte meadows in this lake. By 1988 the Invasive Impact Index had more than doubled, which in turn reduced both the Native Condition Index and LakeSPI score for this lake. The following 21 years from 1988 to 2009 have shown a more gradual increase in the Invasive Impact Index, but with smaller changes to the Native Condition Index or LakeSPI score. This lake presently has the second highest Native Condition Index after Lake Rotomahana and one of the lowest Invasive Impact Index scores for any of the lakes, which contributes to its high LakeSPI ranking.

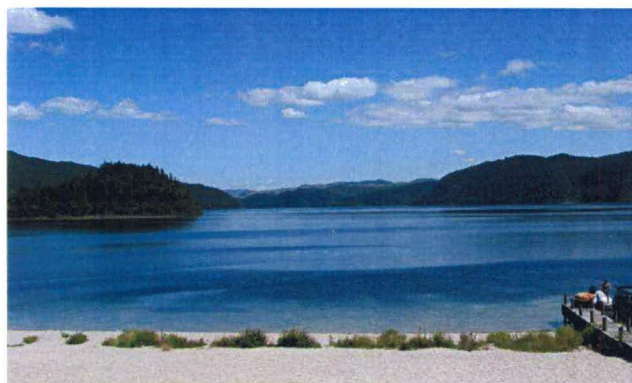
Lake condition: Moderate

Stability: Stable

In the past 29 years (from 1981 to 2010), LakeSPI scores for Lake Okataina have been reasonably stable, with only minor fluctuations. Care must be taken in interpreting these results, as the lake has no outlet and water levels can vary by several metres. Although lake level changes tend to be quite slow, they can still affect the available habitat for submerged vegetation in shallow water and the corresponding adjustments in the maximum depth of charophyte colonisation may be slower.

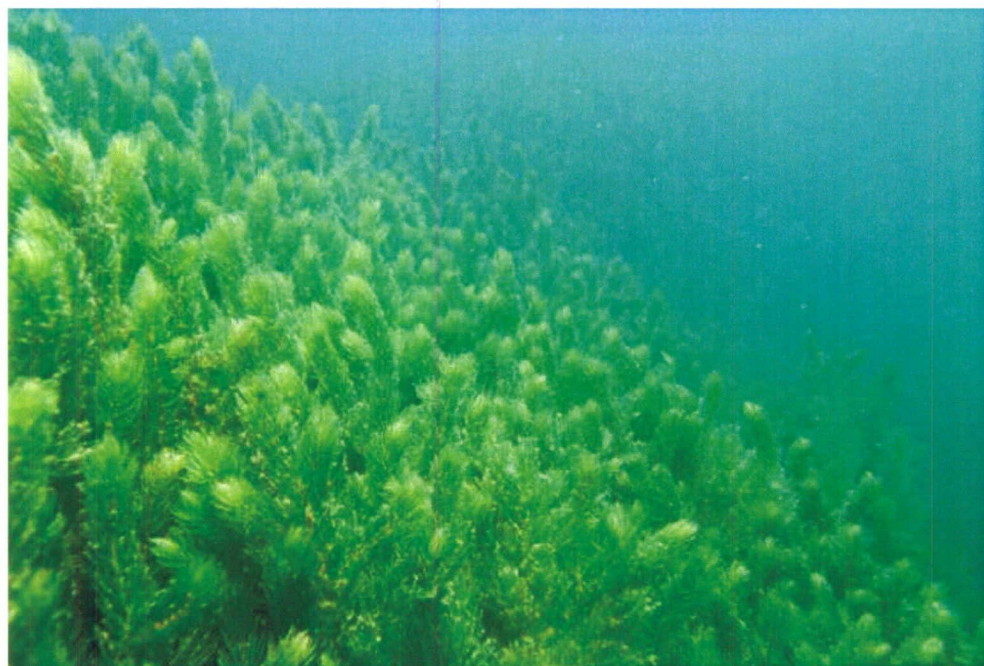
**Figure 3:** Invasive weed bed of hornwort (*Ceratophyllum demersum*) forming a wall of growth 8 m high and growing down to 12 m depth at the south-western end of Lake Okataina. (Photograph by Rohan Wells)

The discovery of an established bed of hornwort (*Ceratophyllum demersum*) during the most recent 2010 survey poses a serious threat to the future condition of Okataina. Hornwort fragments were found at the south-west end of the lake, with a search of the surrounding area revealing an established hornwort weed bed (Figure 3) growing in the middle bay west of Motuwhetero Island (authors pers obs.). Because only a couple of hornwort shoots were recorded from one of the five LakeSPI baseline sites, the Invasive Impact Index and the other indices have not yet been greatly affected.

the colony suggests it has been present for some time and subsequent dispersal to other locations within the lake is likely. Further hornwort growth remains a major threat to Lake Okataina.

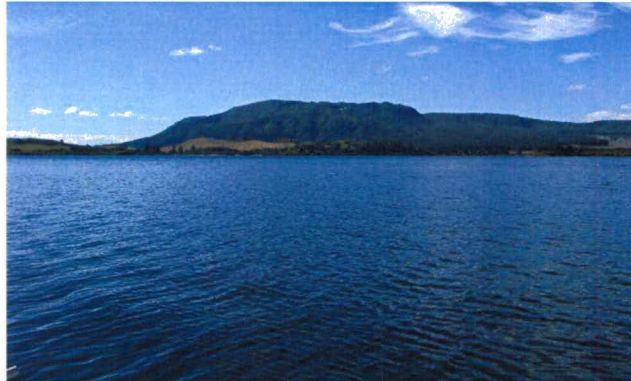
Lake condition: Moderate  
Stability: Declining  
Lake ranking 4<sup>th</sup>

After remaining relatively stable from 1988 to 2008, the most recent LakeSPI assessment shows a decline in the overall condition of Lake Rerewhakaaitu. Increased Invasive Impact scores reflect the wider impacts that egeria is now having upon the lake; and apparent decreases in water quality (author pers obs.) and retraction in charophyte depth limits are concerning for the future state of this lake.

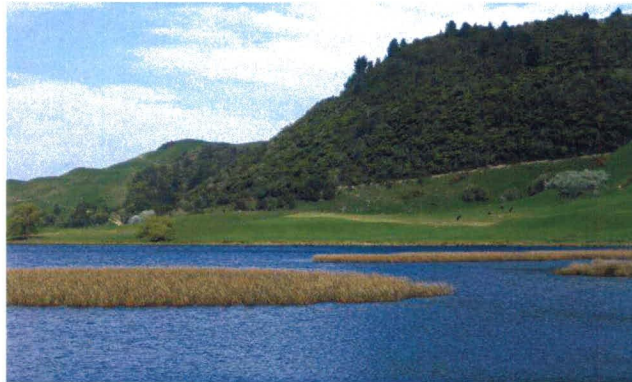
Lake condition: Moderate

Stability: Stable

Lake Okareka currently appears to be in a stable condition indicated by the recent LakeSPI indices showing little change over the last six years, from 2003 to 2009. Prior to this however, a 10% decrease in the LakeSPI Index between 1988 and 2003, resulted from a decline in the quality of native plant communities present, indicated by the Native Condition Index, and an increase in the Invasive Impact Index over the same time frame.

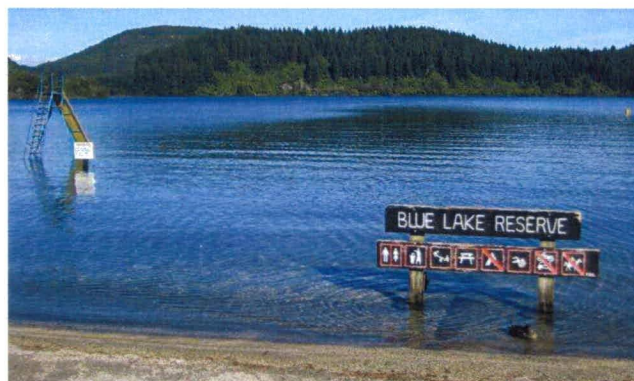
Lake condition: Moderate

Stability: Declining

The LakeSPI Index shows a reduction of 29% over the last 22 years to 2010 indicating that the condition of Lake Tikitapu has deteriorated faster than the other 11 Rotorua Lakes over this same period. Unlike the other lakes this decline is not due to the impact from new invasive species but from a substantial decline in the quality and extent of the native plant communities present.

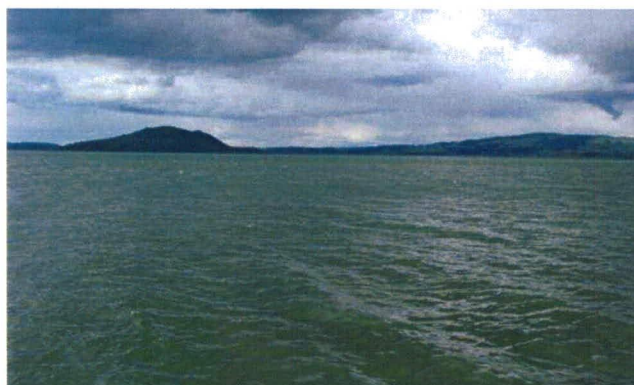
Lake condition: Moderate

Stability: Improving

Lake Rotorua is the only lake to have shown improving lake condition scores over the last 21 years. This lake has a large shallow littoral zone subject to considerable wave action, which has the effect of reducing silt build up and helps prevent large surface-reaching weed beds forming around much of the lake margin. The wave washed shallow regions of this lake can support a wide range of native turf-forming species along with shallow water charophyte beds and the presence of these native plants resulted in the higher Native Condition Index generated from the most recent 2009 survey. Charophyte meadows were recorded at 4 of the 5 LakeSPI baseline sites, compared to only 1 site in 2006, and they grew down to a maximum depth of 6.5 m. This and the extended area that the native plant communities are currently occupying has seen a 10% increase in the Native Condition Index for Lake Rotorua over the last 3 years. Care must be taken when interpreting these results however as these shallow water plant communities are also subject to seasonal storms and can be temporary in nature.

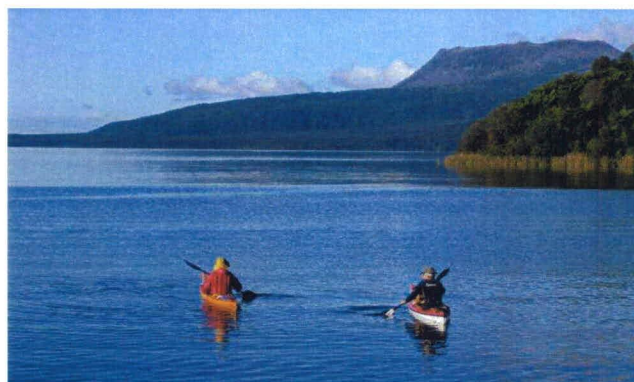
Lake condition: Moderate

Stability: Stable

Lake Tarawera remains in a moderate condition and is not expected to change in the near future since the full impact of hornwort (*Ceratophyllum demersum*) has now taken place.

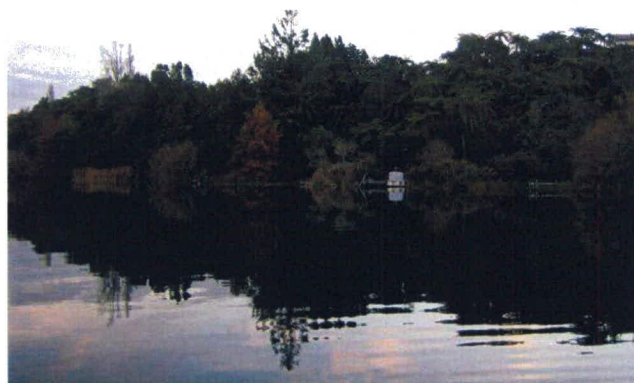
Lake condition: Poor  
 Stability: Stable  
 Lake ranking 10<sup>th</sup> equal

Lake Rotoiti has consistently had one of the highest Invasive Impact Index scores and continued to have one of the lowest LakeSPI Indices so far recorded for any of the 12 lakes in this region. A small increase in the LakeSPI Index over the last 3 years, 2006 to 2009, is attributable to the development of native charophyte meadows at 2 of the 5 LakeSPI baseline sites, growing to a maximum depth of 7.6 m, and is reflected by an increase in Native Condition scores.

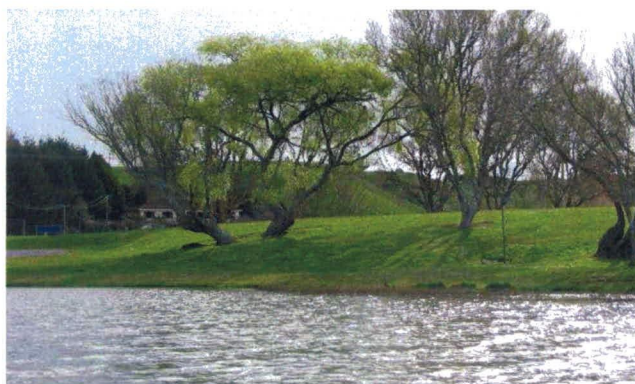
Lake condition: Poor  
 Stability: Stable  
 Lake ranking 10<sup>th</sup> equal

Elodea is the only invasive species currently reported in this lake. The hypereutrophic nature of this lake presents an unfavourable habitat for submerged vegetation. This is reflected in the highly variable cover and depth range of elodea, both seasonally and annually. It is also likely to explain root lyses (root death and detachment) in elodea beds from periods of oxygen stress and anoxia. On several occasions we have observed rooted shallow water elodea beds, while at around 2 m depth and deeper all of the elodea appears as non-rooted 'drift'. This may well coincide with periods of shallow stratification with severe anoxia below the thermocline resulting in root death and shoot detachment.

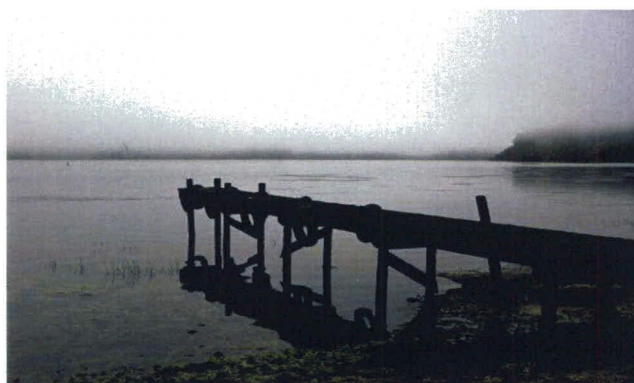
Lake condition: Poor  
 Stability: Declining  
 Lake ranking 12<sup>th</sup>

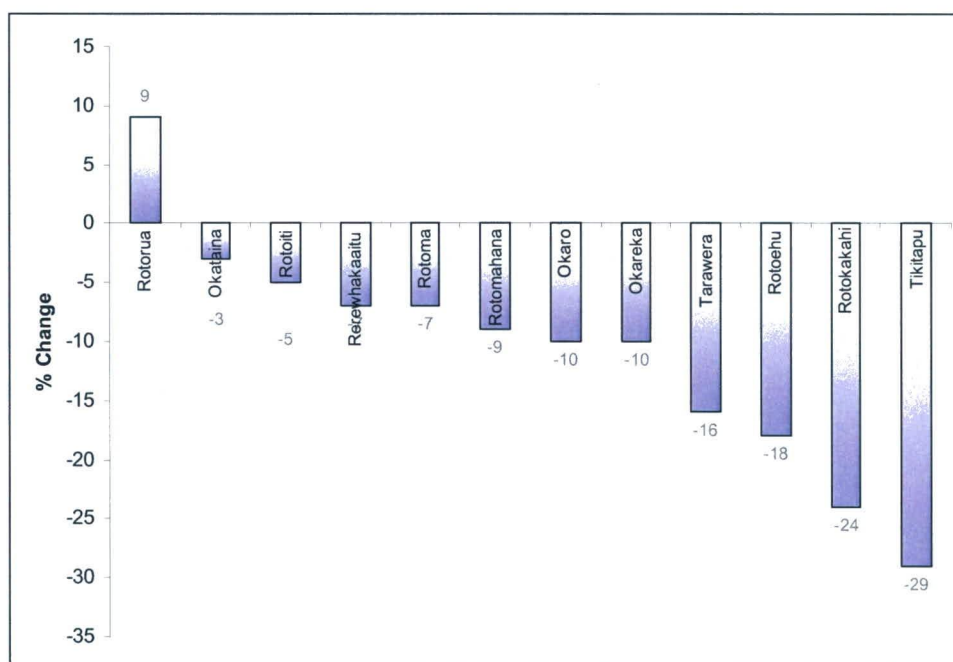
**Figure 4:** Percentage of change as indicated by the LakeSPI Index over the last 22 years, 1988 to 2009/10.

Many of the Rotorua Lakes have undergone significant change over the last two decades (Figure 4) and continue to be vulnerable to further changes from invasive plants and water quality deterioration. The submerged plant indicators used in LakeSPI provide an effective and alternative means to being able to assess these changes and monitor trends over time.

Lakes Tikitapu and Rotokakahi show the biggest change in lake condition over the last 20 years resulting from a notable reduction in the quality and extent of native submerged vegetation present in the lakes. There has been no new invasive species in either lake since full lake surveys in 1988, so these changes are likely the result of deteriorating water quality and clarity. Submerged plants are able to integrate long term changes in water clarity and nutrient status over time and often one of the first signs of deterioration is a retraction of the lower depth limit of plant growth (Schwarz et al. 1999). In many lakes the first valuable plant community to disappear is the charophyte meadow that grows into deeper water and this has been the case in Lake Tikitapu. In 1988 Lake Tikitapu supported extensive charophyte meadows at all 5 LakeSPI sites down to a mean depth of 19.5 m. By 2008, charophyte meadows ( $\geq 75\%$  cover) were found at only one LakeSPI site with remnants ( $\leq 5\%$  cover) found at one

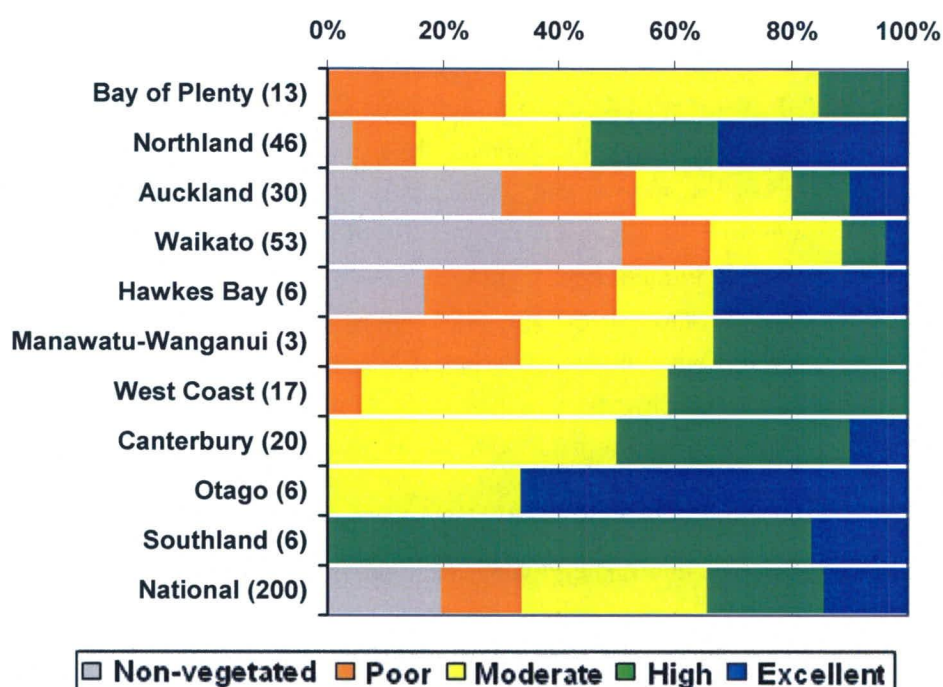
**Figure 5:** Proportions of lakes designated by the LakeSPI classification system showing regional and national differences, with number of lakes shown in parenthesis. Note some regions have had only limited LakeSPI assessments carried out and are therefore under-represented in terms of lake surveys.

A 'moderate' condition category contains the majority of the Rotorua Lakes and contains the largest proportion of lakes nationally. This 'moderate' condition group of lakes are representative of those lakes that are impacted in varying degrees by invasive weeds.

A smaller proportion of the Rotorua Lakes are classified as being in a 'poor' condition. This group of lakes tends to represent those with extensive invasion and dominance by one of the country's worst weeds, hornwort (*Ceratophyllum demersum*), as is the case for 2 of the 3 Rotorua Lakes ranked in this 'poor' category. Similar groups of substantially invaded lakes are represented in the Waikato, Auckland, and the Hawkes Bay Regions in particular. Water quality issues that have created unfavourable conditions for submerged plant growth are also often represented in this group of 'poor' condition lakes (e.g., Lake Okaro).
