The ecological condition of the Rotorua Lakes using LakeSPI-2011

Prepared for Bay of Plenty Regional Council

August 2011

NIWA Client Report No:	HAM2011-050
Report date:	August 2011
NIWA Project:	BOP11201

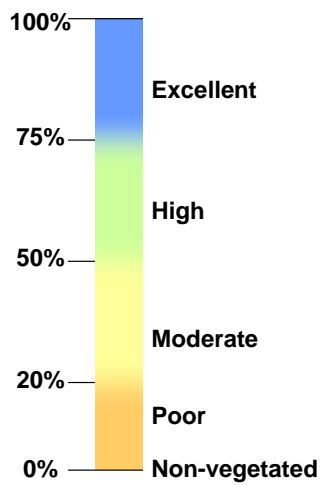
Figure 2: LakeSPI indices categorise lakes into five lake condition groups.

For the purposes of ranking and discussing results, lakes have been categorised into five main groups based on the LakeSPI Index. Lakes are grouped as being in an 'excellent', 'high', 'moderate', 'poor', or 'non-vegetated' condition (Figure 2). These new lake groupings support an MfE initiative to ensure national consistency in terminology and reporting and allow for better comparisons of lakes nationally and regionally.

Note: These categories are imposed on a continuum scale of scores; therefore we recognise some flexibility in the placement of lakes with scores close to the transition between categories. Lake placement in these cases will be made using expert opinion based on the current status of the lake and the pressures exerted on it.

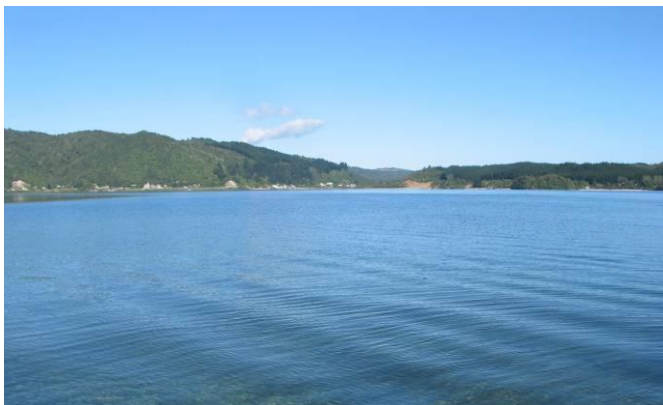
3.1 Lake Rotoma

Lake condition: High

Stability: Stable

Lake Rotoma is now the highest ranked lake in the Rotorua region after lake condition values have remained relatively stable over the last 23 years, from 1988 – 2011. In 1973 Lake Rotoma had a high LakeSPI score, which reflected the early stage of lagarosiphon invasion and the extensive high cover charophyte meadows in this lake. By 1988 the Invasive Impact Index had more than doubled, which in turn reduced both the Native Condition Index and LakeSPI score for this lake. Since then, Invasive Impact scores have increased more gradually, with smaller changes occurring to the Native Condition Index or LakeSPI score. As a result this lake presently has the highest Native Condition Index for any of the lakes and one of the lowest Invasive Impact Index which contributes to its high LakeSPI ranking.

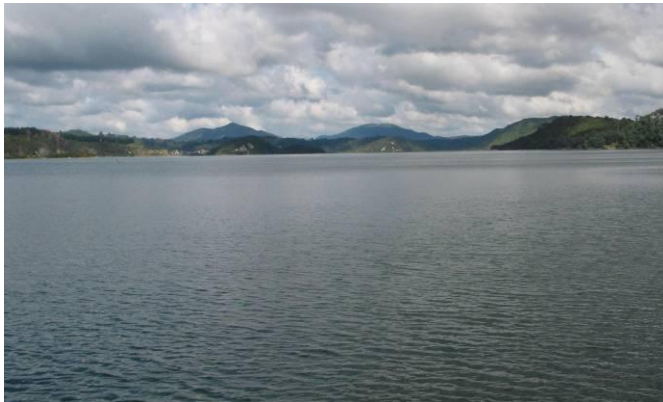
3.2 Lake Rotomahana

Lake condition: Moderate

Stability: Declining

After being the highest ranked lake in the Rotorua region for more than 20 years, declining lake condition values have resulted in Lake Rotomahana sliding into second position. The LakeSPI Index has declined by 20% since 2005 which is the largest change recorded for any of the 12 Rotorua lakes over this 5 to 6 year time frame and Invasive Impact scores have more than doubled. This is largely due to the recent invasion and continued spread by two of New Zealand's worst aquatic plant species, egeria and hornwort. Discovered for the first time in April 2007, egeria was found to be established in only two areas of the lake, at the north-eastern end and in the southern embayment, while hornwort fragments were found growing amongst native plants in the southern embayment (Clayton & de Winton, 2007; Scholes and Bloxham, 2008). Since then both species have continued to spread, with egeria now present at all 5 LakeSPI baseline sites (2 sites more than 2009) and forming bands of weed growth down to a depth of 8.5 m. The most recently recorded average maximum depth of vegetation (8.1 m) had reduced by more than 3 m since the 2009 survey when aquatic vegetation was recorded down to an average maximum depth of 11.4 m. This reduction in the depth and extent of vegetation is concerning and as both egeria and hornwort continue to further impact

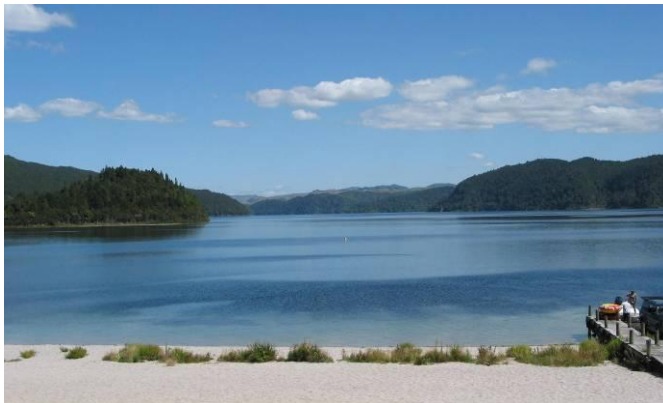
3.3 Lake Okataina

Lake condition: Moderate

Stability: Stable

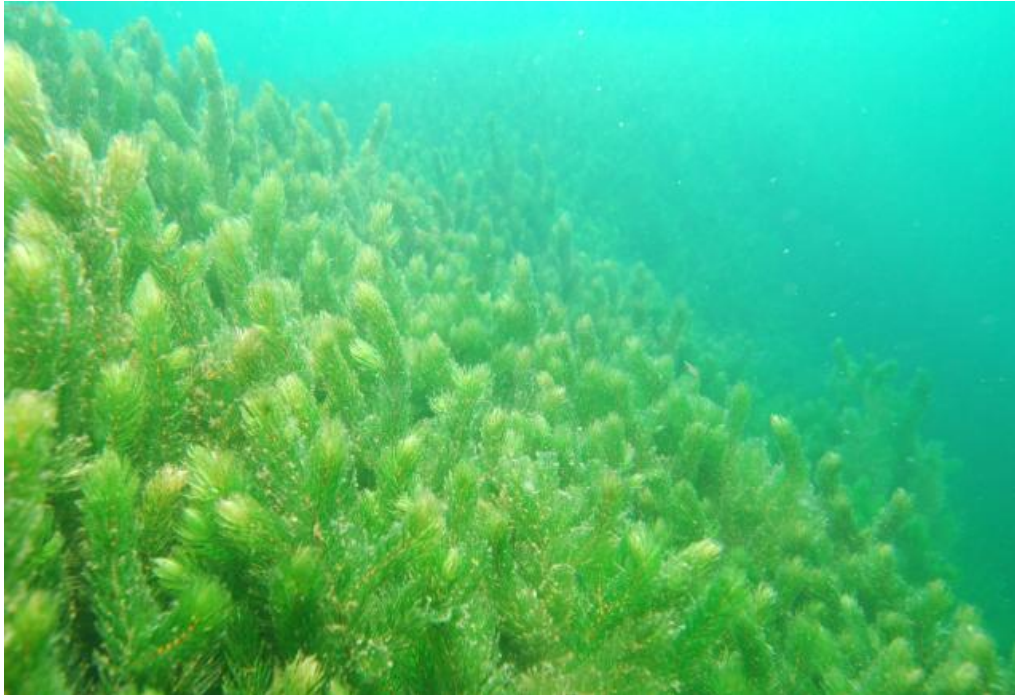
Figure 3: Invasive weed bed of hornwort (*Ceratophyllum demersum*) forming a wall of growth 8 m high and growing down to 12 m depth at the south-western end of Lake Okataina.

The discovery of an established bed of hornwort during the most recent 2010 survey poses a serious threat to the future condition of Lake Okataina. Hornwort fragments were found at the south-west end of the lake, with a search of the surrounding area revealing an established hornwort weed bed (Figure 3) growing in the middle bay west of Motuwhetero Island (authors pers obs.). Because only a couple of hornwort shoots were recorded from one of the five LakeSPI baseline sites, the Invasive Impact Index and other indices have not yet been greatly affected.

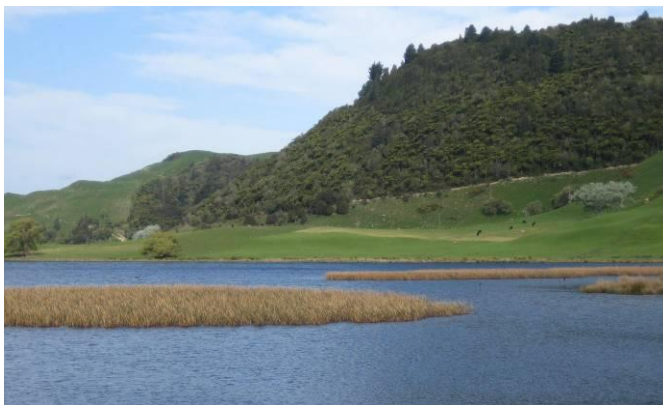
3.4 Lake Okareka

Lake condition: Moderate

Stability: Stable

Lake Okareka currently appears to be in a stable condition indicated by the recent LakeSPI indices showing little change over the last 8 years, from 2003 to 2011. Prior to this however, a 10% decrease in the LakeSPI Index between 1988 and 2003, resulted from a decline in the quality of native plant communities present, indicated by the Native Condition Index, and an increase in the Invasive Impact Index over the same time frame.

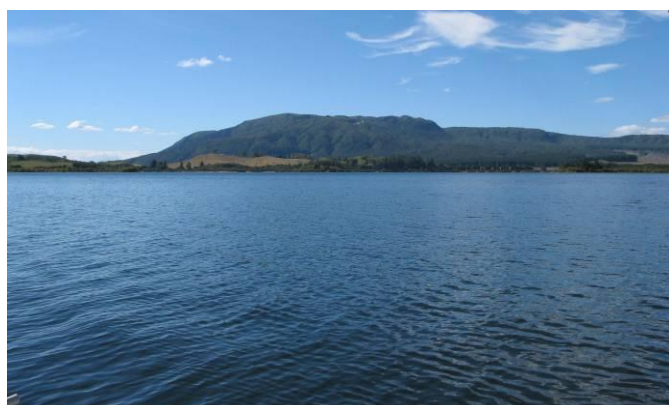
3.5 Lake Rerewhakaaitu

Lake condition: Moderate

Stability: Declining

After remaining relatively stable from 1988 to 2008, the most recent LakeSPI assessment shows a decline in the overall condition of Lake Rerewhakaaitu. Increased Invasive Impact scores reflect the wider impacts that egeria is now having upon the lake; and apparent decreases in water quality (author pers obs.) and retraction in charophyte depth limits are concerning for the future state of this lake.

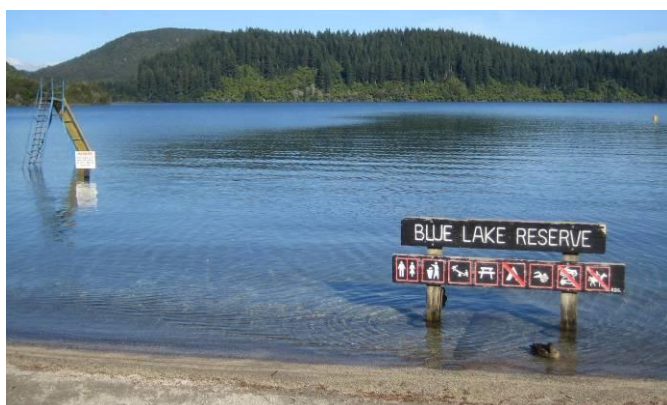
3.6 Lake Tikitapu

Lake condition: Moderate

Stability: Declining

The LakeSPI Index shows a reduction of 29% over the last 22 years to 2010 indicating that the condition of Lake Tikitapu has deteriorated faster than the other 11 Rotorua Lakes over this same period. Unlike the other lakes this decline is not due to the impact from new invasive species but from a substantial decline in the quality and extent of the native plant communities present.

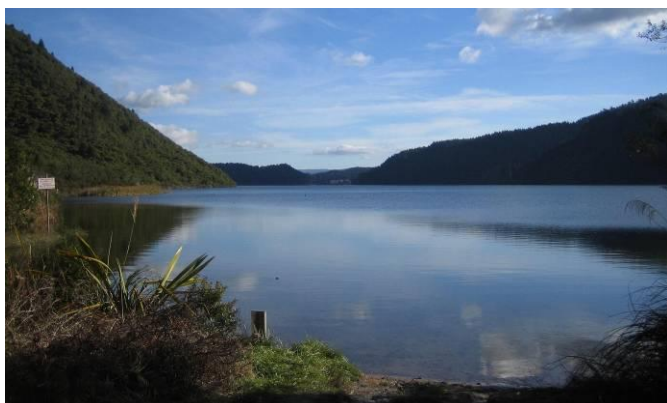
3.7 Lake Rotokakahi

Lake condition: Moderate

Stability: Declining

Lake Rotokakahi has undergone the second largest decline behind Lake Tikitapu shown for any of the 12 lakes over the same 22 year time period. The LakeSPI Index has almost halved with a 24% reduction from 1988 to 2010, whilst the Native Condition Index has also decreased by 38% largely due to a decline in charophyte meadows. This has occurred even though there has been no change in the dominant invasive species (*Elodea canadensis*) in this lake; although the relative impact of invasive presence on overall submerged vegetation has increased. The declining condition of Lake Rotokakahi, like Lake Tikitapu, is not due to invasive weeds but rather a decline in native condition presumably due to a change in water quality. Additional observations support this in Lake Rotokakahi, with filamentous algae prevalent on submerged vegetation and blue-green algal mats often covering sediments beyond the maximum depth of plant growth. These are indicators of poor lake health. Nutrient inputs are likely to be entering this lake from the predominantly farmland catchment as well as from sediment nutrient release during summer stratification. Recent logging in the catchment appears to have further increased lake turbidity since the last 2008 LakeSPI survey. A decline in oxygen content in deeper water has been noted by David Hamilton (Waikato University pers comm.), which is consistent with hypolimnetic nutrient enrichment taking place. Lake Rotokakahi is now the only Rotorua Lake to remain relatively free of significant invasive weed species.

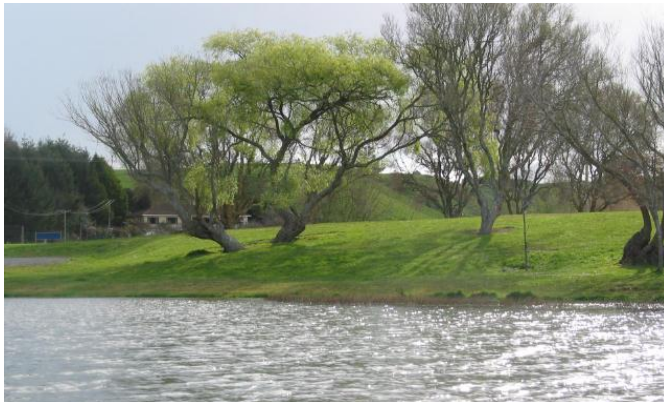
3.8 Lake Okaro

Lake condition: Poor
 Stability: Improving
 Lake ranking 8th

The degraded nature of Lake Okaro and its wide fluctuations in water quality and clarity account largely for the variation in LakeSPI scores, in particular in the Invasive Impact scores, generated for this lake over the last 29 years. The most recent LakeSPI results, however, are indicating a small improvement in the condition of Lake Okaro and it is now ranked in 'Moderate' condition. This result may reflect recent efforts by Environment Bay of Plenty to reduce nutrient influx into the lake and nutrient release from hypolimnetic sediments, which may well be helping to improve water clarity and be resulting in a positive vegetation response.

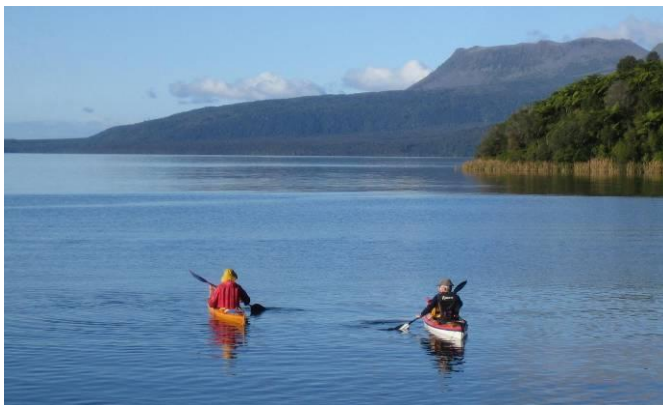
3.9 Lake Tarawera

Lake condition: Moderate

Stability: Stable

Lake Tarawera remains in a moderate condition and is not expected to change in the near future since the full impact of hornwort has now taken place.

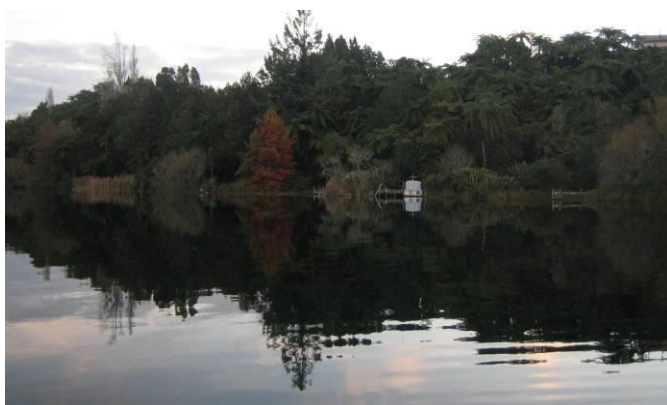
3.10 Lake Rotoiti

Lake condition: Poor
 Stability: Stable
 Lake ranking: 10th equal

Lake Rotoiti has a complex morphometry with areas along the northern shoreline that are too steep to support submerged vegetation, making them unsuitable for LakeSPI. The western end of Lake Rotoiti has in the past been predominantly influenced from Lake Rotorua inflows and there had been a progressive decline in submerged vegetation in several arms of Lake Rotoiti such as Okawa Bay, Wairau Bay and Te Weta Bay. Construction of the diversion wall to entrain Lake Rotorua inflows down the Kaituna River may see reduced water quality impacts, especially in this area. However flow-on effects on submerged vegetation is not yet clear. Sheltered areas with low water quality are presently often dominated by loose filamentous algae, attached benthic blue-green algal mats and planktonic blue-green algal blooms. The LakeSPI scores indicate poor water quality in this lake.

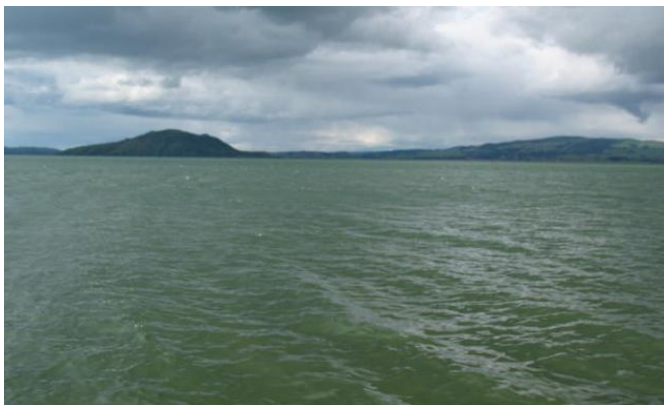
3.11 Lake Rotorua

Lake condition: Poor
 Stability: Stable
 Lake ranking: 10th equal

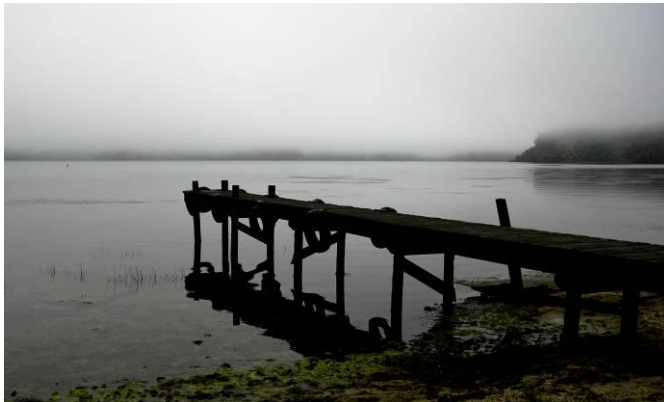
3.12 Rotoehu

Lake condition: Poor
 Stability: Declining
 Lake ranking 12th

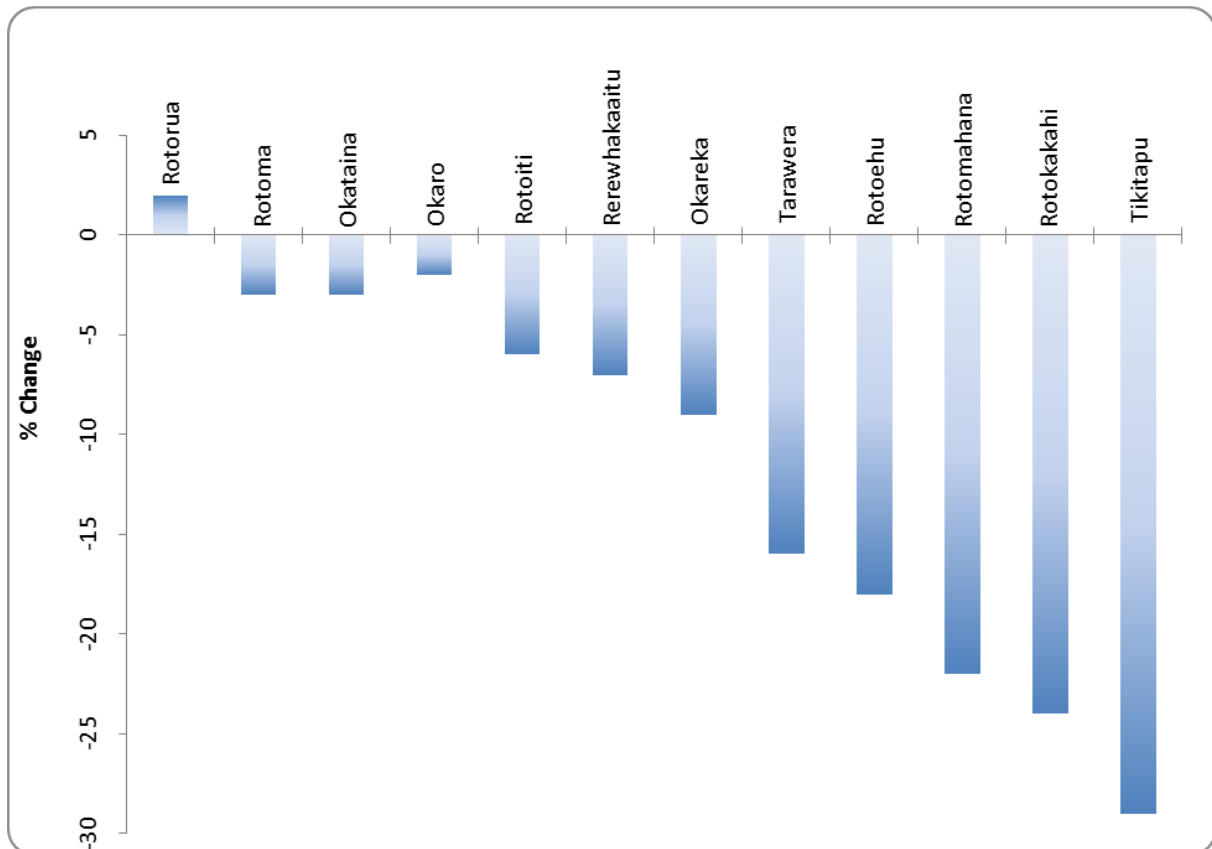
Figure 4: Percentage of change as indicated by the LakeSPI Index over the last 23 years, 1988 to 2010/11.

Many of the Rotorua Lakes have undergone significant change over the last two decades (Figure 4) and continue to be vulnerable to further changes from invasive plants and water quality deterioration. The submerged plant indicators used in LakeSPI provide an effective and alternative means to being able to assess these changes and monitor trends over time.

Lakes Tikitapu and Rotokakahi show the biggest change in lake condition over the last 20 years resulting from a notable reduction in the quality and extent of native submerged vegetation present in the lakes. There has been no new invasive species in either lake since full lake surveys in 1988, so these changes are likely the result of deteriorating water quality and clarity. Submerged plants are able to integrate long term changes in water clarity and nutrient status over time and often one of the first signs of deterioration is a retraction of the lower depth limit of plant growth (Schwarz et al. 1999). In many lakes the first valuable plant community to disappear is the charophyte meadow that grows into deeper water and this has been the case in Lake Tikitapu. In 1988 Lake Tikitapu supported extensive charophyte meadows at all 5 LakeSPI sites down to a mean depth of 19.5 m. By 2008, charophyte meadows ($\geq 75\%$ cover) were found at only one LakeSPI site with remnants ($\leq 5\%$ cover)

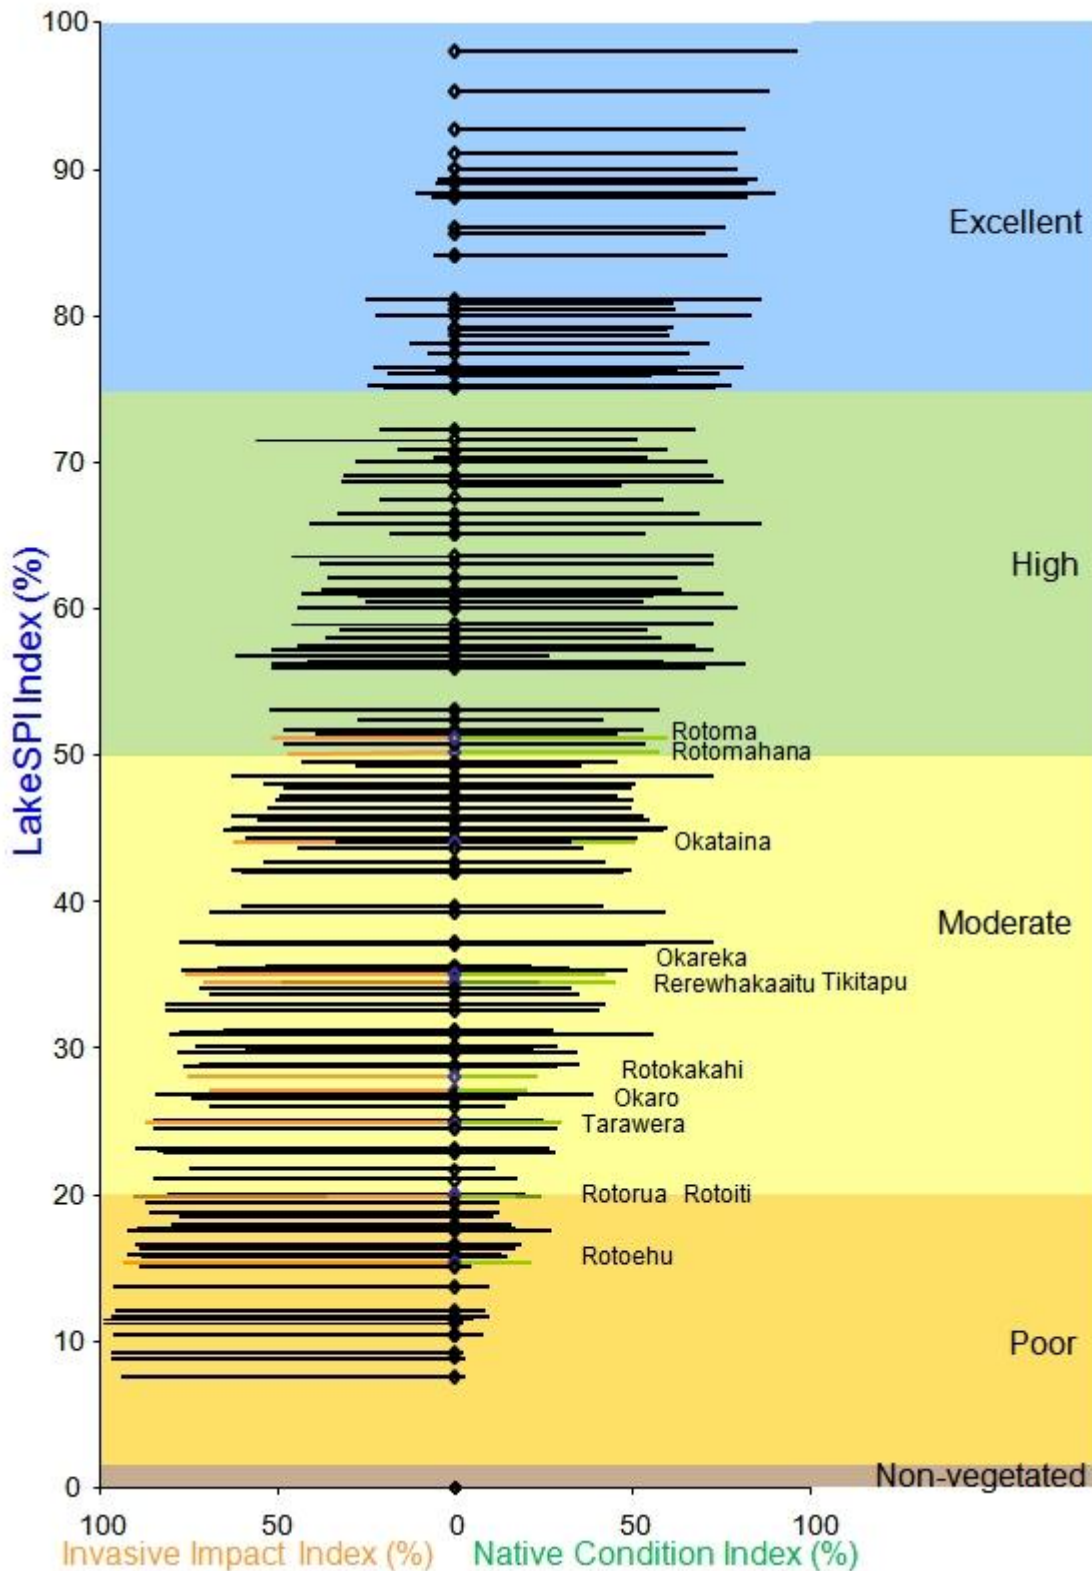
Figure 5: Current LakeSPI scores for 215 New Zealand lakes showing LakeSPI Index, Native Condition Index (right hand bars), and Invasive Impact Index (left hand bars).

Compared nationally, the Rotorua Region have no lakes classified as being in 'excellent' condition (representing those close to their maximum potential ecological condition) and only one lake classified as being in 'high' condition (Figure 5).

A 'moderate' condition category contains the majority of the Rotorua Lakes and contains the largest proportion of lakes nationally. This 'moderate' condition group of lakes are representative of those lakes that are impacted in varying degrees by invasive weeds.
