Assessment of the Rotorua Te Arawa lakes using LakeSPI - 2014

Prepared for Bay of Plenty Regional Council

June 2014

NIWA Client Report No:	HAM2014-067
Report date:	June 2014
NIWA Project:	BOP14203

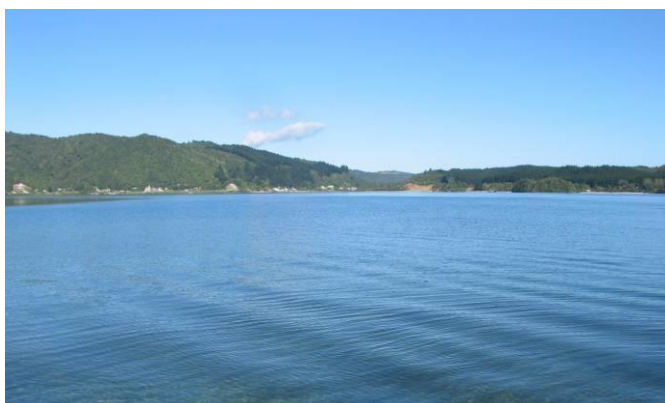
Lake Rotoma is the highest ranked lake in the Rotorua region and is categorised as being in high ecological condition with a LakeSPI Index of 55% (Figure 4).

In 1972 an underwater marker buoy was placed at the bottom boundary of submerged plant growth at one of the five LakeSPI baseline sites. Despite some water level fluctuations since that time this buoy still accurately marks the deepest plant boundary in 2013 after 40 years, which provides good evidence for the stability in water clarity during this period. This confirms that the impact of invasive species on submerged vegetation was the key early driver of change in LakeSPI scores.

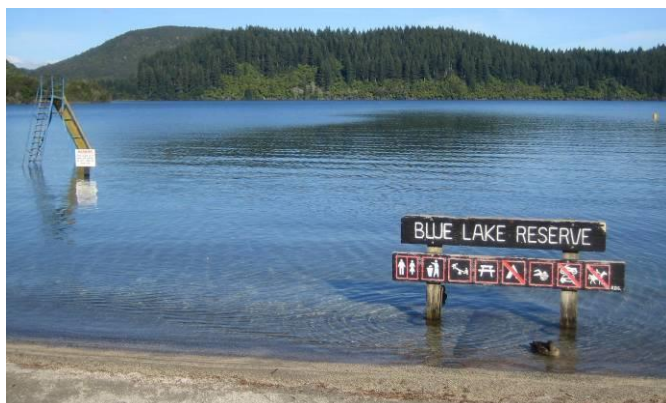
Lake Tikitapu is categorised as being in moderate ecological condition with a LakeSPI Index of 45% (Figure 5).

Longer term however, LakeSPI values show a significant reduction in the Native Condition Index compared to 26 years ago (Figure 5) reflecting a decline in the diversity and extent of the native plant communities present. Unlike most other lakes, this reduction has not been due to the impact from new invasive species.

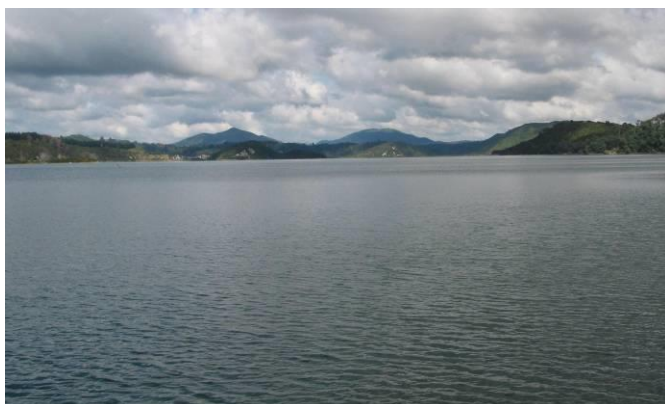
Lake Rotomahana is categorised as being in moderate ecological condition with a LakeSPI Index of 42% (Figure 6).

After being the highest ranked lake in the Rotorua region for more than 20 years, declining lake condition has resulted in Lake Rotomahana moving into third rank order. The LakeSPI Index has dropped 24% since 2008 which is the largest change recorded for any of the 12

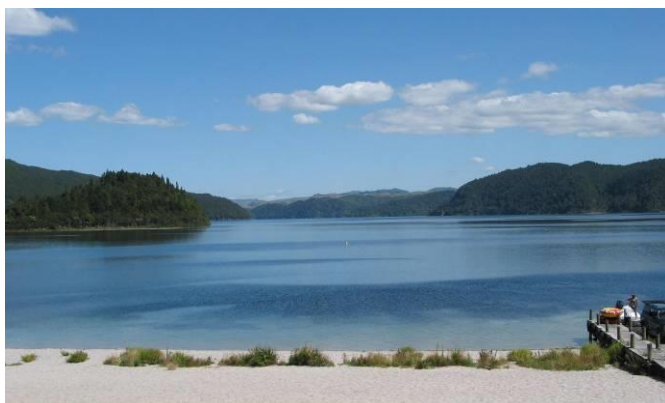
Lake Okataina is categorised as being in moderate ecological condition with a LakeSPI Index of 40% (Figure 5).

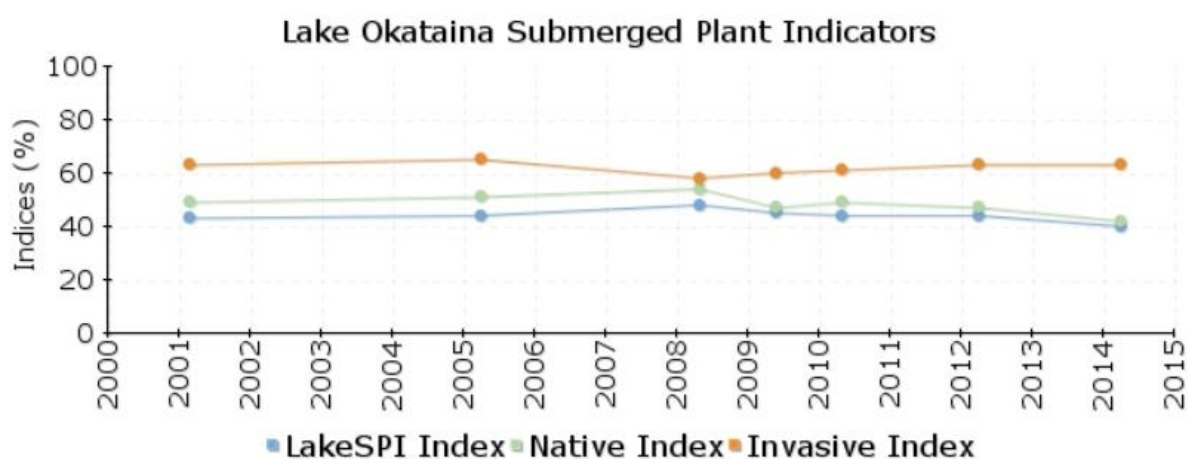
Survey Date	Status	LakeSPI %	Native Condition %	Invasive Impact %
March 2014	Moderate	40%	42%	63%
March 2012	Moderate	44%	47%	63%
April 2010	Moderate	44%	49%	61%
May 2009	Moderate	45%	47%	60%
April 2008	Moderate	48%	54%	58%
March 2005	Moderate	44%	51%	65%
February 2001	Moderate	43%	49%	63%
November 1988	Moderate	47%	53%	57%
April 1981	High	51%	57%	53%

Figure 7: LakeSPI results for Lake Okataina. LakeSPI Indices expressed as a percentage of lake maximum potential.

A reduction in the depth extent of plant communities was noted in during the 2014 survey, although this was insufficient to cause a significantly change in LakeSPI scores. Because the lake has no outlet, water levels can vary by several metres, so there is potential for water levels to affect the available habitat for submerged vegetation in shallow water, and also the maximum depth extent of plant colonisation. Nevertheless, if water level changes are slow, vegetation can usually compensate by migrating up- and down-slope. BOPRC water level recordings show that lake levels during the 2014 survey were approximately 1m lower than during the 2012 survey and could have influenced the apparent depth reduction. Over the long-term, LakeSPI scores for Lake Okataina have been stable, with only minor fluctuations.

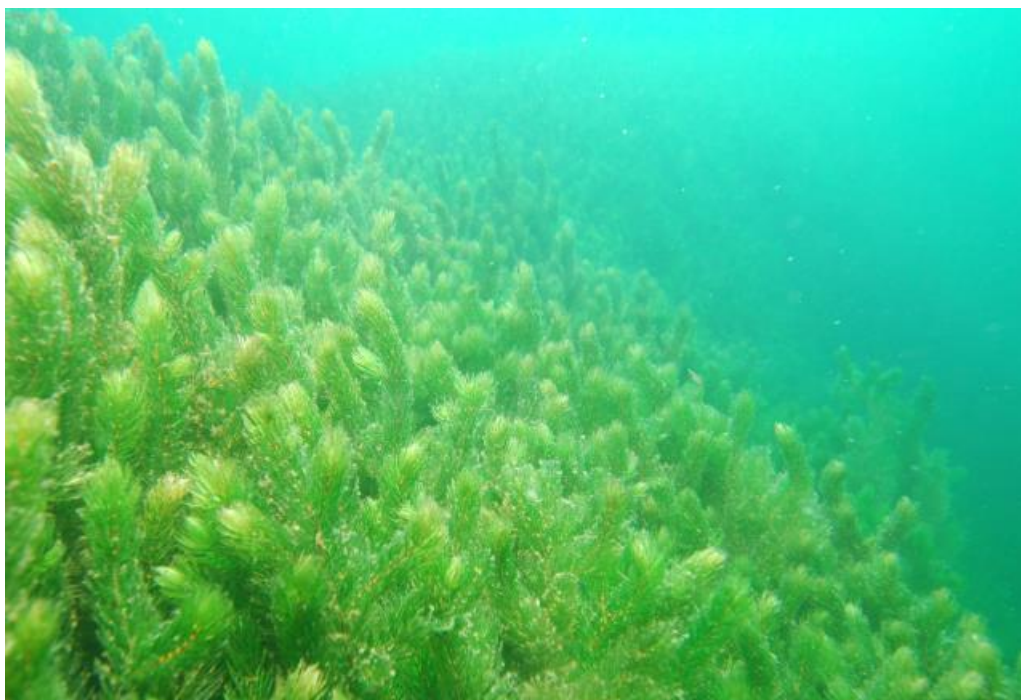
Figure 8: Invasive weed bed of hornwort (*Ceratophyllum demersum*) forming a wall of growth 8 m high and growing down to 12 m depth at the south-western end of Lake Okataina in 2010.

Hornwort continues to pose the most serious threat to the future condition of Lake Okataina. Hornwort was first detected in Lake Okataina in 2007 and was thought to be successfully eradicated. It was not until 2009 that the detection of additional drift fragments led to the discovery of a major hornwort incursion in 2010. Incursion management since this time, using a weed cordon and diquat herbicide, has likely prevented a major spread and impact of hornwort and it is still not yet recorded at any LakeSPI sites. It was however found during the 2014 survey to be established close to one of the LakeSPI sites, in the South Eastern Bay, South of Motuwhetero Island (author's observations). Should hornwort continue to spread, it is likely that we will see a reduction in LakeSPI scores in the future.

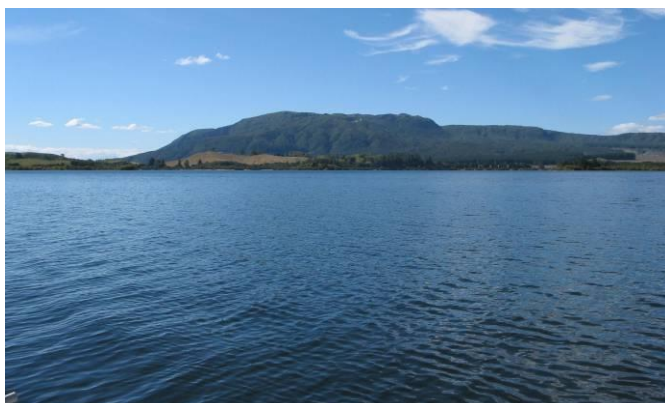
Lake Rerewhakaaitu is categorised as being in moderate ecological condition with a LakeSPI Index of 40% (Figure 9).

Lake Rerewhakaaitu currently appears to be in a stable condition with possible early signs of improvement. This has followed a period of instability, predominantly due to the impacts from invasion by *Lagarosiphon* and *Egeria*. A current LakeSPI Index of 40%, close to what it was in 2008 (Figure 9) followed a small increase in the depth extent of native plants at most sites

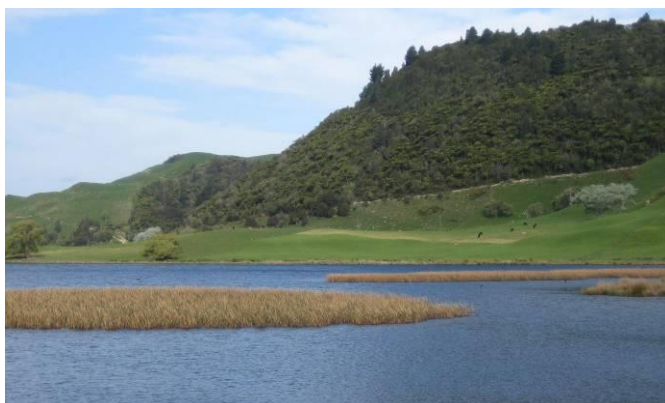
Lake Okareka is categorised as being in moderate ecological condition with a LakeSPI Index of 36% (Figure 10).

Lake Okareka is currently in a stable condition indicated by the recent LakeSPI indices showing little change since 2008 (Figure 10). Prior to this however, a small increase in the Invasive Impact Index in 2003 due to the establishment of egeria, led to a 10% decrease in the LakeSPI Index.

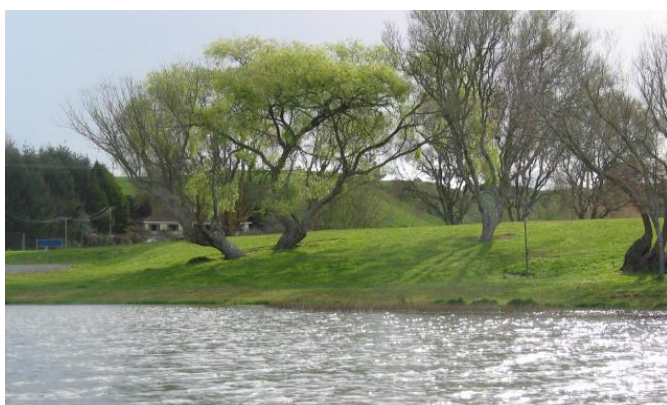
Lake Okaro is categorised as being in moderate ecological condition with a LakeSPI Index of 35% (Figure 11).

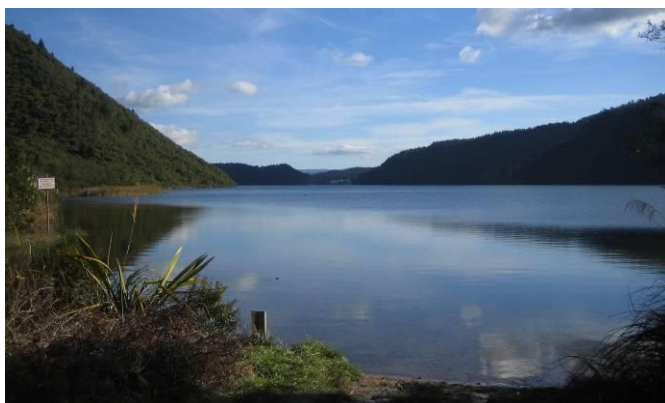
Lake Rotokakahi is categorised as being in moderate ecological condition with a LakeSPI Index of 26% (Figure 12).
