# Lake Ōkātina water quality Background information 2012

September 2012

This document is prepared to assist with development of a Lake Ōkātina Action Plan –  
a non-statutory document for improving water quality in Lake Ōkātina.

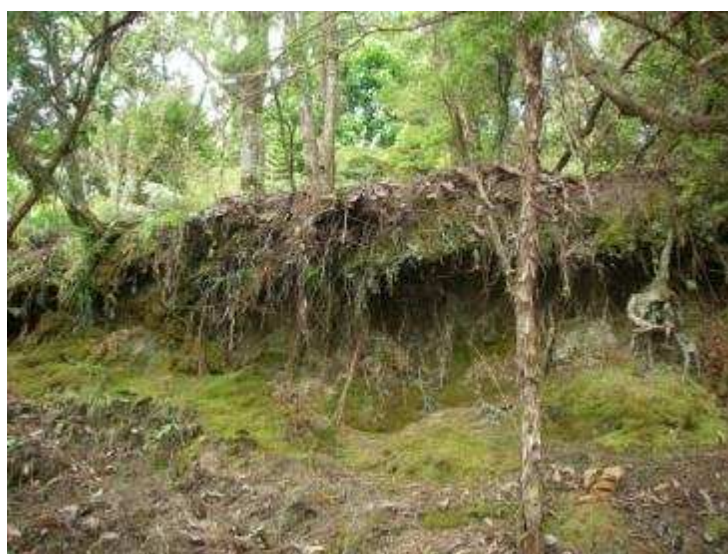
**Figure 4. Photo showing organic matter holding the soil together, Eastern Lake Ōkātina walkway, December 2011**

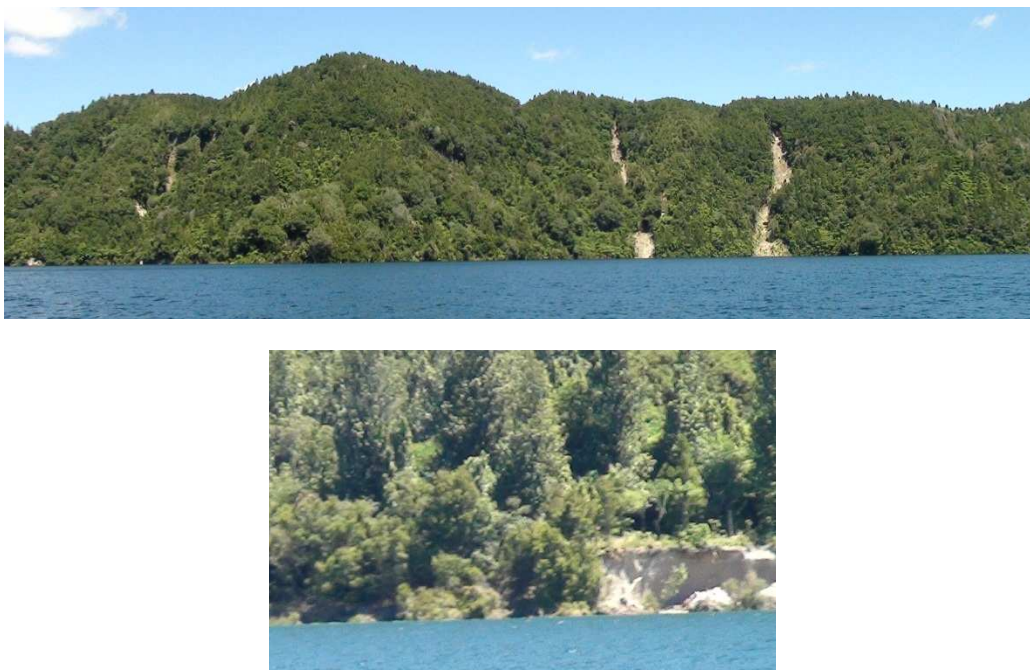
**Figure 6. Photos showing landslides and erosion, January 2012**

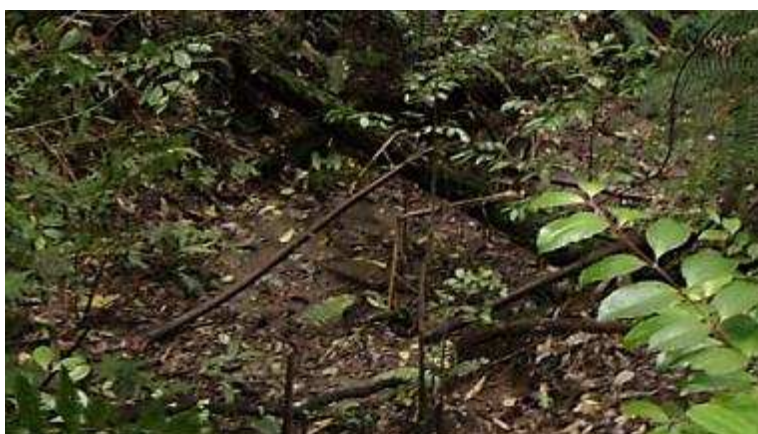
**Figure 7. Pukahu Stream during summer.**

Streams are seasonal in the Lake Ōkātina catchment. The Pukahu Stream was dry in January 2012.

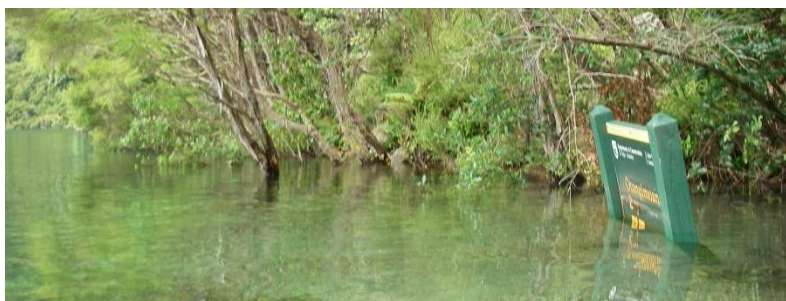
**Figure 8. High water levels in Lake Ōkātina submerge a sign post at Otangimoana Bay, November 2011**

During the past 30 years, the lake level has had a range of about 5 m (Department of Conservation). Between 1962 and 1971 the lake rose 3 m, submerging beaches, damaging bush and causing major erosion around the lake (Gosling, 2002; Department of Conservation). A rise of more than 10 m has occurred in the last 100 years or so. During dry spells, the lake bed can be exposed. Better understanding of the causes of natural fluctuations in water levels will help our interpretation of water quality in Lake Ōkātina.

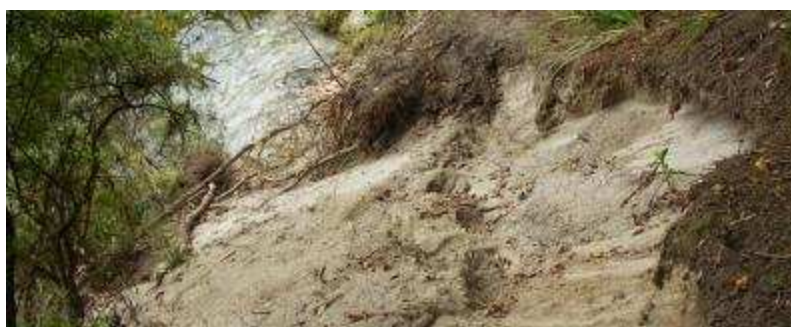
**Figure 9. A slip by the lake edge, Eastern Ōkātina Walkway between Oruaroa Bay and Otangimoana Bay, November 2011**

Once saturated by water, the pumice soil tends to erode easily causing landslides into Lake Ōkātina (Rijkse and Guinto, 2010).

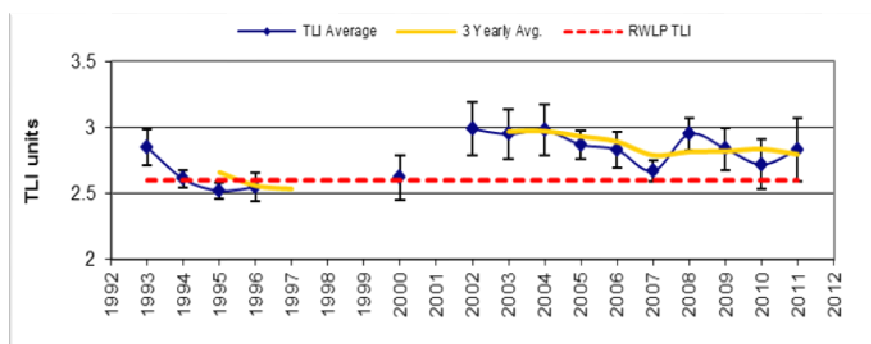
**Figure 11. Annual average TLIs, three-yearly average TLIs and the target TLI set in Regional Water and Land Plan**

The trend in the last 10 years shows the concentration of total phosphorus has been going up slightly, while the concentration of total nitrogen has been coming down slightly.

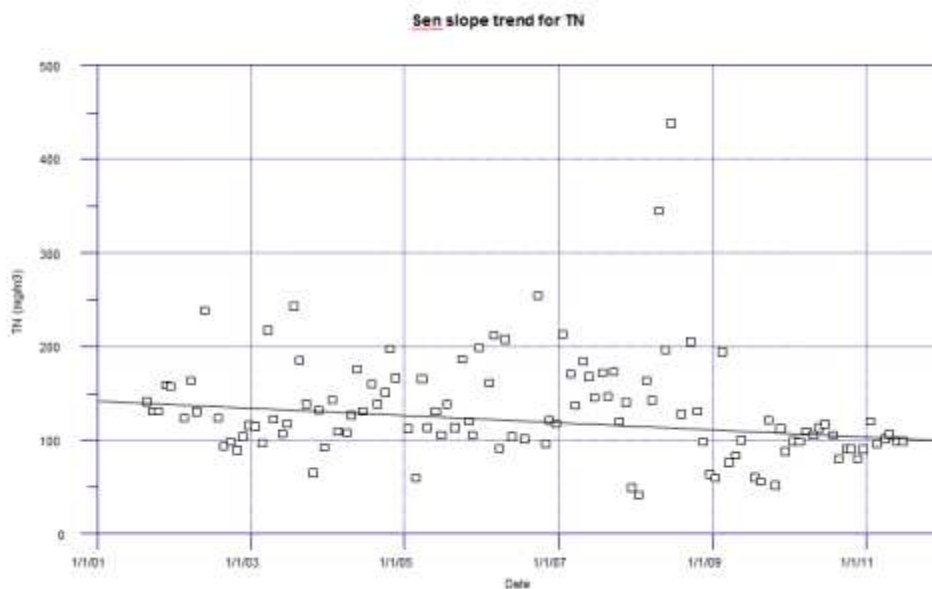
**Figure 13. Nitrogen concentration in Lake Ōkātina (2001-11)**

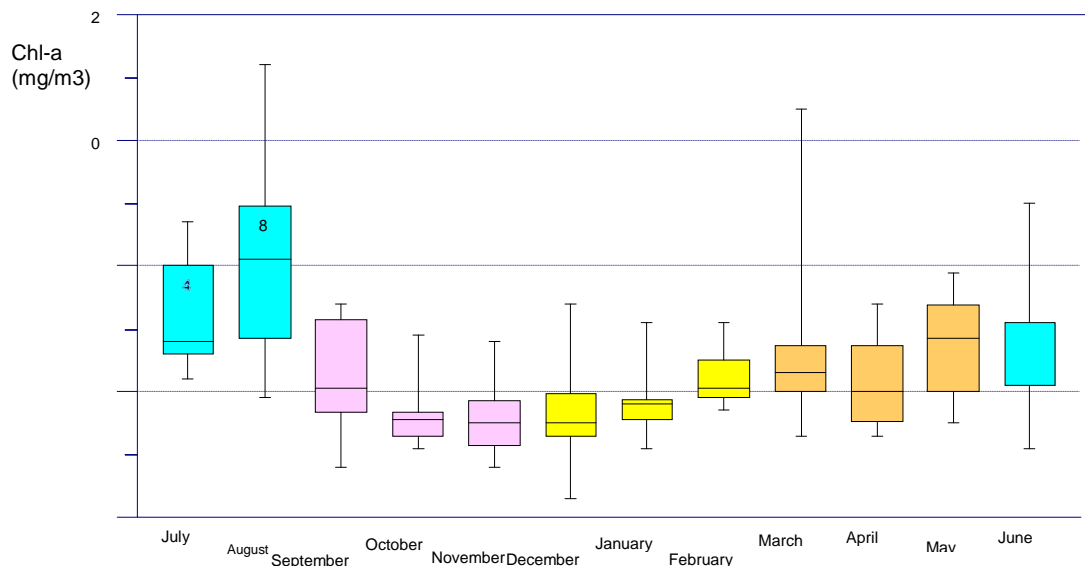
**Figure 14. Concentration of chlorophyll-a in Lake Ōkātina showing seasonal variation**

Concentrations are high in winter and low in summer. Box and whisker plot shows average, upper and lower quartile and maximum and minimum chlorophyll-a concentrations from 2000 – 2011.

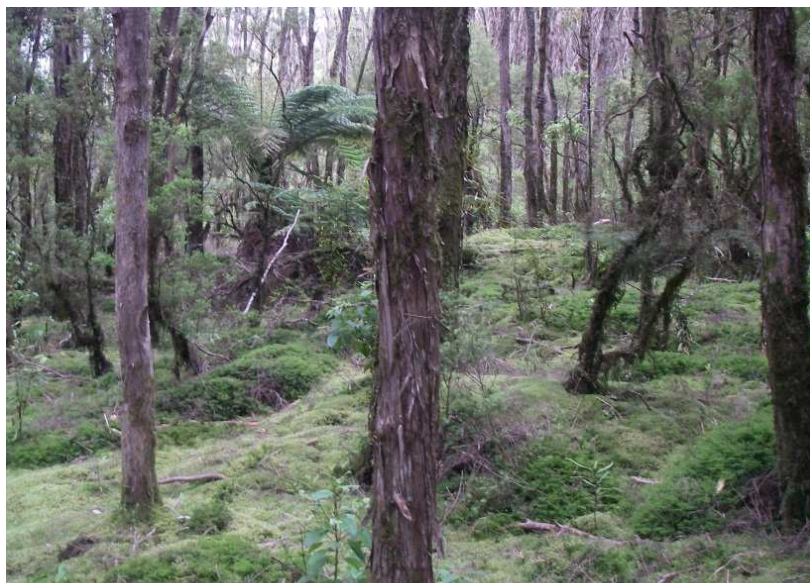
**Figure 22. Native Forest, Lake Ōkātina**

Nearly 80 percent of the land cover in the Ōkātina catchment is native forest.

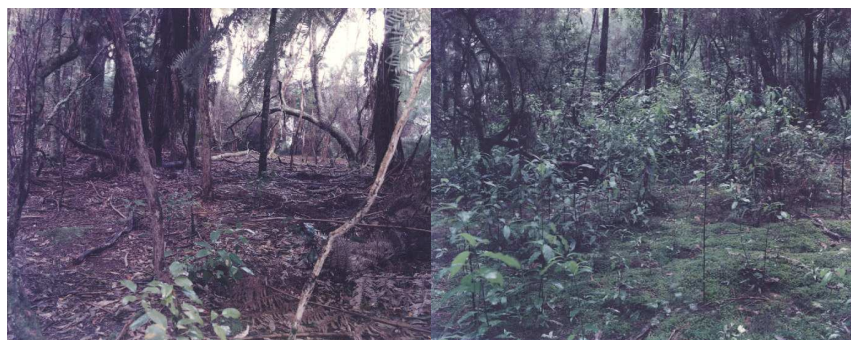
According to the Department of Conservation, the Ōkātina Scenic Reserve forest has been damaged at all levels by a variety of pest animals, from the ground to the canopy. Native bush in Ōkātina is infested with wallabies and deer, which graze the forest understory. An experimental site is showing how forest can regenerate and provide dense cover.

**Figure 23. Photos showing the difference between animal-grazed (left in 1995) and non-grazed forest (right in 2011 with pest exclusion), near Lake Ōkātina**

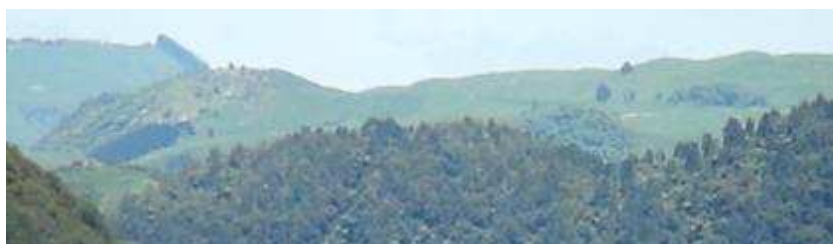
**Figure 24. Most pasture land is located at the top (elevated) part of this catchment, January 2012**

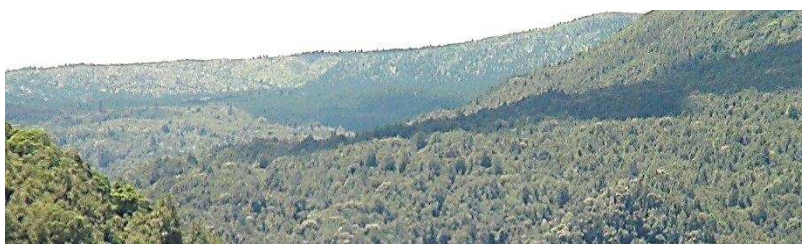
**Figure 25. Forestry land on the top of the Lake Ōkātina catchment, January 2012**

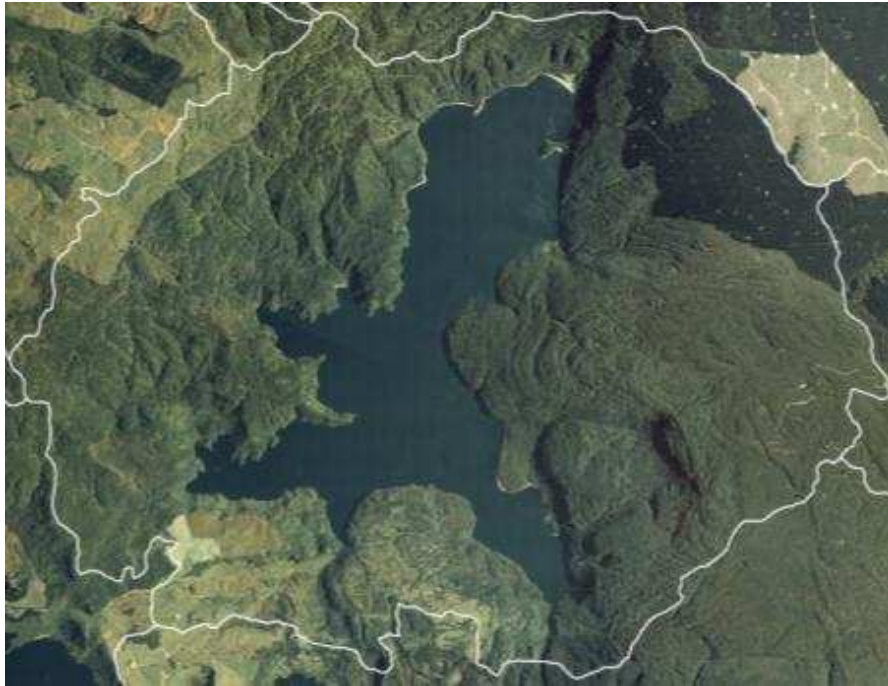
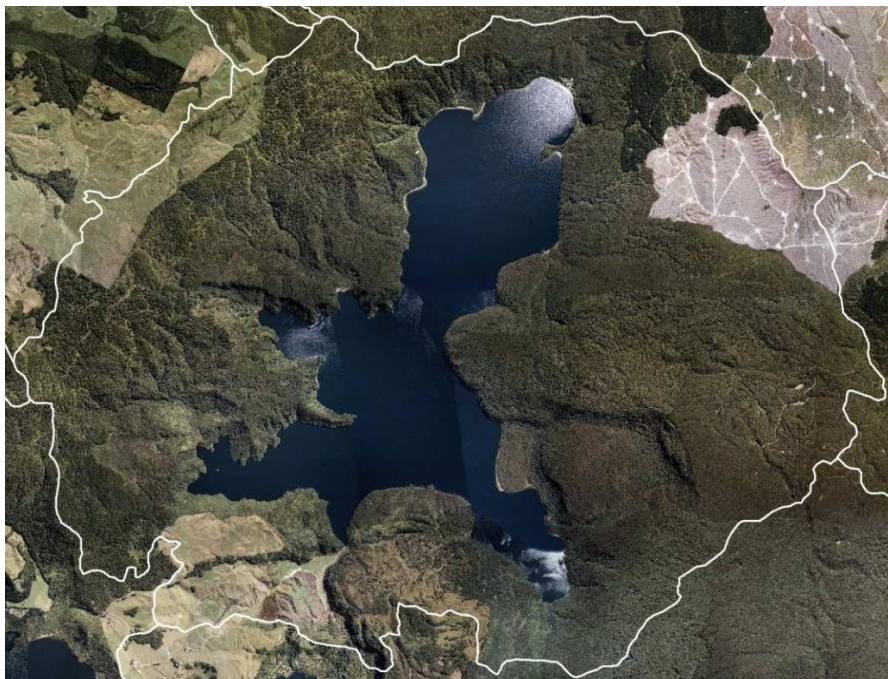
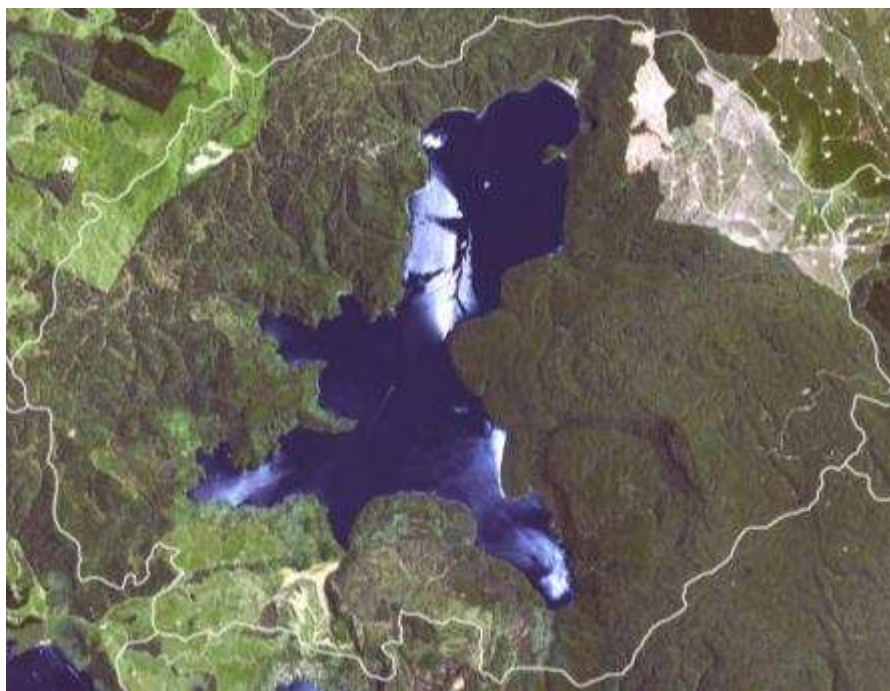
The surface cover of both pastoral and exotic forest land could change rapidly as economic returns from these primary industries change. The following three images show the surface changes of the Lake Ōkātina catchment between 2003 and 2009.

**Figure 26. Lake Ōkātina catchment aerial mosaic image, 2003**

**Figure 27. Lake Ōkātina catchment aerial photo image, 2006/2007**

**Figure 28. Lake Ōkātina catchment satellite image, 2009**

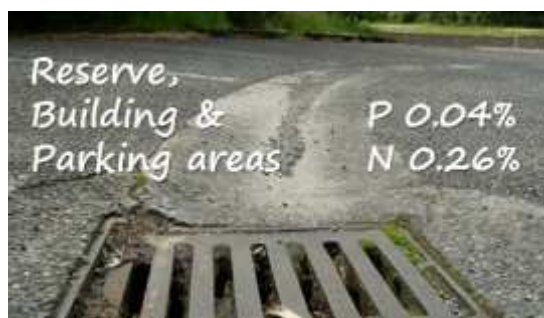
Figure 29. Stormwater drain in the car park next to Tauranganui Bay

The Ōkātina catchment has a limited built-up area, which contributes a small amount of nutrients to the lake every year.

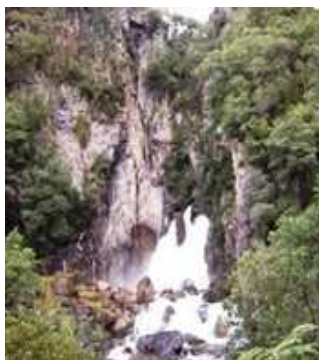
**Figure 30. Tarawera waterfall**

Tarawera waterfall (Figure 30) and Earthquake Flat are two good examples showing groundwater dynamics in the district.

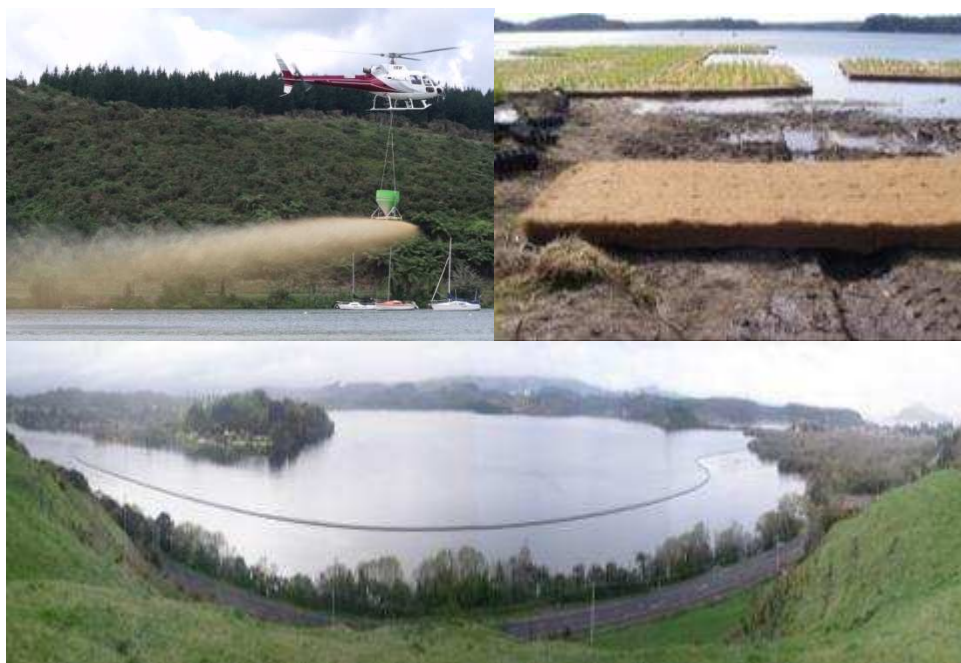
**Figure 32. Chemical dosing at Lake Ōkāreka (top left); floating wetland in Lake Rotorua (top right); diversion wall in Lake Rotoiti (bottom)**

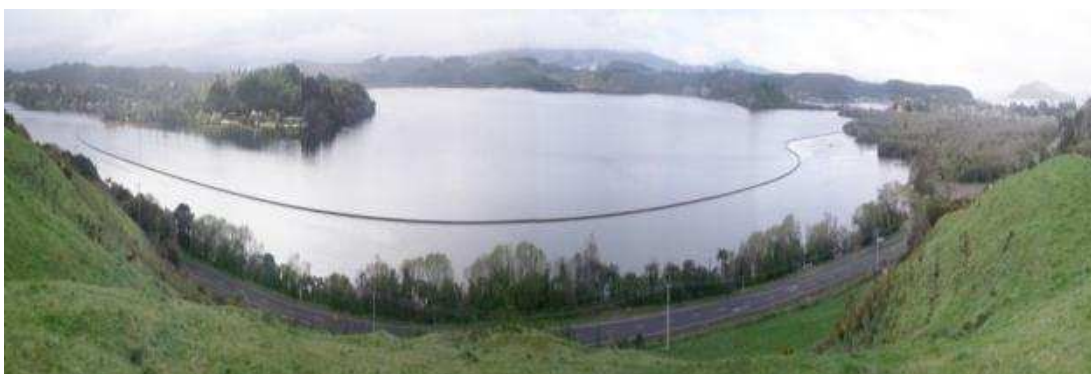
**Figure 33. Diversion wall in Lake Rotoiti**

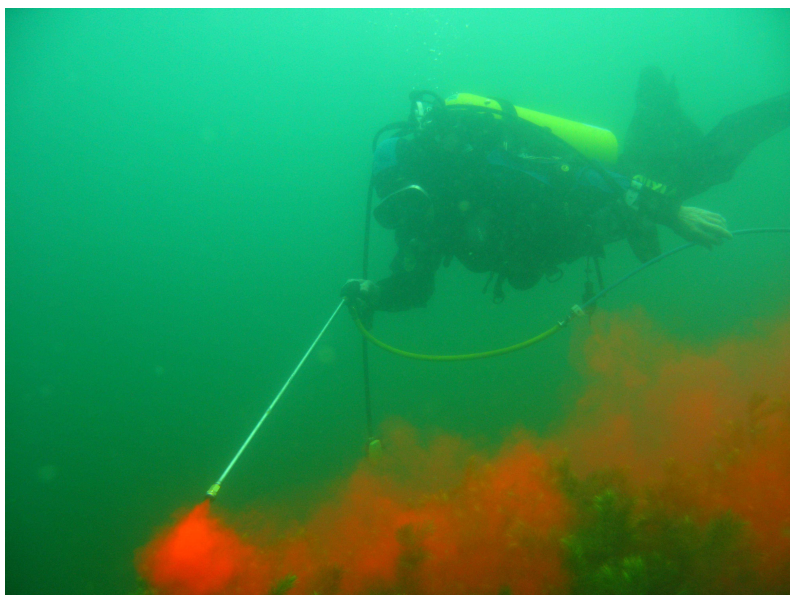
**Figure 34. Controlling aquatic weeds in Lake Ōkātina by manually applying tracer-dyed herbicide on Hornwort (photo by courtesy of NIWA)**
