Lake Rotokakahi water quality update 1990-2011

ERI report number: 009

Prepared for Bay of Plenty Regional Council By Joseph Butterworth

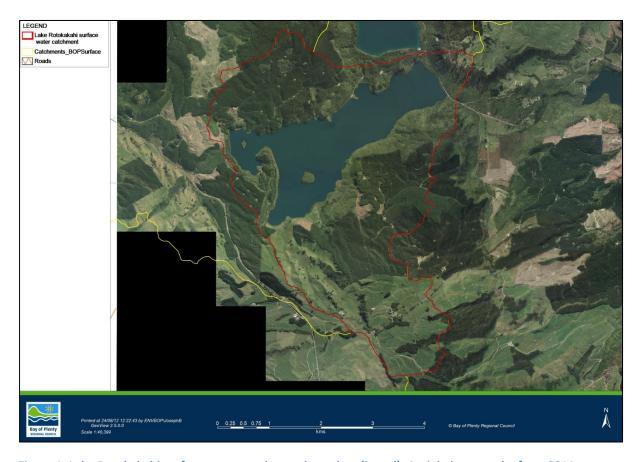
Figure 1: Lake Rotokakahi surface water catchment boundary (in red). Aerial photography from 2011.

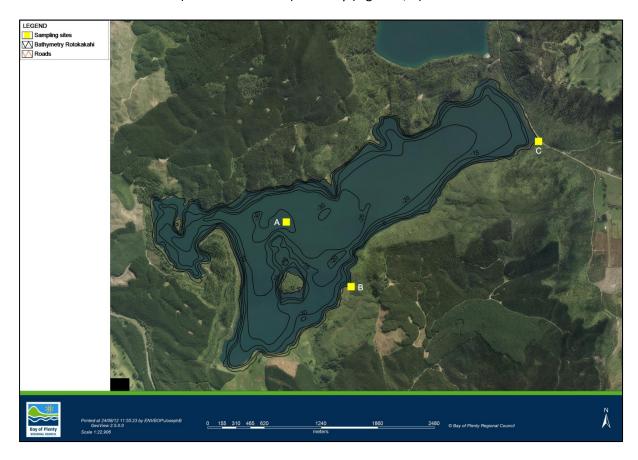
Figure 2: Lake Rotokakahi sampling locations. A = central-lake station, B = small spring-fed inflow, C = Lake Outlet (Te Wairoa Stream). Image from aerial photography in 2011.

From 2006-present water quality sampling was conducted monthly at both a central lake sampling station near the Lake's deepest point (Figure 2, A) and at the only known surface inflow comprising of a small spring fed stream (Figure 2, B). From 2000-present Bay of Plenty Regional Council staff has monitored the Lake Outlet (Te Wairoa stream) monthly (Figure 2, C).

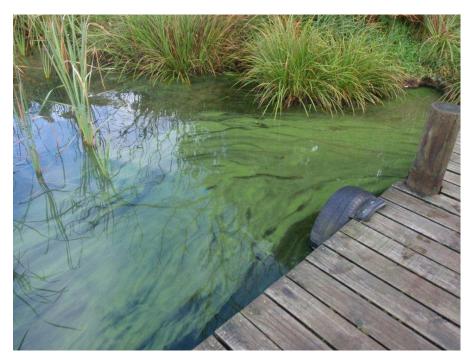
Figure 11: Surface bloom of Anabaena lemmermannii at the southern access boat ramp. Photographed on the 3 May 2011, 20 days before the Te Wairoa Stream fish kill.

On the morning of 23 May 2011 light south to south-west winds appeared to cause the algal bloom to accumulate against the lake shore near the Lake Outlet. By afternoon the bloom had become highly concentrated and cells were likely entering the Lake Outlet in high concentrations, subsequently resulting in the death of many trout within the stream overnight. As fish kill events resulting from cyanobacteria blooms alone are very unusual, a possible scenario is that the short but highly concentrated pulse of algal cells created multiple unfavourable conditions within the stream. These conditions may have included short-term low dissolved oxygen levels which likely combined with an elevated pH level within the stream. The cyanobacteria may also have caused some "clogging" of the gills which would have restricted gaseous exchange (Matt Bloxham, pers. Comm.), however this was not confirmed (for more detail on this fish kill event refer to the appendix). This event was of particular concern to Eastern Fish and Game New Zealand as mature spawning trout within the Te Wairoa Stream are used as brood stock for the Rotorua Trout Hatchery.

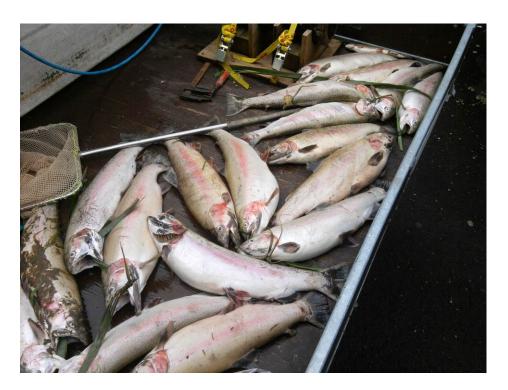
Figure 1: Rainbow trout retrieved from Te Wairoa Stream by Fish and Game staff.

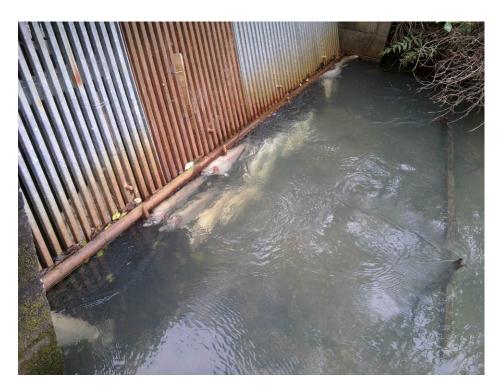
Figure 2: Rainbow trout as found by Fish and Game staff at the Te Wairoa Stream fish trap. Photograph taken by Mark Sherburn on the 24th May (the morning after the evening 'event'). Note stream milky though not obviously green in the way it would be if transporting bloom material.

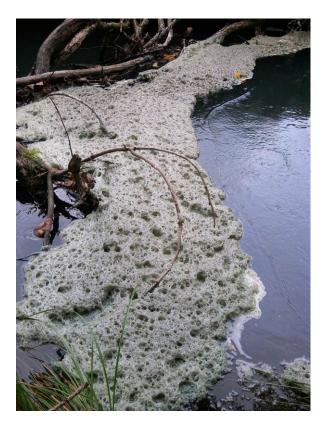
Figure 3: Scum material similar to that sampled by Mark Sherburn the investigating Fish and Game officer on the 24th May (the morning after the evening 'event'). Photograph taken by Mark Sherburn.

We analysed Mark's Te Wairoa scum sample (Figure 3) and confirmed that it was dominated by *Anabaena lemmermannii, a* known cyanotoxin producing species. Arrangements were therefore made to send a sample off for cyanotoxin analysis. Mark Sherburn's May 24th sample⁴, the most concentrated sample collected, was sent away to Cawthron for analysis.

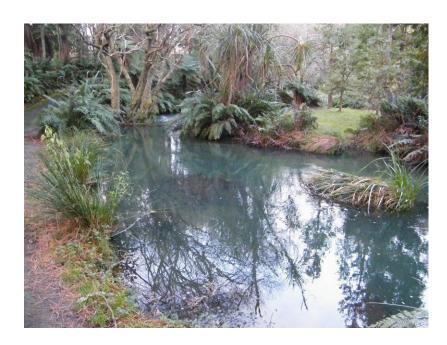
Figure 4: Te Wairoa Stream photographed by Pam McGrath, 26th May (two days after the bloom event).

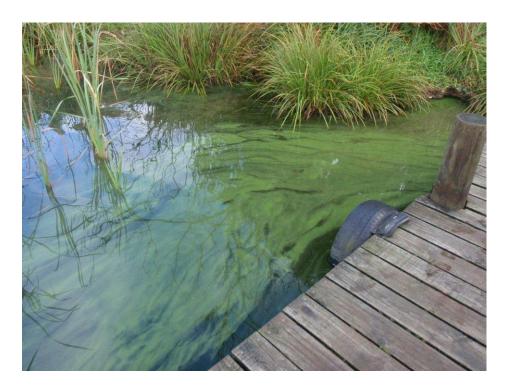
Figure 5: Scum material at the southern end of Lake Rotokakahi photographed by Joseph Butterworth on the 3rd of May 2011, 20 days before the Te Wairoa fish kill).

Weather was poor with high winds and rain. The high winds forced Joseph and Ross to launch at the sheltered southern end of the lake. Wind was blowing onshore at the Tarawera Road end of the lake. Bloom material was observed at the launching point similar to this earlier surface bloom (Figure 5) at the opposite (southern) end of the lake.

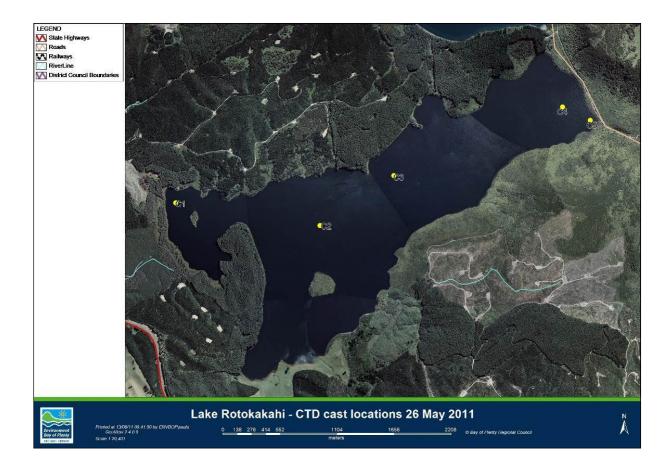
Light was only penetrating to ten metres depth indicating the water clarity was only in the order of a few metres. Conductivity shows a well-mixed epliminion, with varying conductivity in the hypolimnion as might normally be expected. Fluorescence sensor also shows algae were well mixed through the epliminion and at levels lower than more eutrophic lakes.

Figures 6 and 7: Schematic showing location of CTD casts and graph showing results for cast 3 (middle of lake) and DO, conductivity, PAR/irradiance Temperature depth profiles from 26th May (3 days after the Te Wairoa Stream event).

Two days after the initial fish kills were reported, Joseph Butterworth, Brooke Thomas and Ross Powell carried out water sampling and measured the lakes DO profile using the CTD. A number of profiles where undertaken down the length of the lake to investigate whether the lake had become destratified and/or whether there were any abnormalities of note. Figure 6 shows the location of the casts.

Cast 3 in the lake's deeper sections confirmed that the lake was still stratified days after the event as water in the bottom three to four metres of the lake was anoxic and had a different temperature gradient⁵. It has been variously suggested that a smaller expulsion of anoxic water from the hypolimnion could have occurred. However, the tendency is not for anoxic water to upwell in concentrated slugs but for surface waters to gradually mix down at turnover, making an anoxic event, in the lake at least, less likely (pers. comm. John McIntosh).
