Ohau Channel Diversion Wall

John McIntosh
Te Waiti Marae
22 November 2013

The wall was completed in August 2008

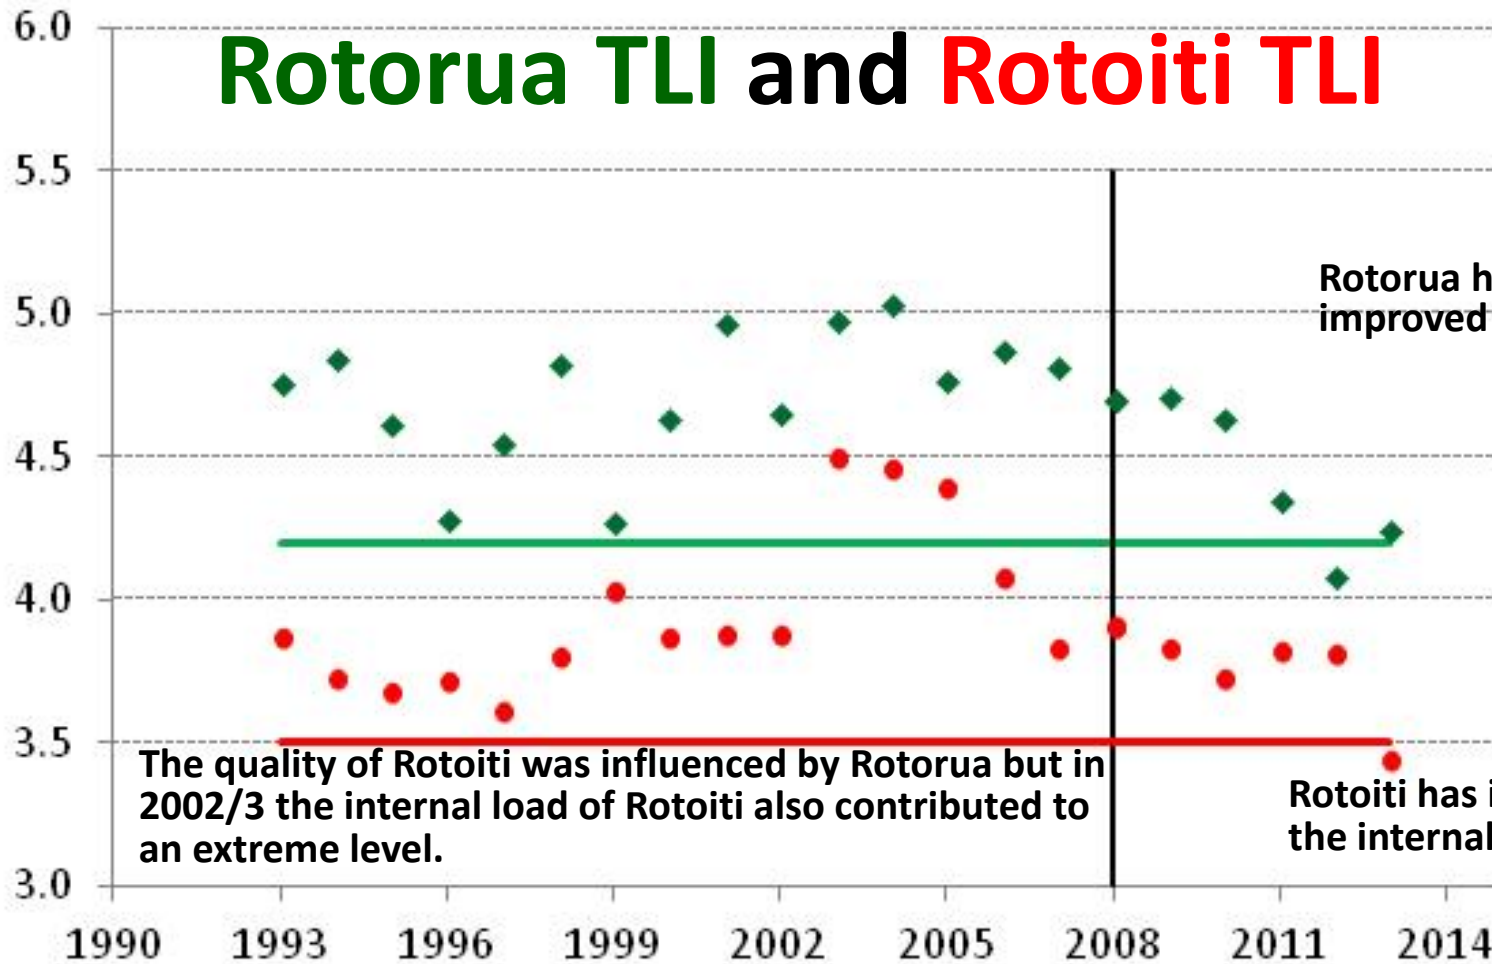
Rotorua TLI and Rotoiti TLI

Rotorua has improved markedly

The quality of Rotoiti was influenced by Rotorua but in 2002/3 the internal load of Rotoiti also contributed to an extreme level.

Rotoiti has improved as the internal load subsides

**Lake Rotorua - improved quality
due to sewage reticulation,
alum dosing and some land-
use change.**

**Lake Rotoiti improved by
restricting Lake Rotorua water**

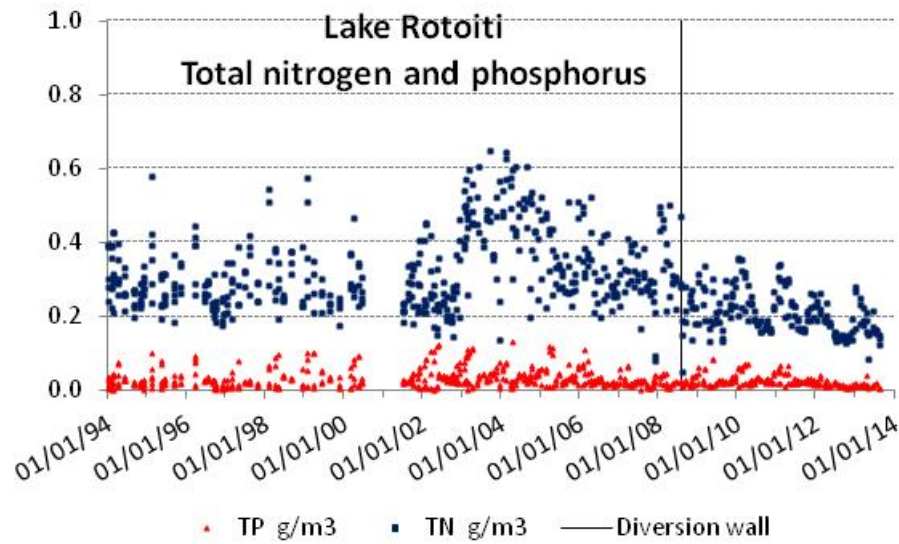
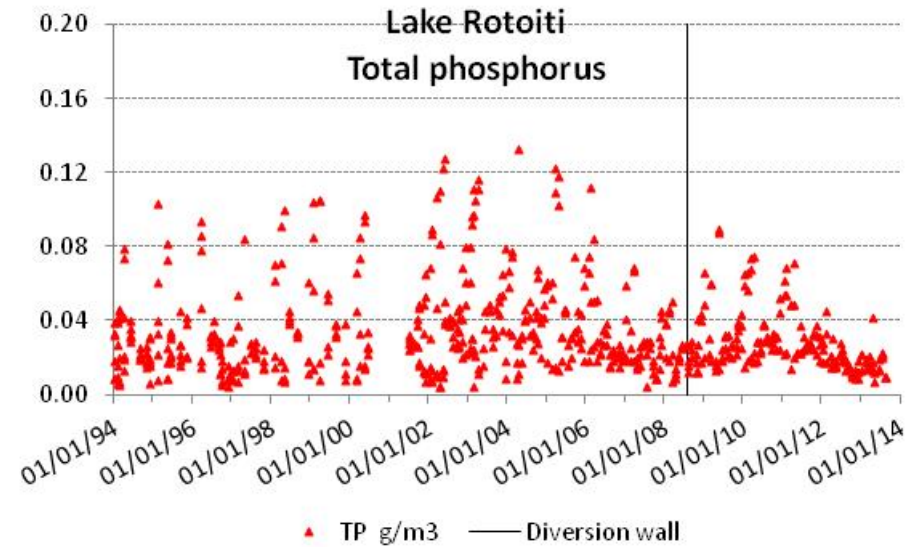
Lake Rotoiti

1994 - 2013

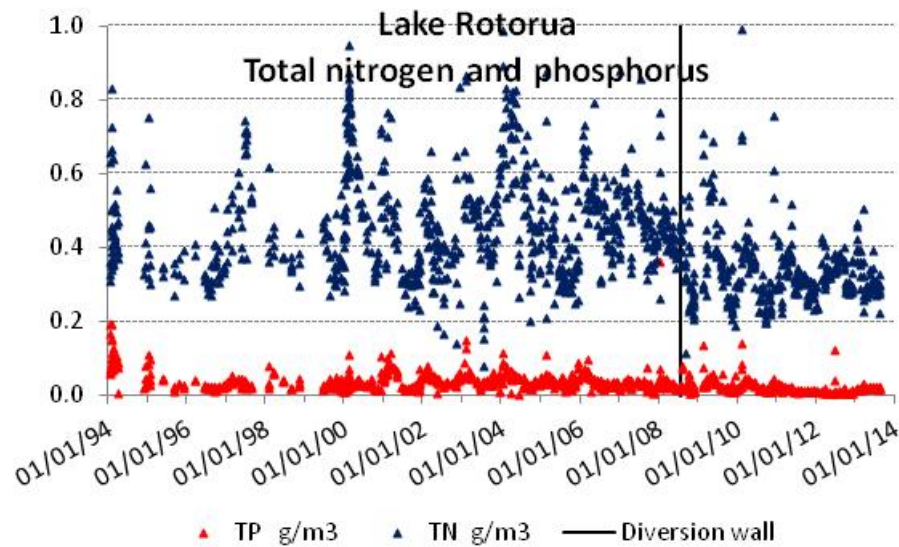
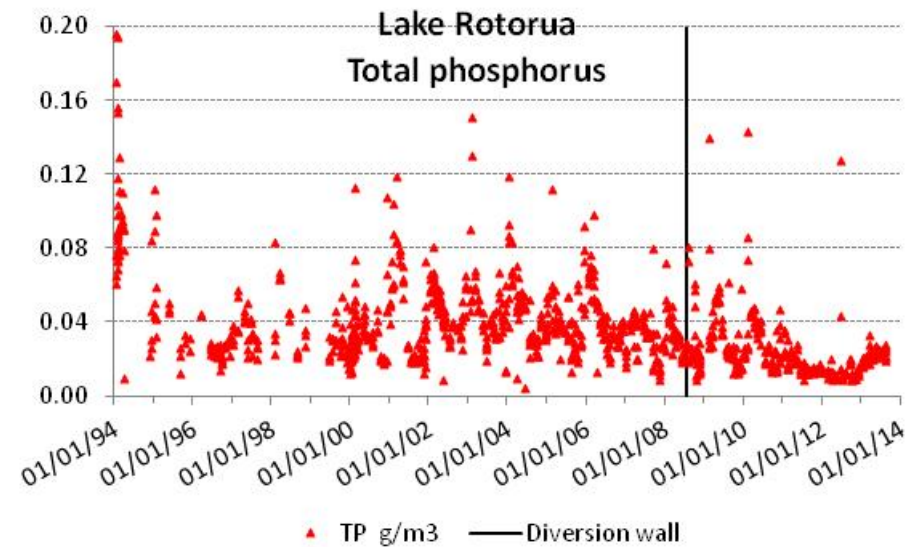
Lake Rotorua

1994 - 2013
