The ecological condition of the Rotorua Lakes using LakeSPI - 2012

Prepared for Bay of Plenty Regional Council

NIWA Client Report No:	HAM2012-085
Report date:	June 2012
NIWA Project:	BOP12201

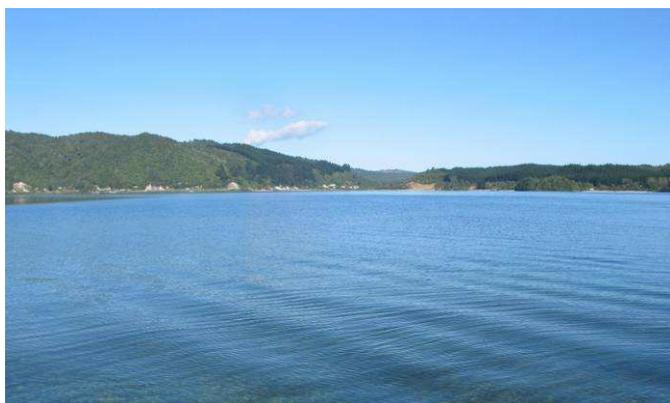
Lake condition: High
 Stability: Stable
 Lake ranking: 1st

Lake Rotoma is the highest ranked lake in the Rotorua region after lake condition values have remained relatively stable over the last 23 years, from 1988 – 2011. In 1973 Lake Rotoma had a high LakeSPI score, which reflected the early stage of lagarosiphon invasion and the extensive high cover charophyte meadows in this lake. By 1988 the Invasive Impact Index had more than doubled, which in turn reduced both the Native Condition Index and LakeSPI score for this lake. Since then, Invasive Impact scores have increased more gradually, with smaller changes occurring to the Native Condition Index or LakeSPI score. As a result this lake presently has the highest Native Condition Index for any of the lakes and one of the lowest Invasive Impact Index which contributes to its high LakeSPI ranking.

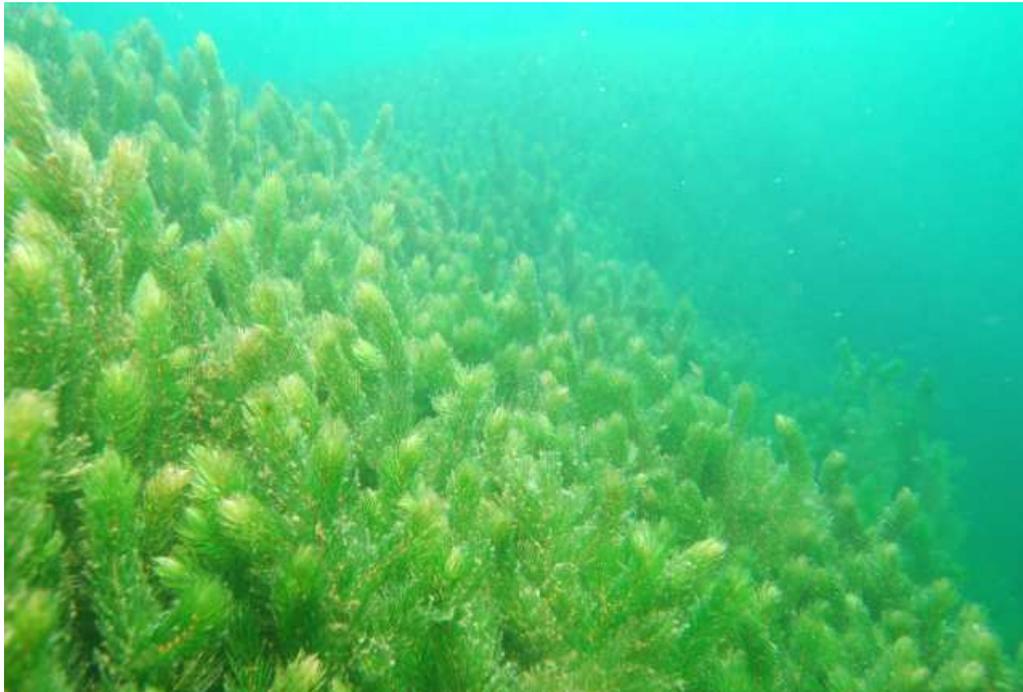
Figure 4: Invasive weed bed of hornwort (*Ceratophyllum demersum*) forming a wall of growth 8 m high and growing down to 12 m depth at the south-western end of Lake Okataina in 2010.

Hornwort, not yet recorded at any of the 5 LakeSPI sites, continues to pose the most serious threat to the future condition of Lake Okataina. While an established hornwort bed found growing in 2010 (Figure 4) at the south-west end of the lake has since been controlled using diquat and isolated from the rest of the lake by a weed cordon, smaller infestations and fragments currently growing in Oruaroa Bay (south-east end of the lake) are still of concern and control measures continue in this area. Prior to the discovery of significant hornwort weed beds in 2010, one established hornwort plant at the northern end of the lake was successfully eradicated from the lake in 2007. However from 2009 onwards additional fragments were located that suggested a possible established incursion within the lake. The

location of the 2010 find in a popular anchorage site suggests an association with boating activity, while the size of the colony indicates it had been present for some time and subsequent dispersal to other locations within the lake was likely.
