Rotorua Lakes

High lake levels and Emergency works

Andy Bruere / Sue-Ellen Craig
August 2017

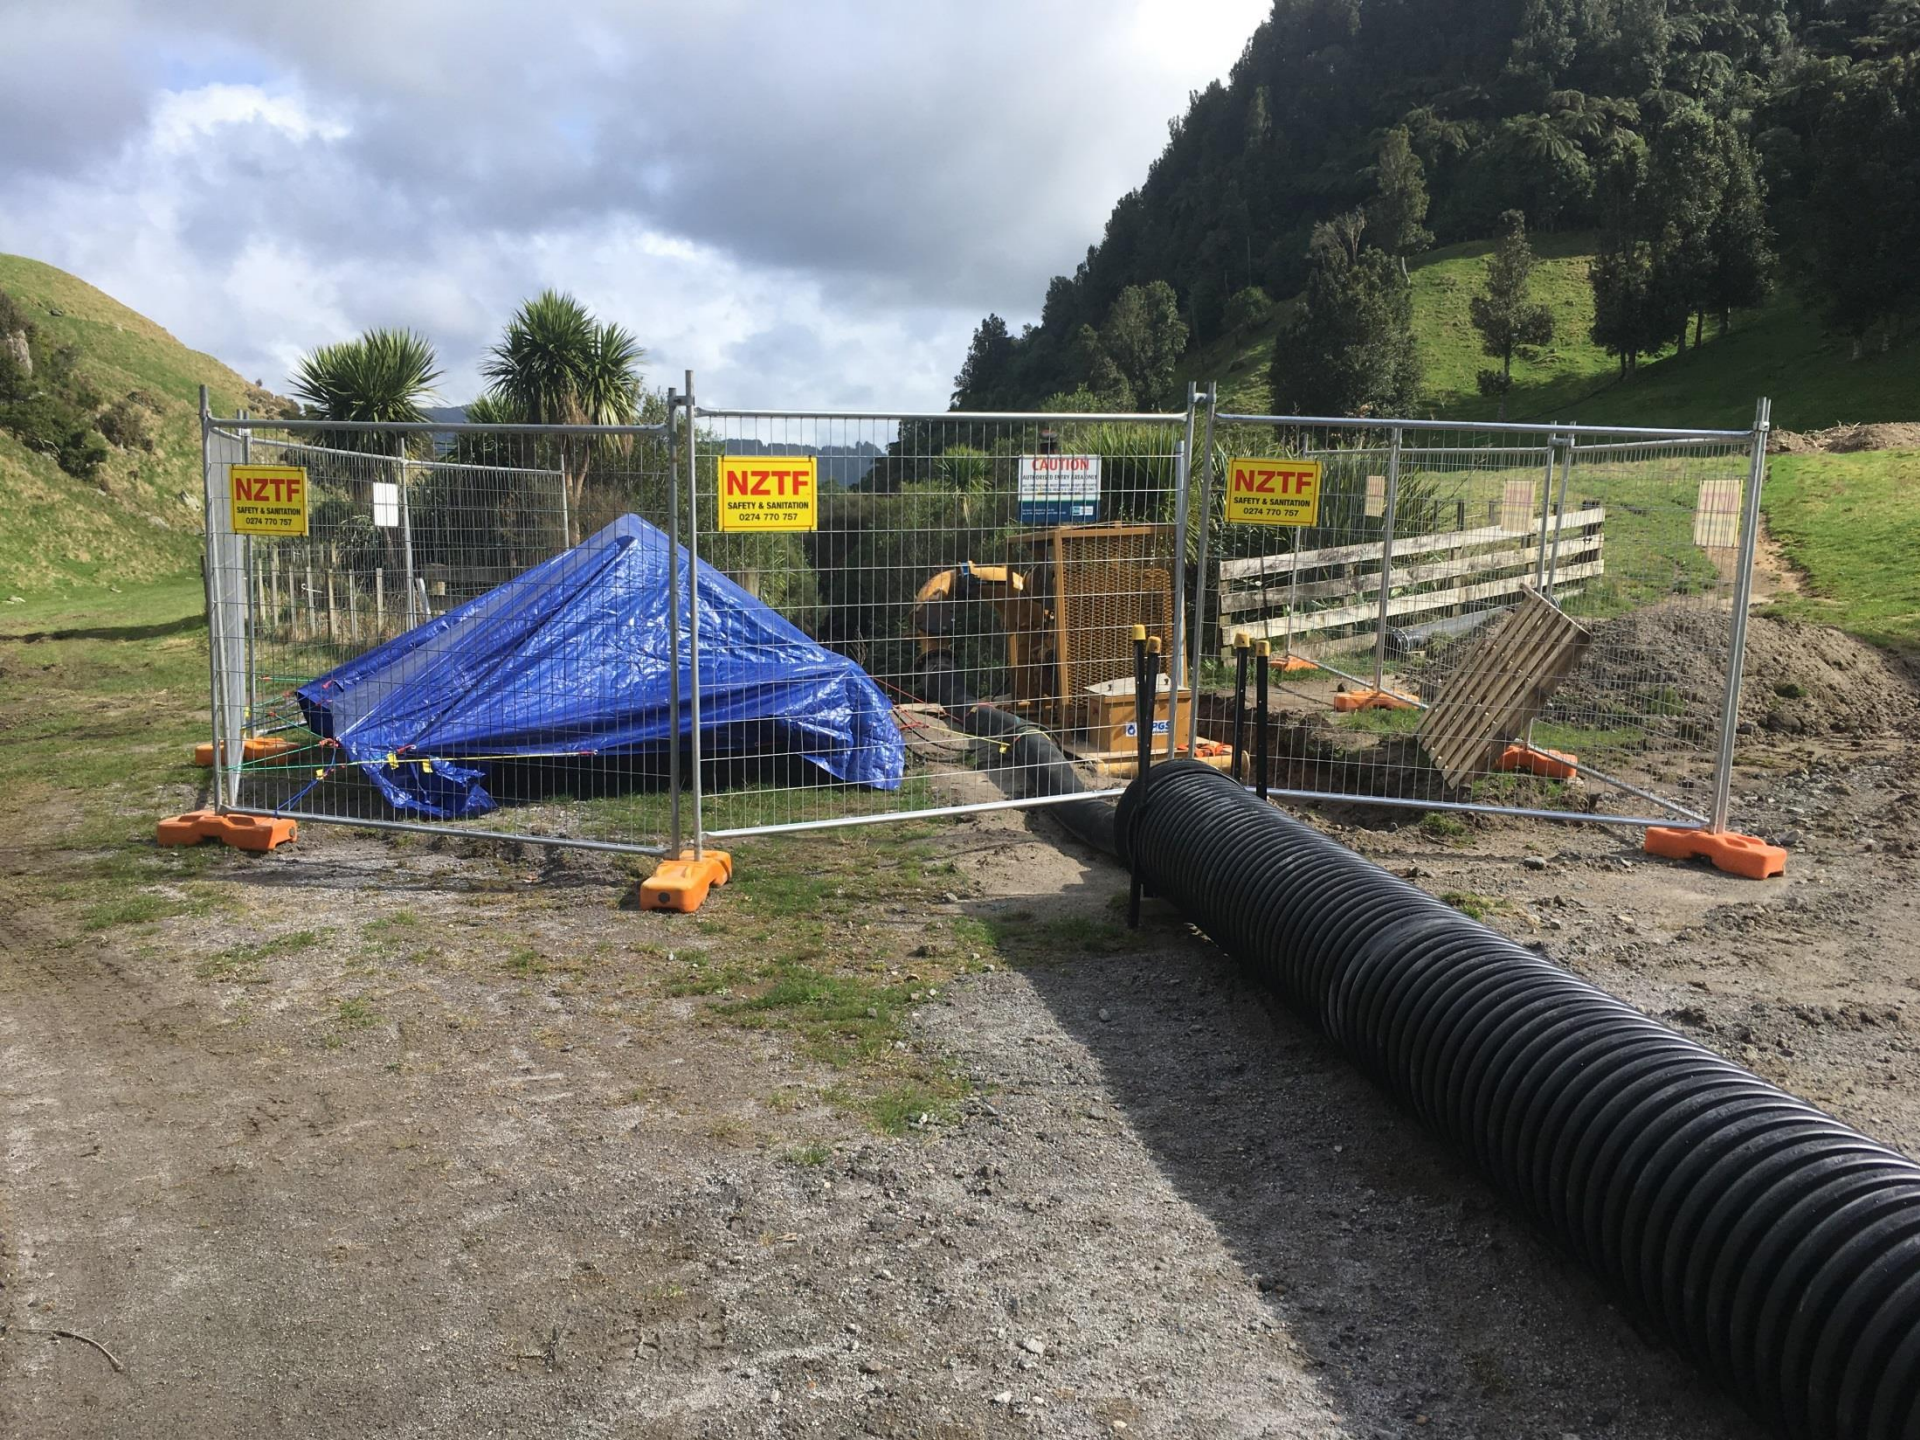
Additional pipe placed
alongside existing pipe

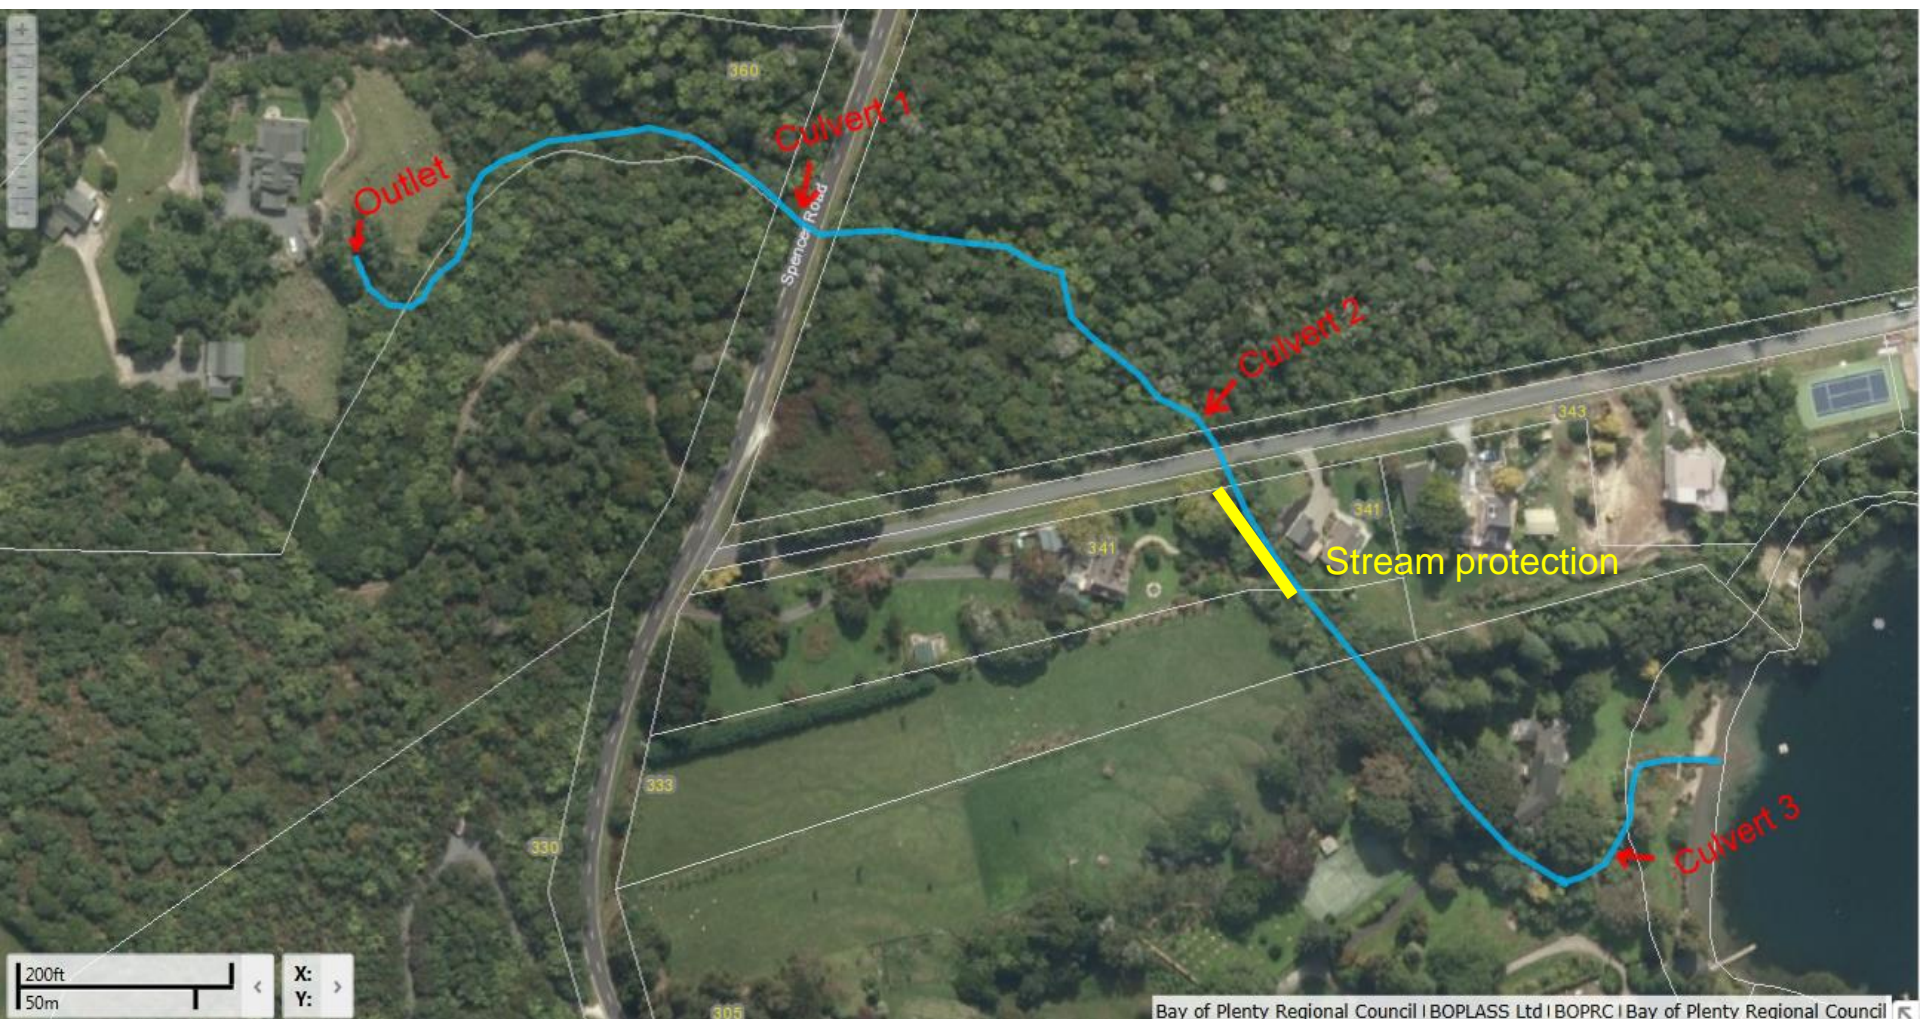
Outlet and Culvert locations for Waitangi Stream, Lake Ōkāreka outlet control

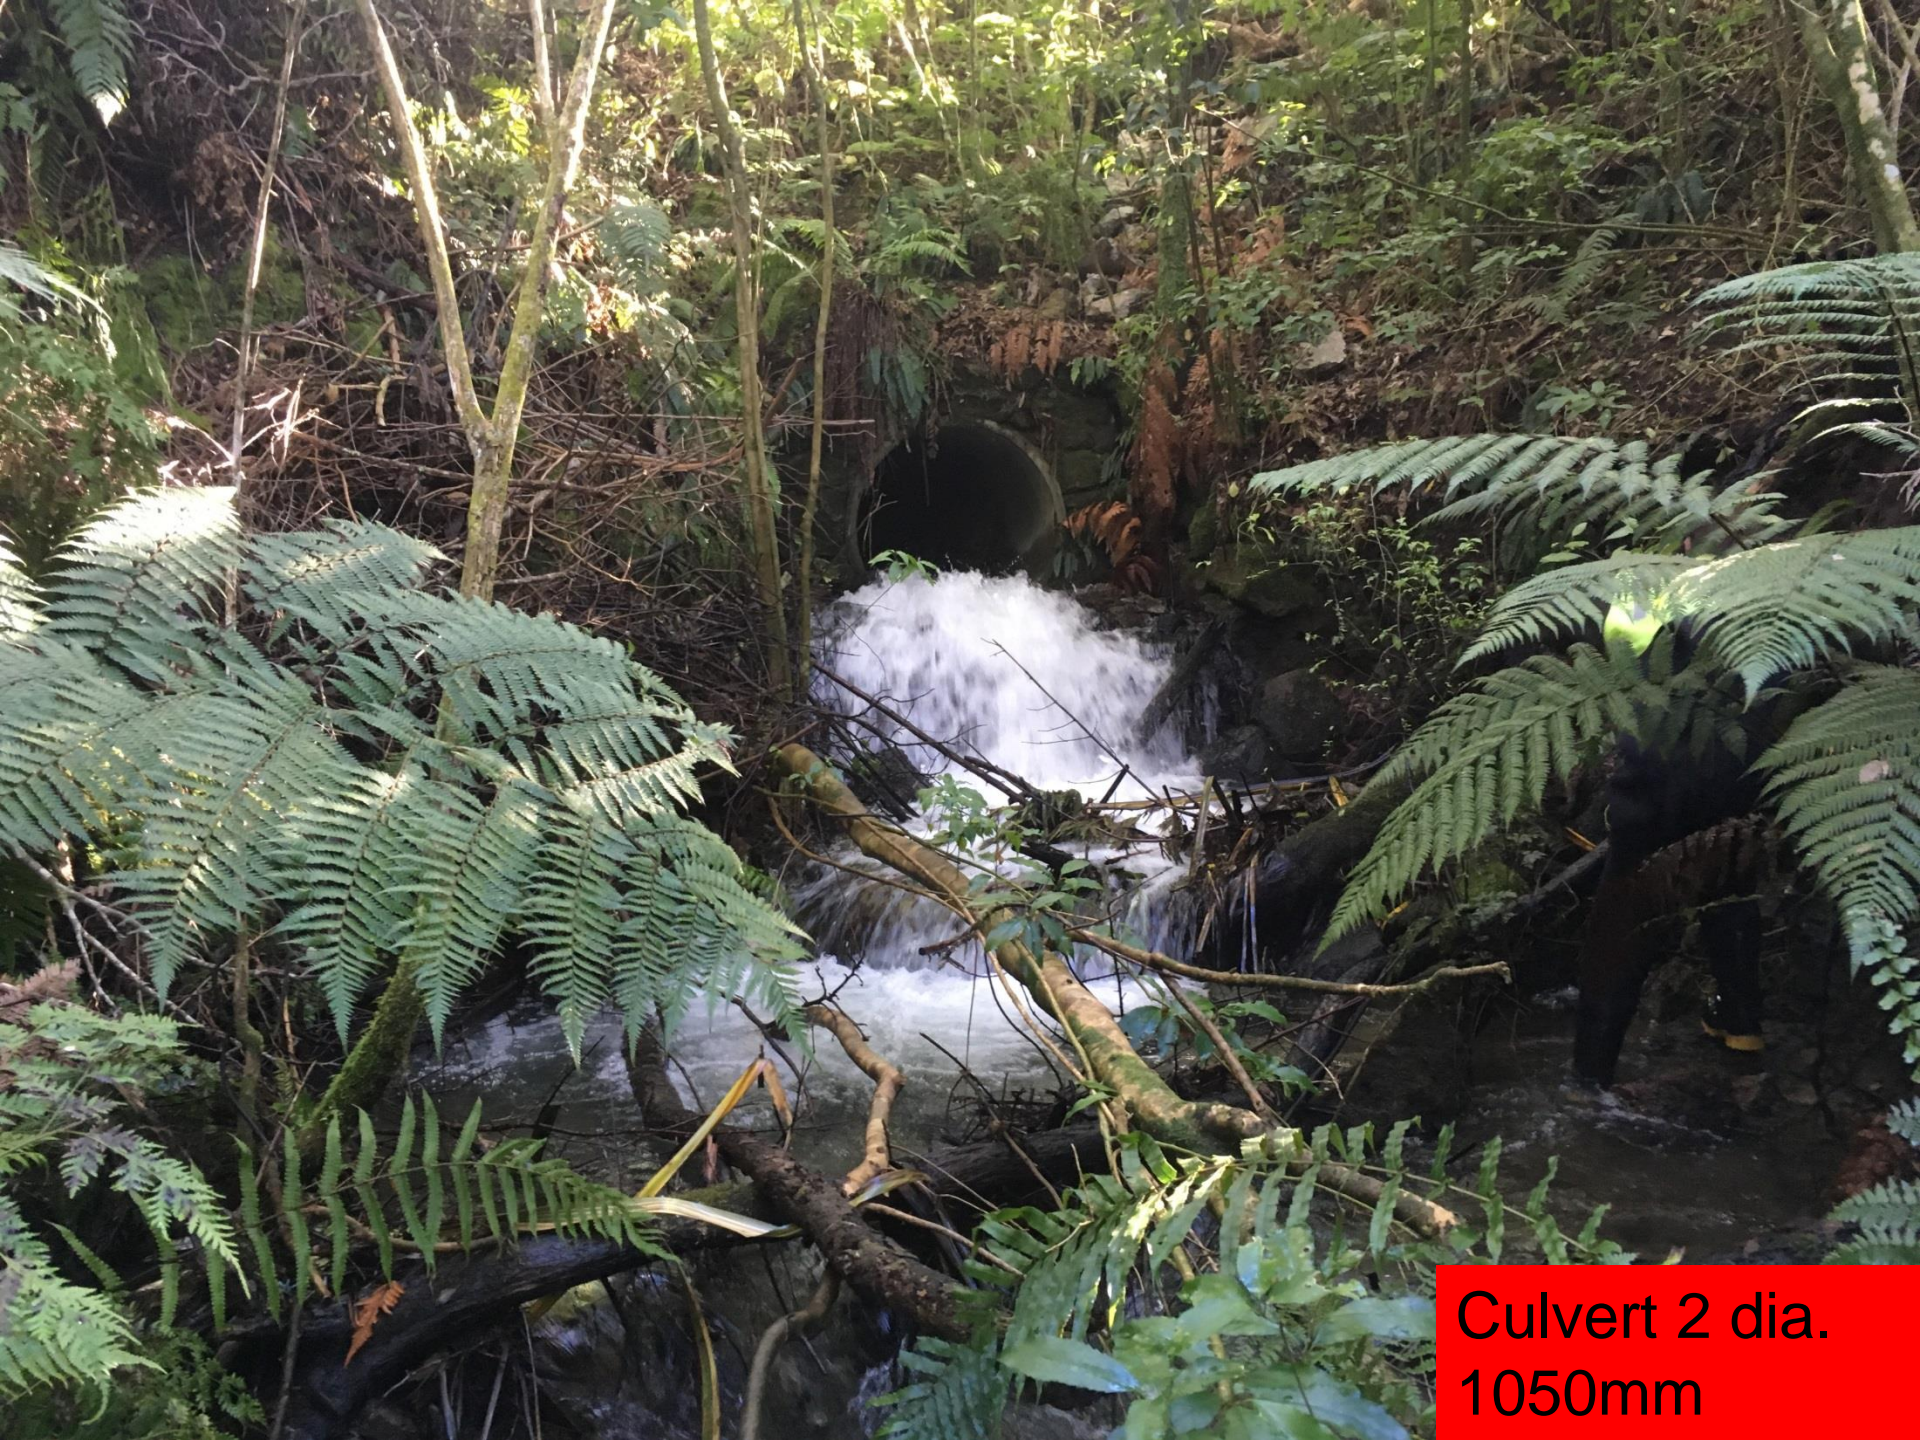
Culvert 2 dia.
1050mm

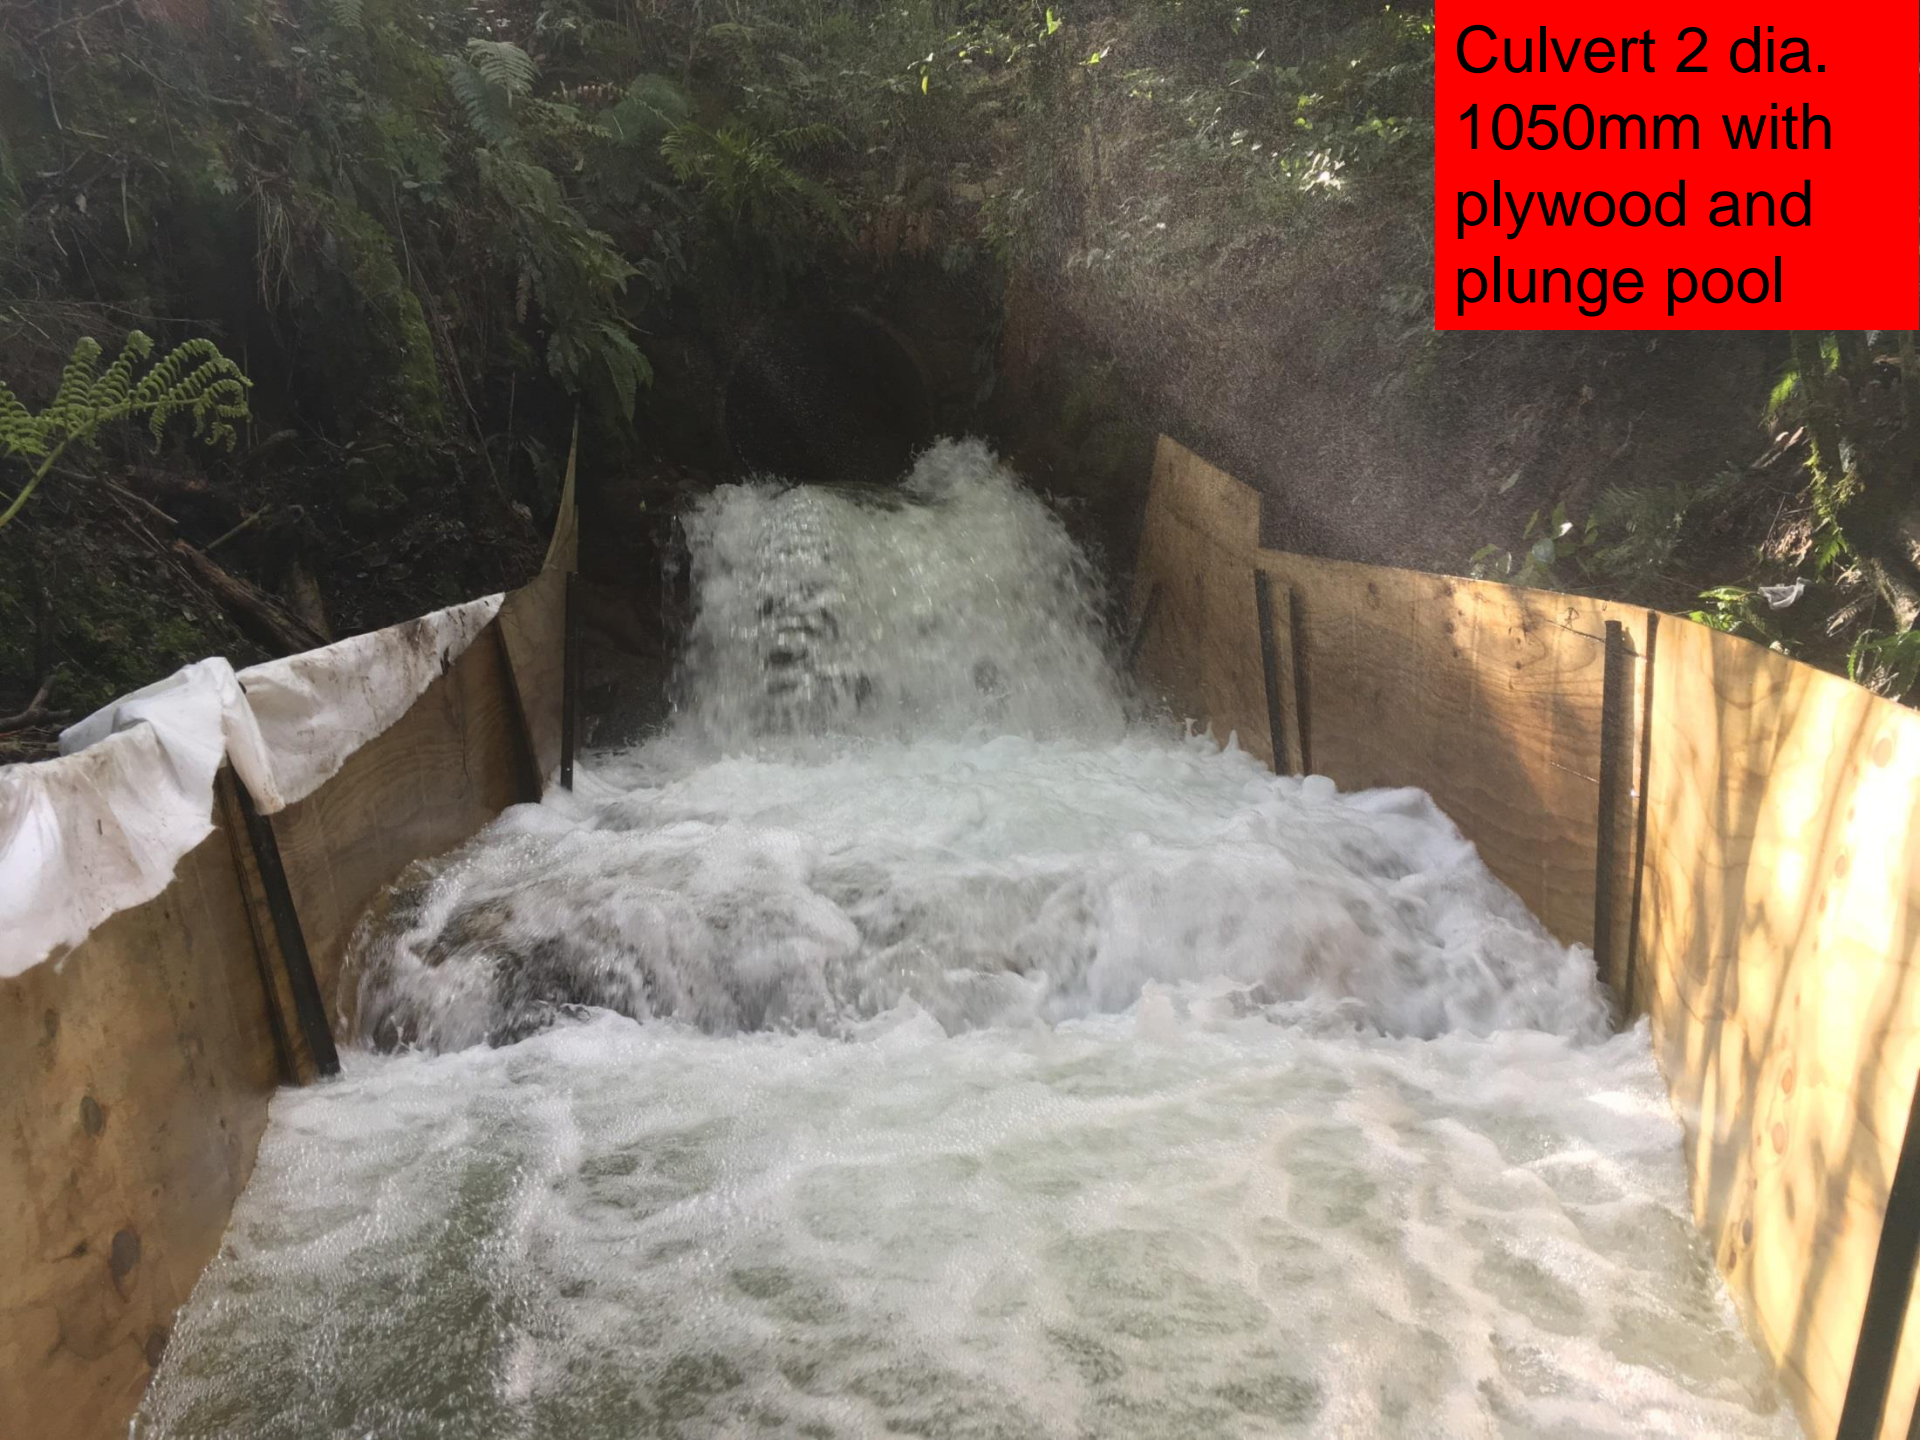
Culvert 2 dia.
1050mm with
plywood and
plunge pool

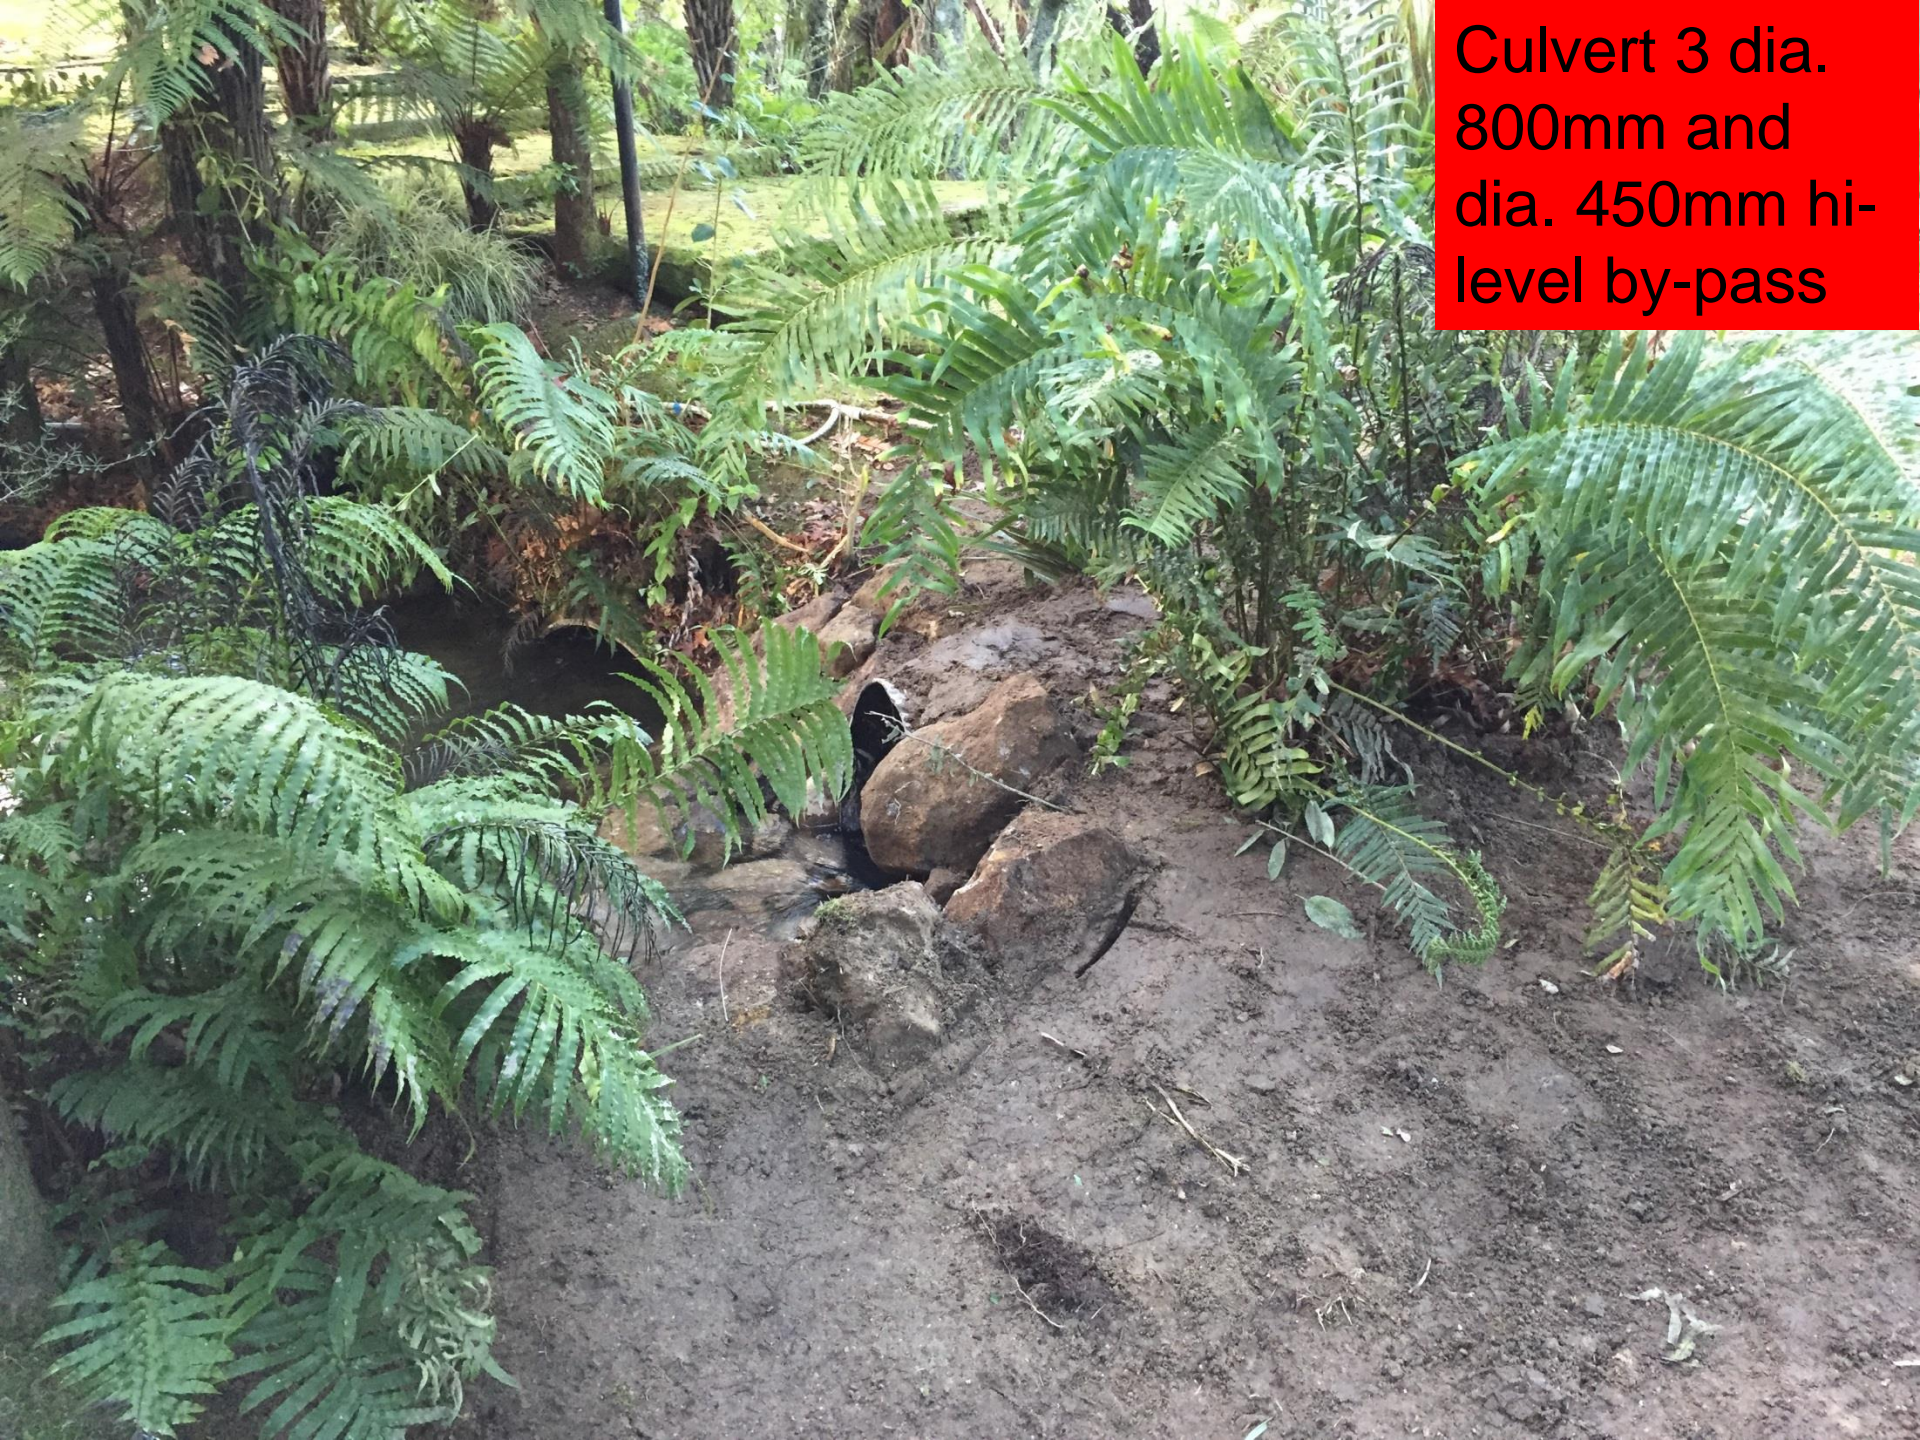
Culvert 3 dia.
800mm and
dia. 450mm hi-
level by-pass

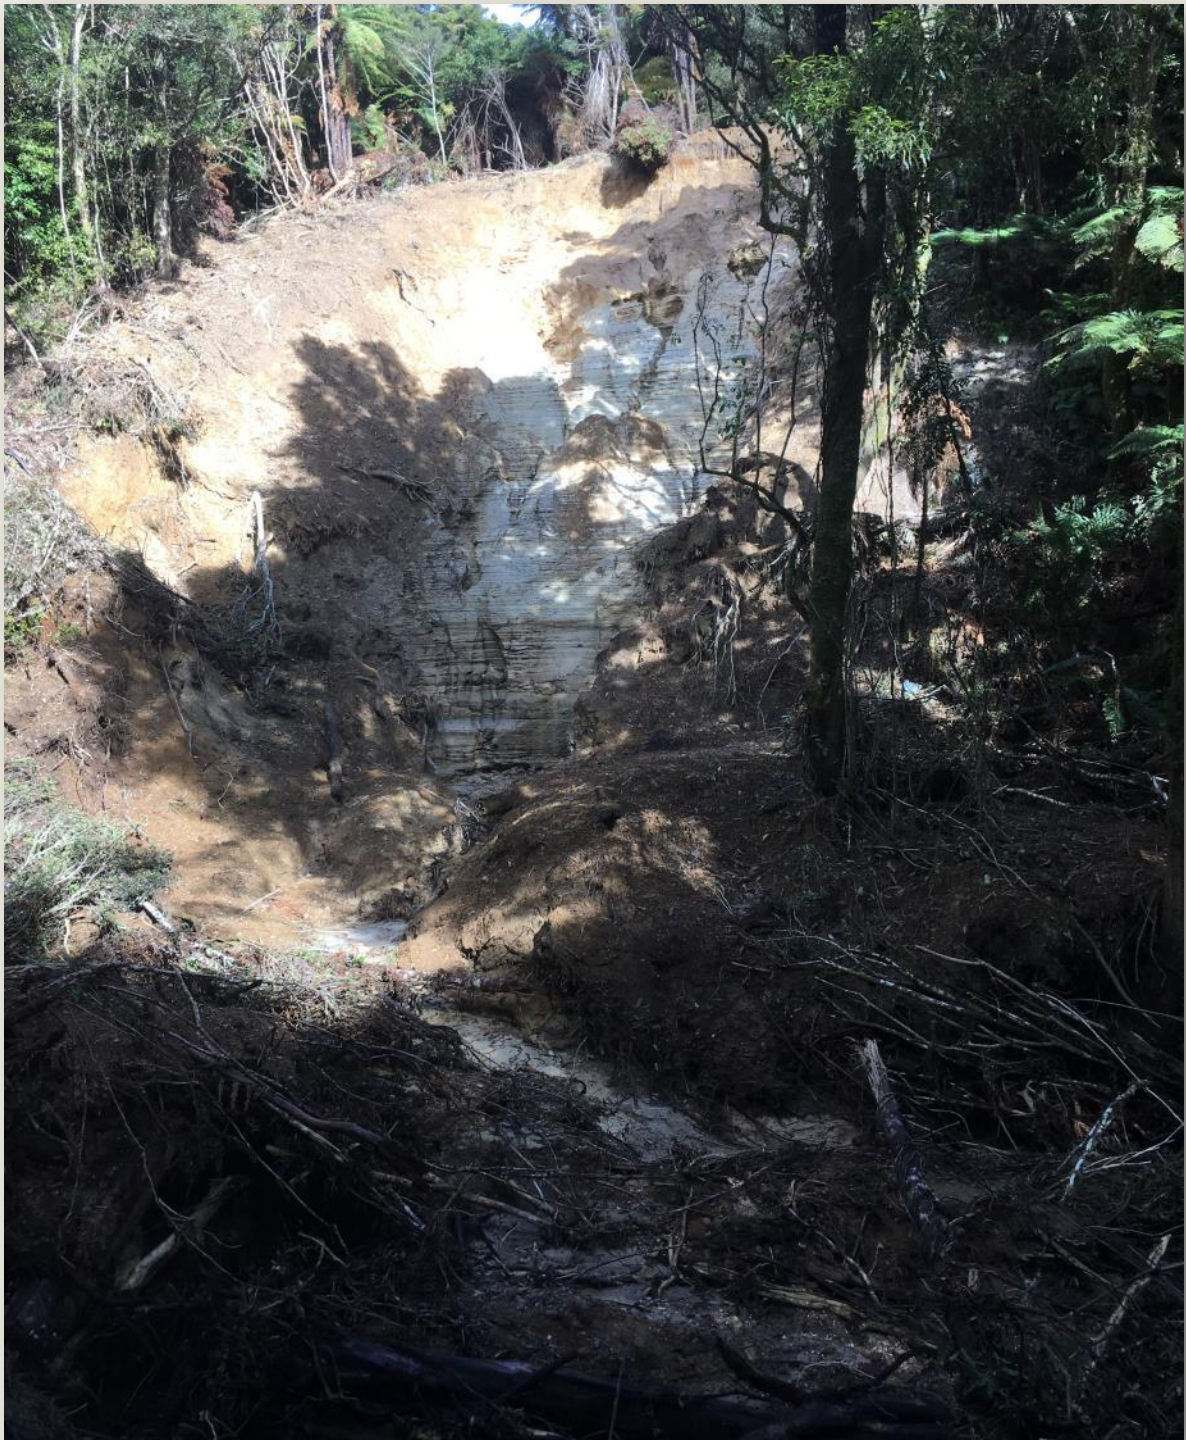
Slips closed SH30 (Lake Rotoiti)
