Bay of Plenty Regional Council

Ohau Channel Flush Monitoring (Fish & Game Consultation) – Channel Velocities & Depth

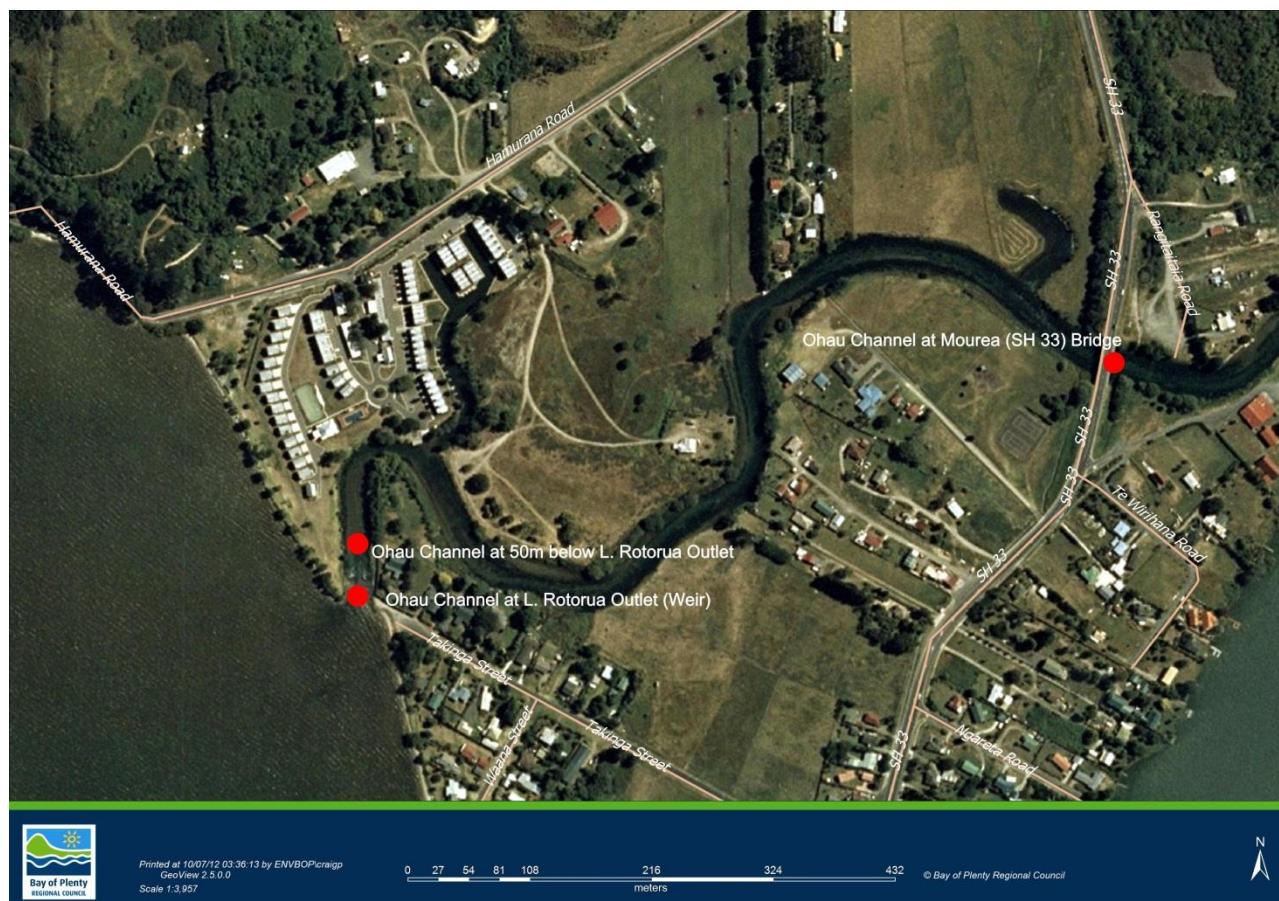
Figure 1 - Map of Velocity & Depth Monitoring Sites

Velocities within the Ōhau Channel were measured at 3 locations:

- a) Lake Rotorua Outlet (1m below upstream edge of weir)
- b) 50m below Lake Rotorua Outlet (long term BOPRC flow monitoring site)
- c) Mourea (SH 33) Bridge

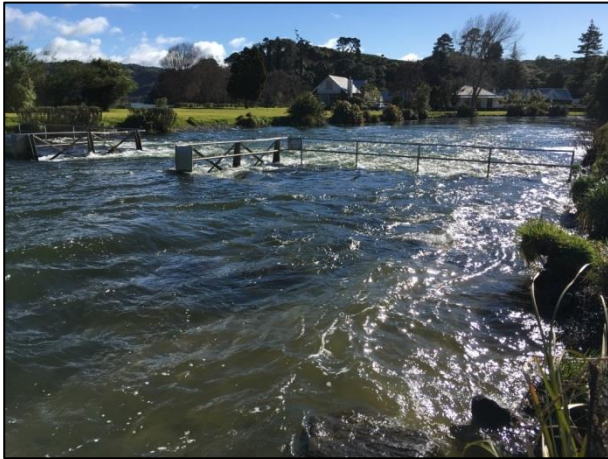
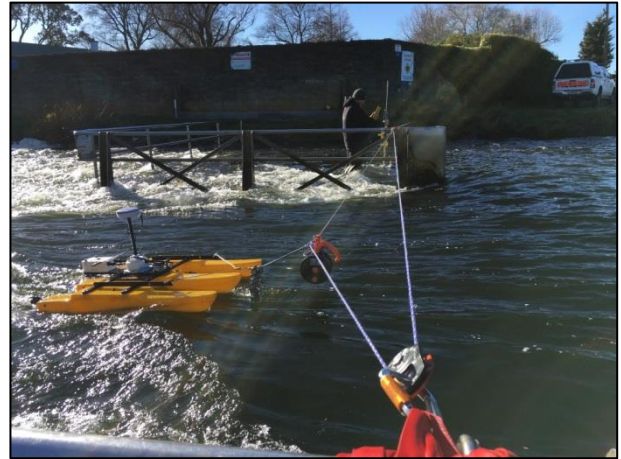
Figure 2 - Weather and water conditions, on 12 July 2018

Conditions on 12 July 2018 included waves <0.1m, with 0-3kts wind from the southwest quarter. The effects of both wind and waves was minimal. Conditions on 01 August 2018 were dead calm.

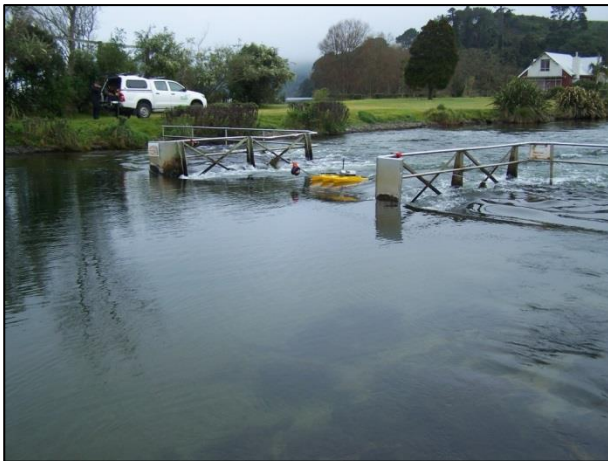
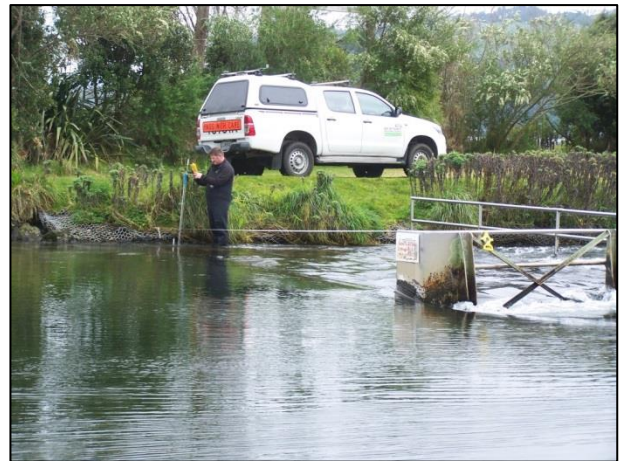
Figure 3 - Weather and water conditions, on 1 August 2018

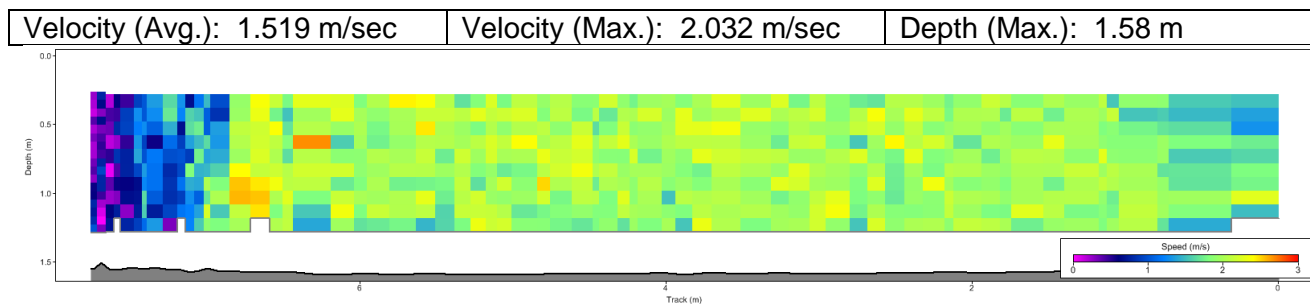
Figure 4 - Water Velocities: Ohau Channel at Lake Rotorua Outlet - Centre of Weir, on 12 July 2018.

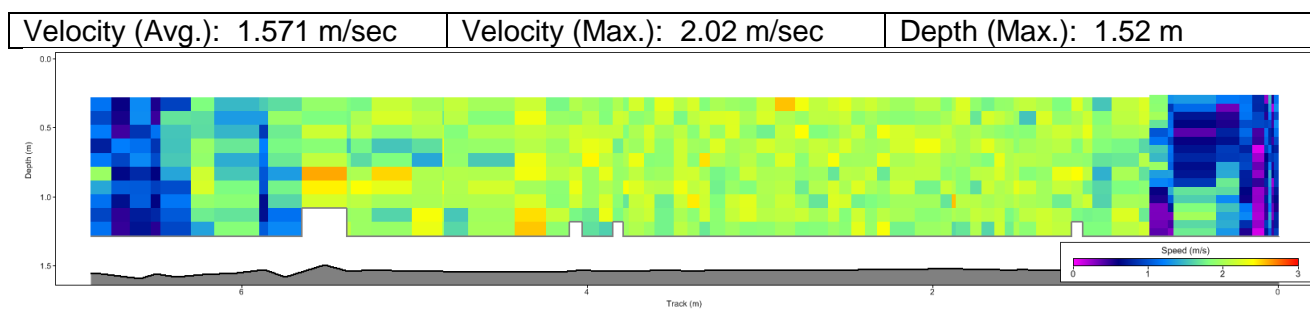
Figure 5 - Water Velocities: Ohau Channel at Lake Rotorua Outlet - Centre of Weir, on 01 August 2018.

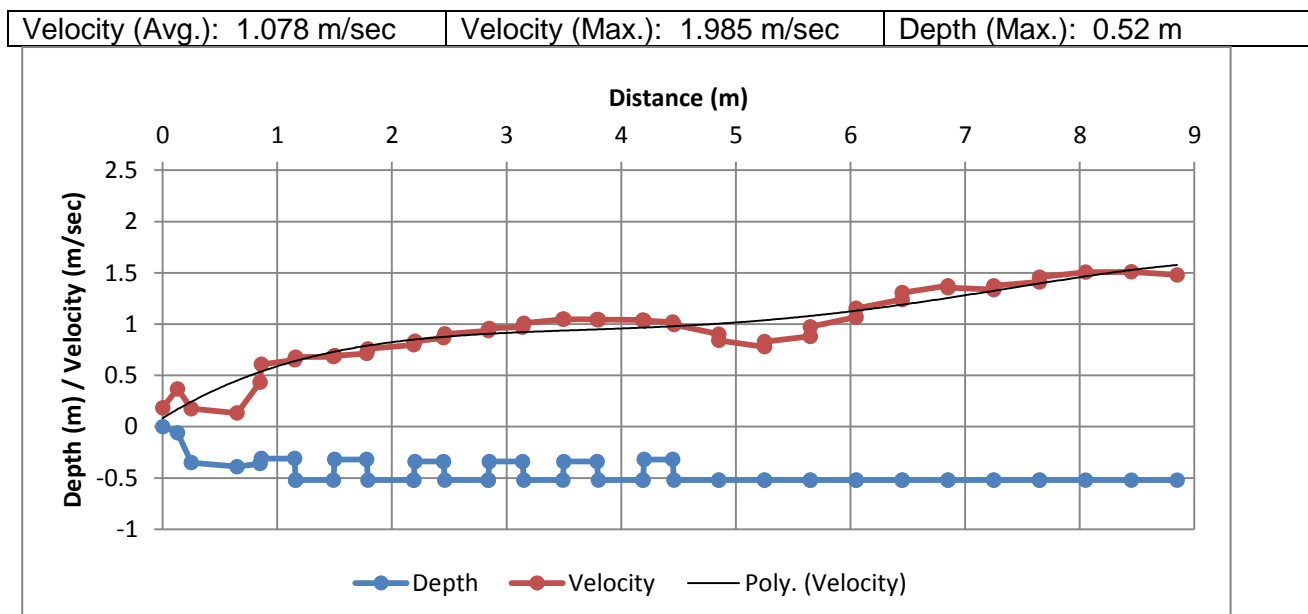
Figure 6 - Water Velocities: Ohau Channel at Lake Rotorua Outlet - True Left Bank Section of Weir, on 12 July 2018.

In regard to the Lake Rotorua Outlet (weir) site, the ADCP method was only used through the main channel. A rod-mounted FlowTracker2 acoustic current meter was used across the control structure, on either side of the main channel, due to the shallow water depth. The main channel represented two thirds of the flow and the highest velocities in the cross section. This is consistent with previous measurements. The three separate survey sections making up the complete cross section are provided separately for reference, in Section 3.

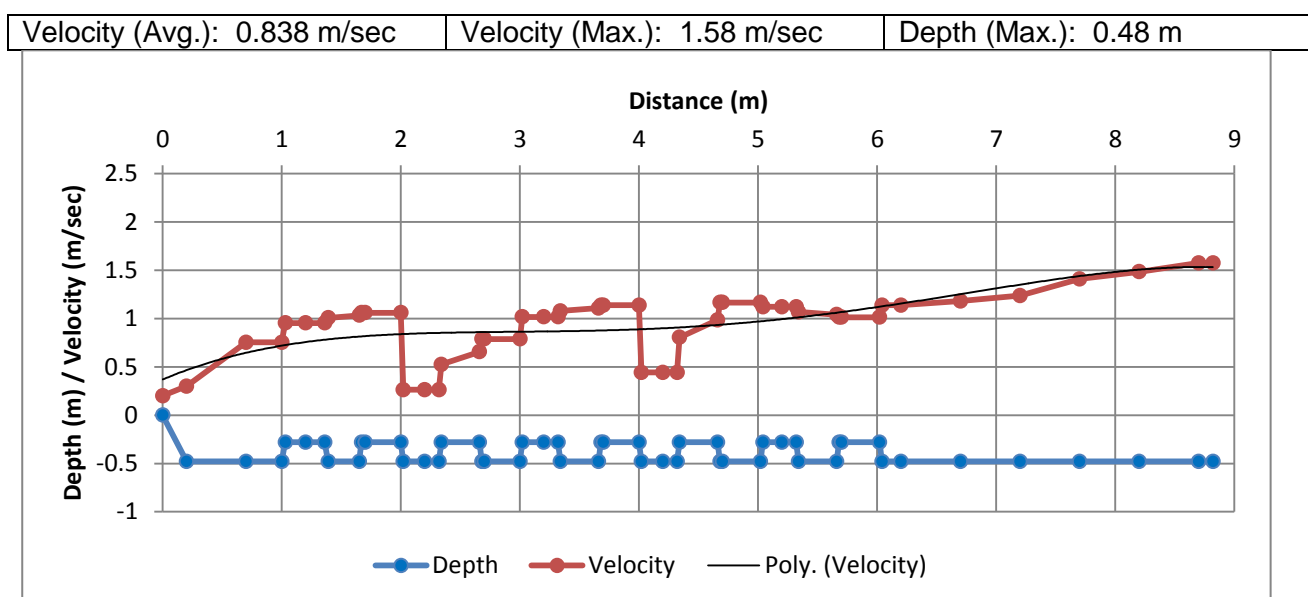
Figure 7 - Water Velocities: Ohau Channel at Lake Rotorua Outlet - True Left Bank Section of Weir, on 01 August 2018.

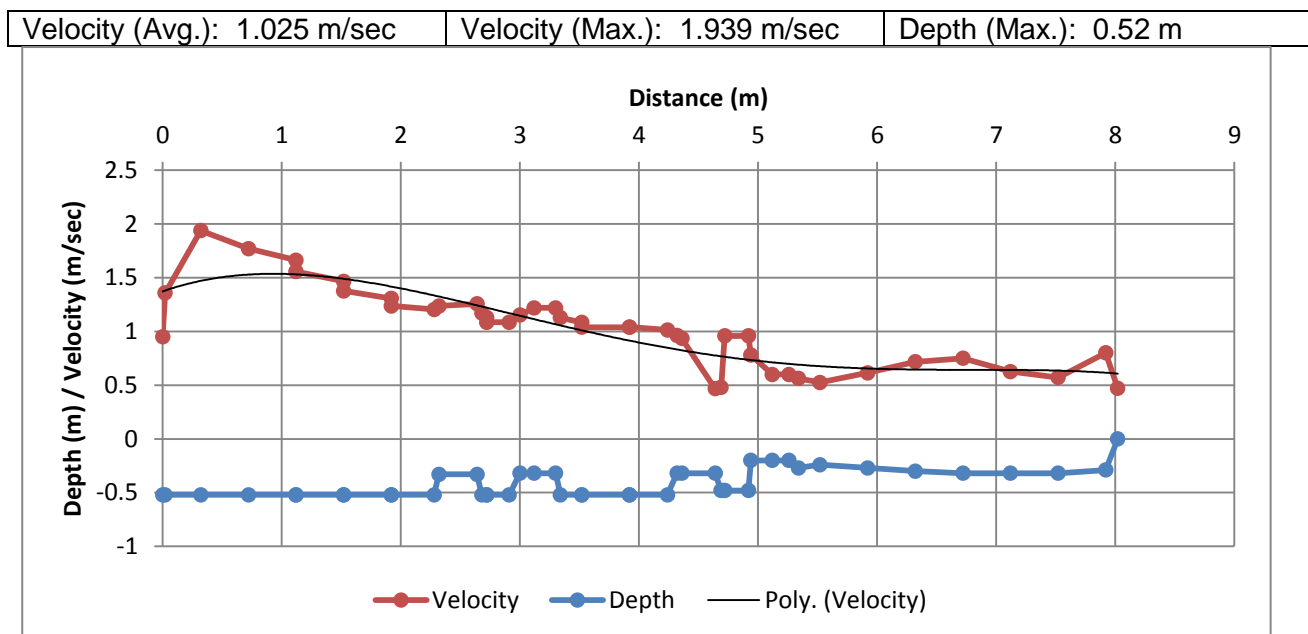
Figure 8 - Water Velocities: Ohau Channel at Lake Rotorua Outlet - True Right Bank Section of Weir, on 12 July 2018.

There was no significant change in mean or max velocities before and after the drawdown period, at any of the sites. A change in velocity appears on the right bank section of the weir, nearest to the main channel. However, this was attributed to a difference in gauging methodology, where the flow was measured by a new staff member, behind the stainless steel panel on the edge of the main channel.

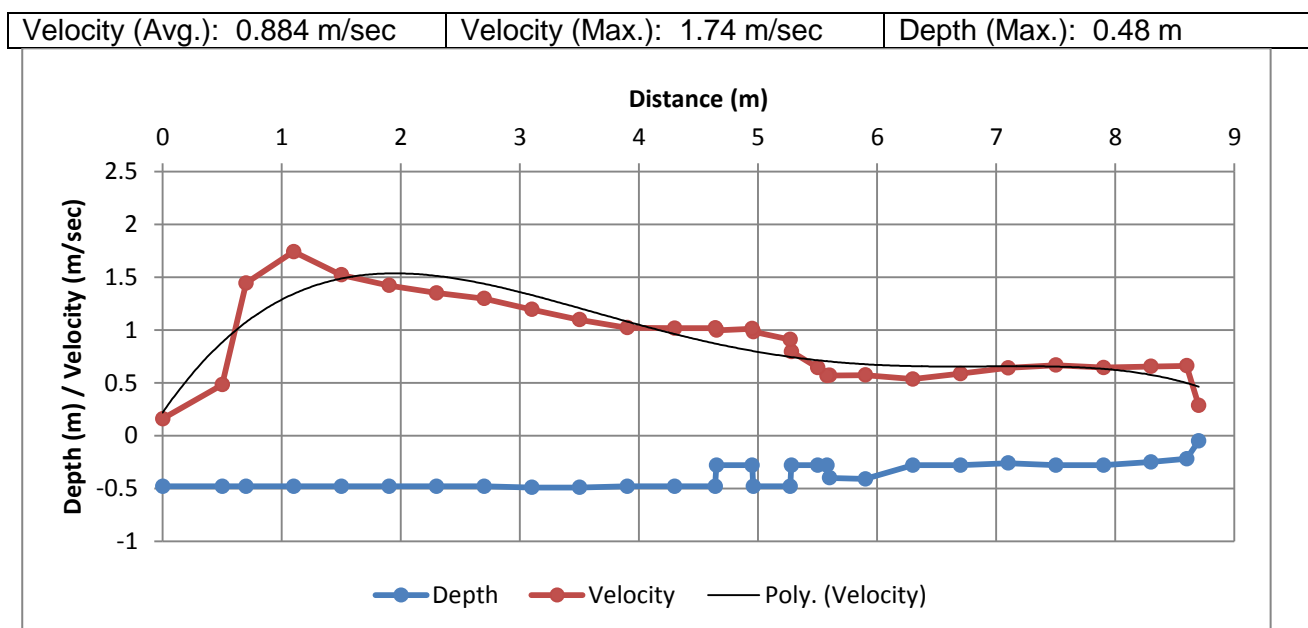
Figure 9 - Water Velocities: Ohau Channel at Lake Rotorua Outlet - True Right Bank Section of Weir, on 01 August 2018.

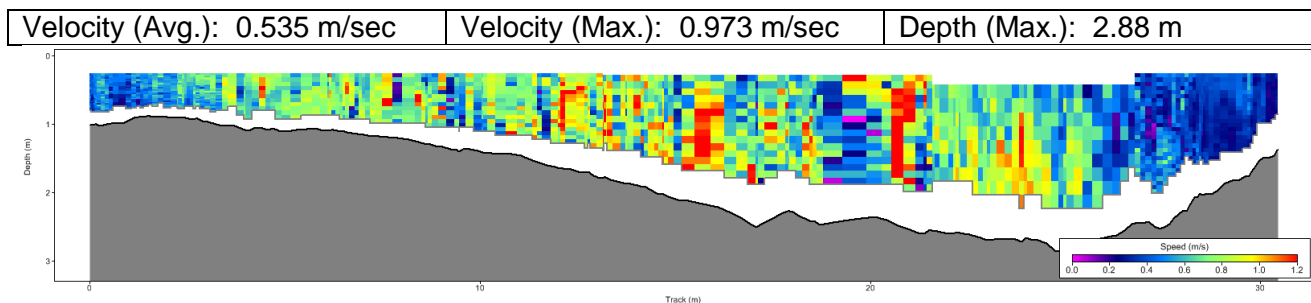
Figure 11 - Water Velocities: Ohau Channel at 50m below Lake Rotorua Outlet, on 01 August 2018.

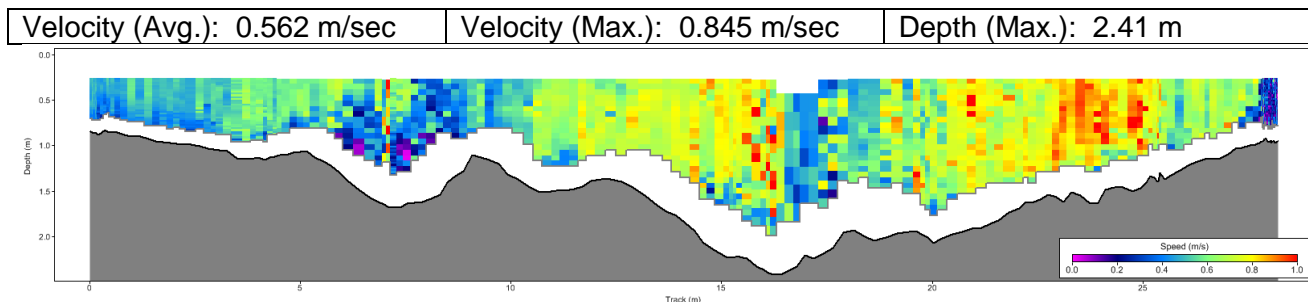
Figure 12 - Water Velocities: Ohau Channel at Mourea (SH 33) Bridge, on 12 July 2018.

The plots shown above are representative examples taken from a series of 2-8 transects (per site, per day) which are normally averaged to produce an accurate flow measurement. The degree of variation shown between each sampling date is similar to that seen in individual transects collected 5 minutes apart from each other. This includes subtle changes in velocity around stream margins and, in particular, behind the bridge abutments at the SH 33 site.

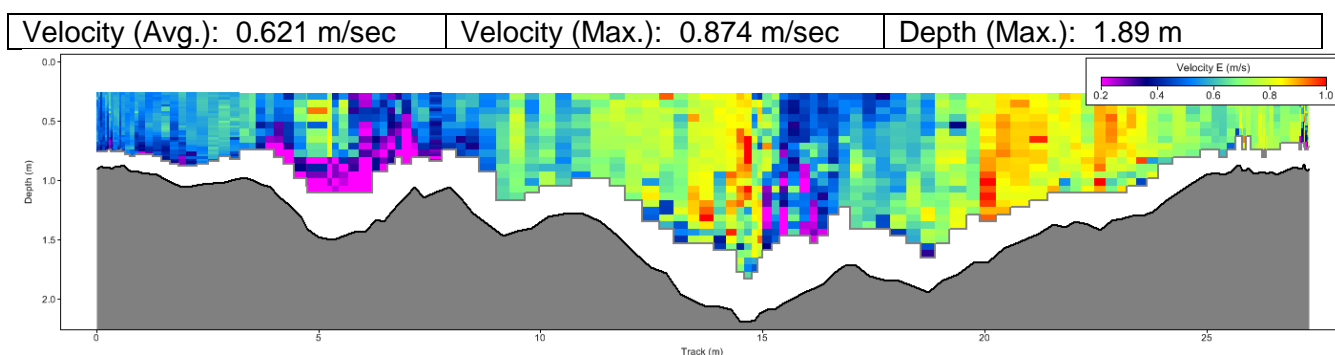
Figure 13 - Water Velocities: Ohau Channel at Mourea (SH 33) Bridge, on 01 August 2018.
