**ROTORUA
TE ARAWA
LAKES
PROGRAMME**

Lake Ōkātaina Action Plan

for better water quality

Environmental Publication 2013/06

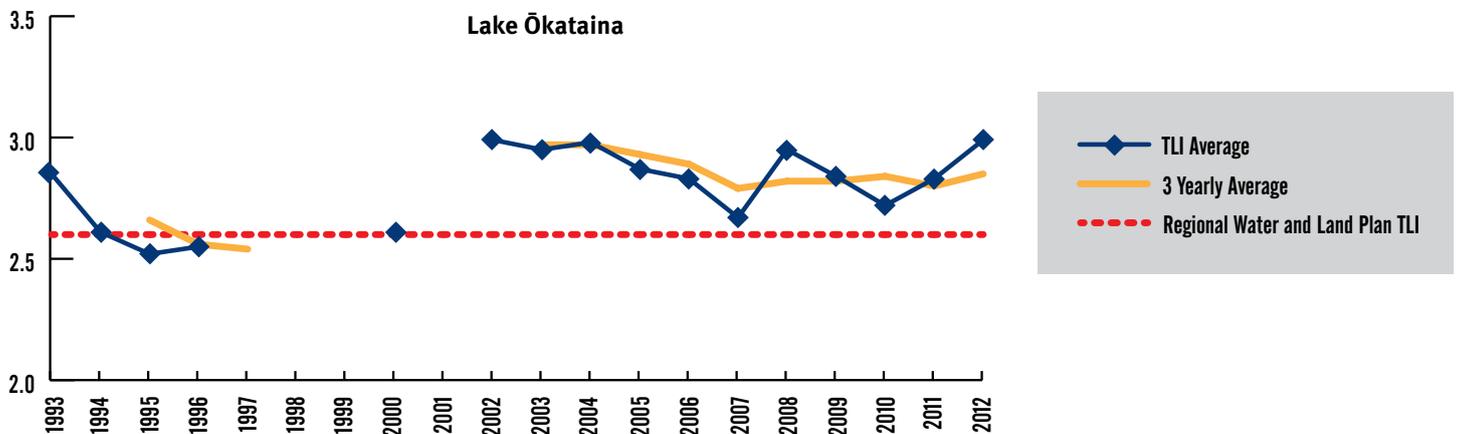
Lake Ōkātaina's water quality trend measured by the TLI

The current TLI at Lake Ōkātaina is 2.9. The trend over the last 10 years shows this lake's TLI is steady compared with other lakes, and more detailed analysis shows that nitrogen has been declining and phosphorus has been increasing.

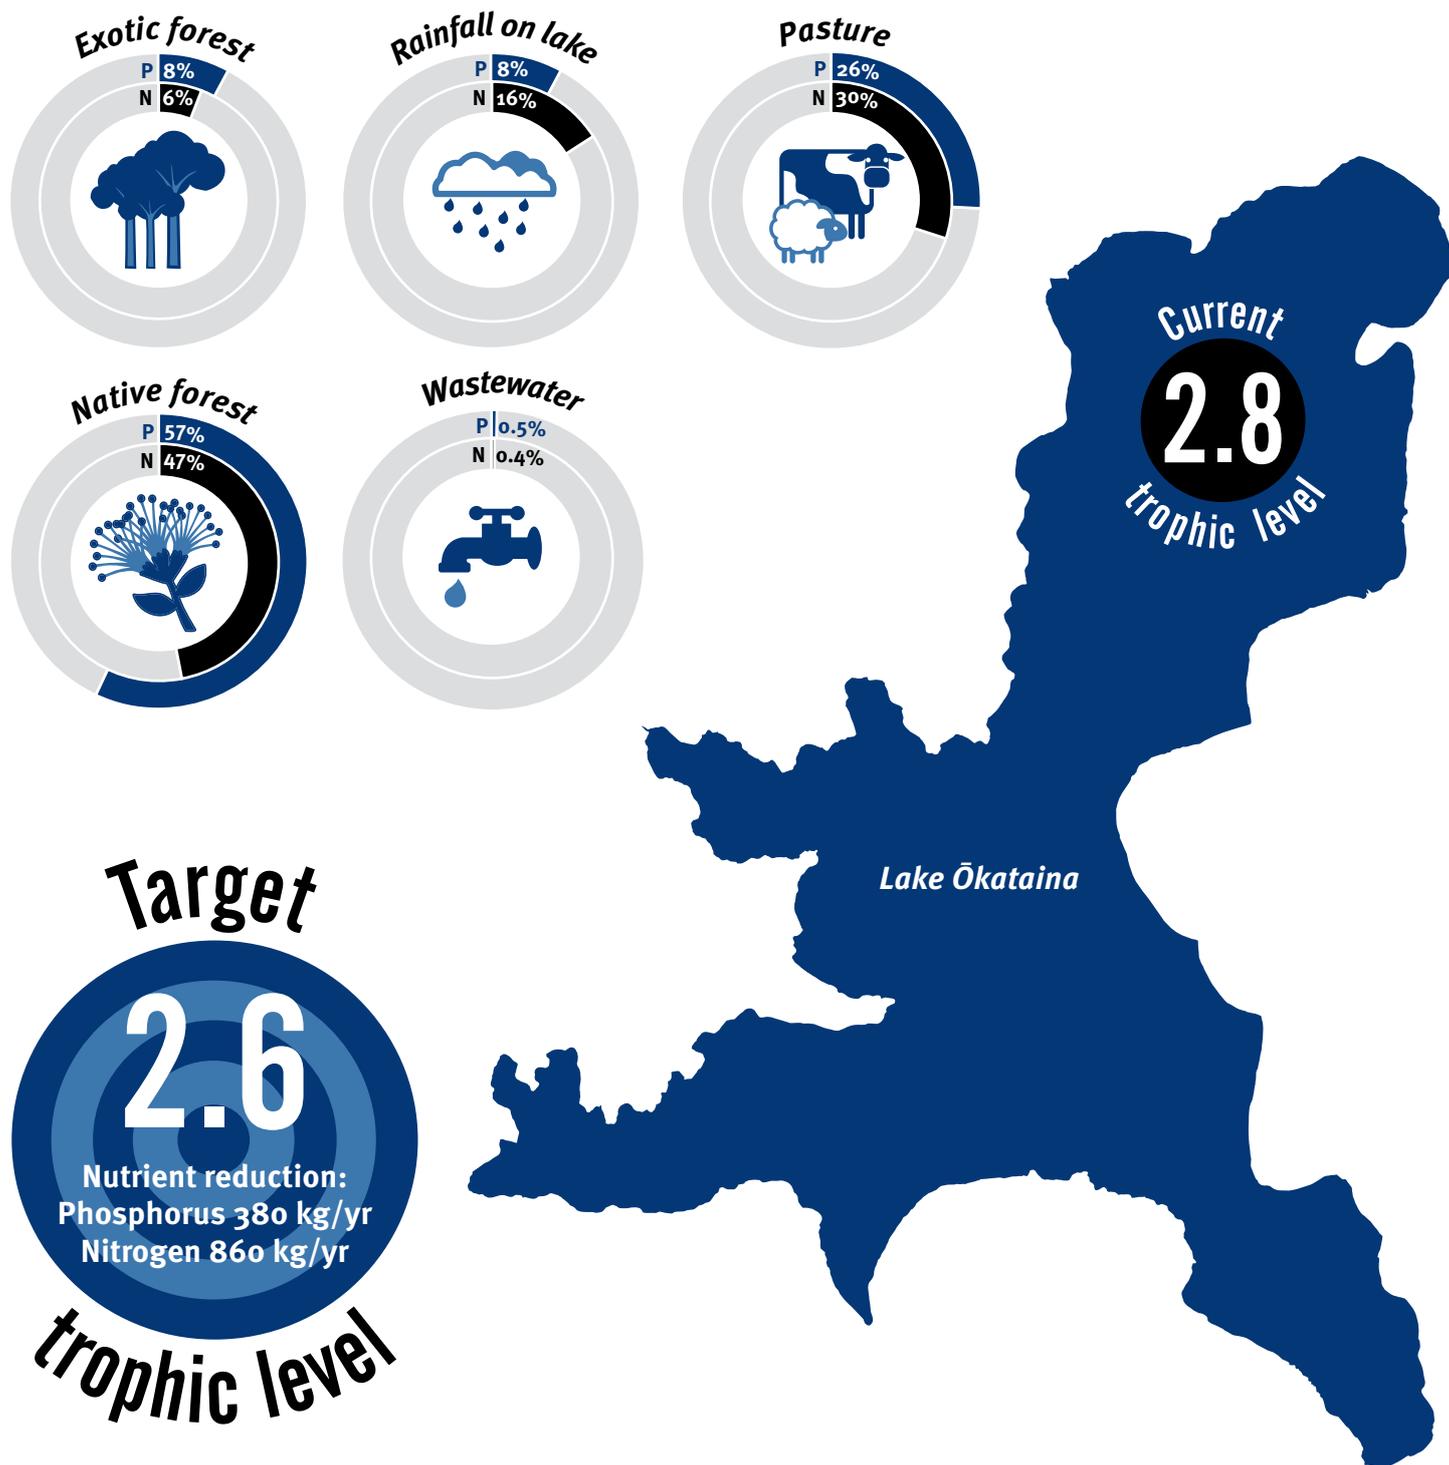
Where are the nutrients coming from?

Land Use	% area (including lake)	% N entering lake	% P entering lake
Native bush	67%	47%	57%
Grassland (pasture)	9%	30%	26%
Rainfall on lake	17%	16%	8%
Exotic forest	7%	6%	8%
Stormwater	<0.1%	0.3%	<0.1%
Septic Tanks	-	0.4%	0.5%

N = Nitrogen, P = Phosphorus

More information about land cover and nutrient source estimation can be found in Appendix One, or in the supporting document “Lake Ōkātina Water Quality Background information 2012”.

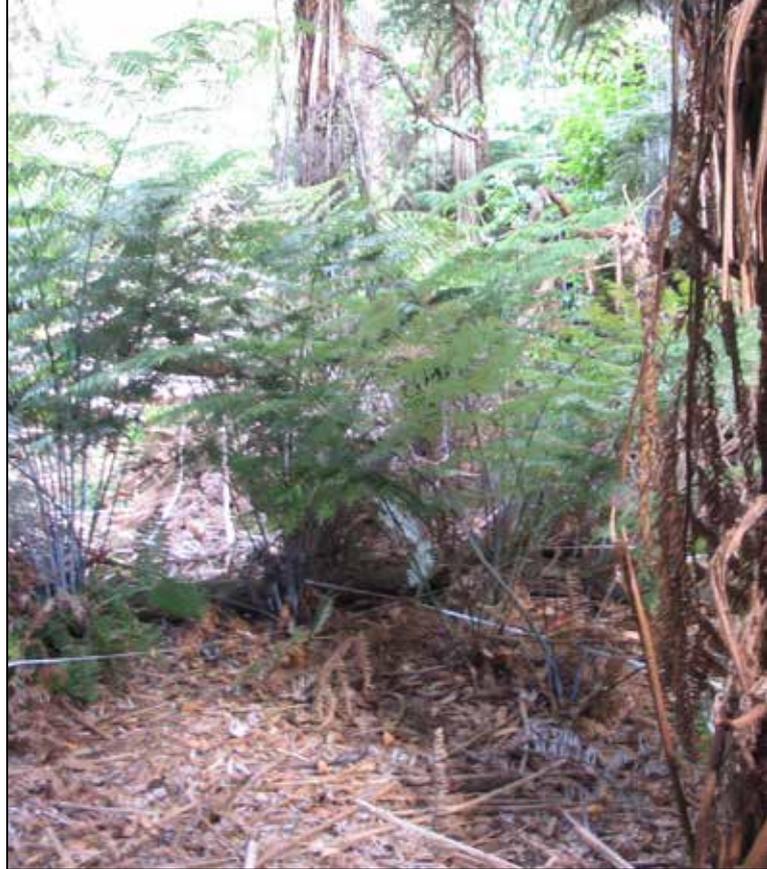
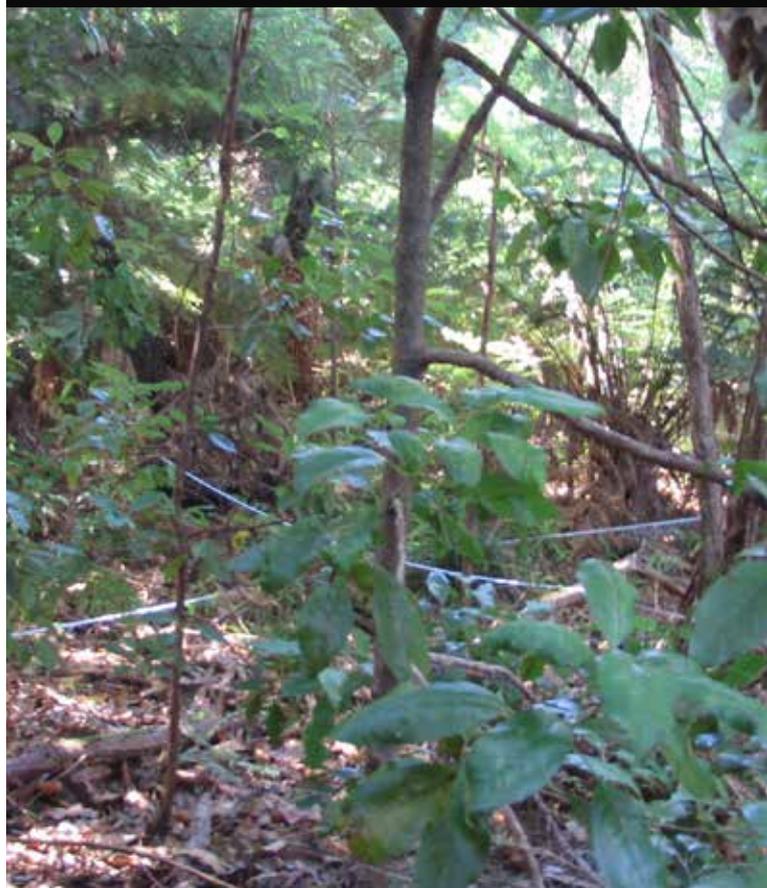
Differences in native bush when animal pests are excluded

The community is concerned about damage to native bush from pests. Understory vegetation is important for the forest ecosystem. The photos show the difference 10 years after the animal pest exclusion area (near Oruaruoa) was installed – the photo above shows outside of the pest animal exclusion area, and the photo below shows inside of the pest animal exclusion area.

We don't know to what degree the water quality is affected by pest animals degrading the native bush. The community has observed a significant impact on the native bush and scientists recognise that it is an area that requires further investigation.

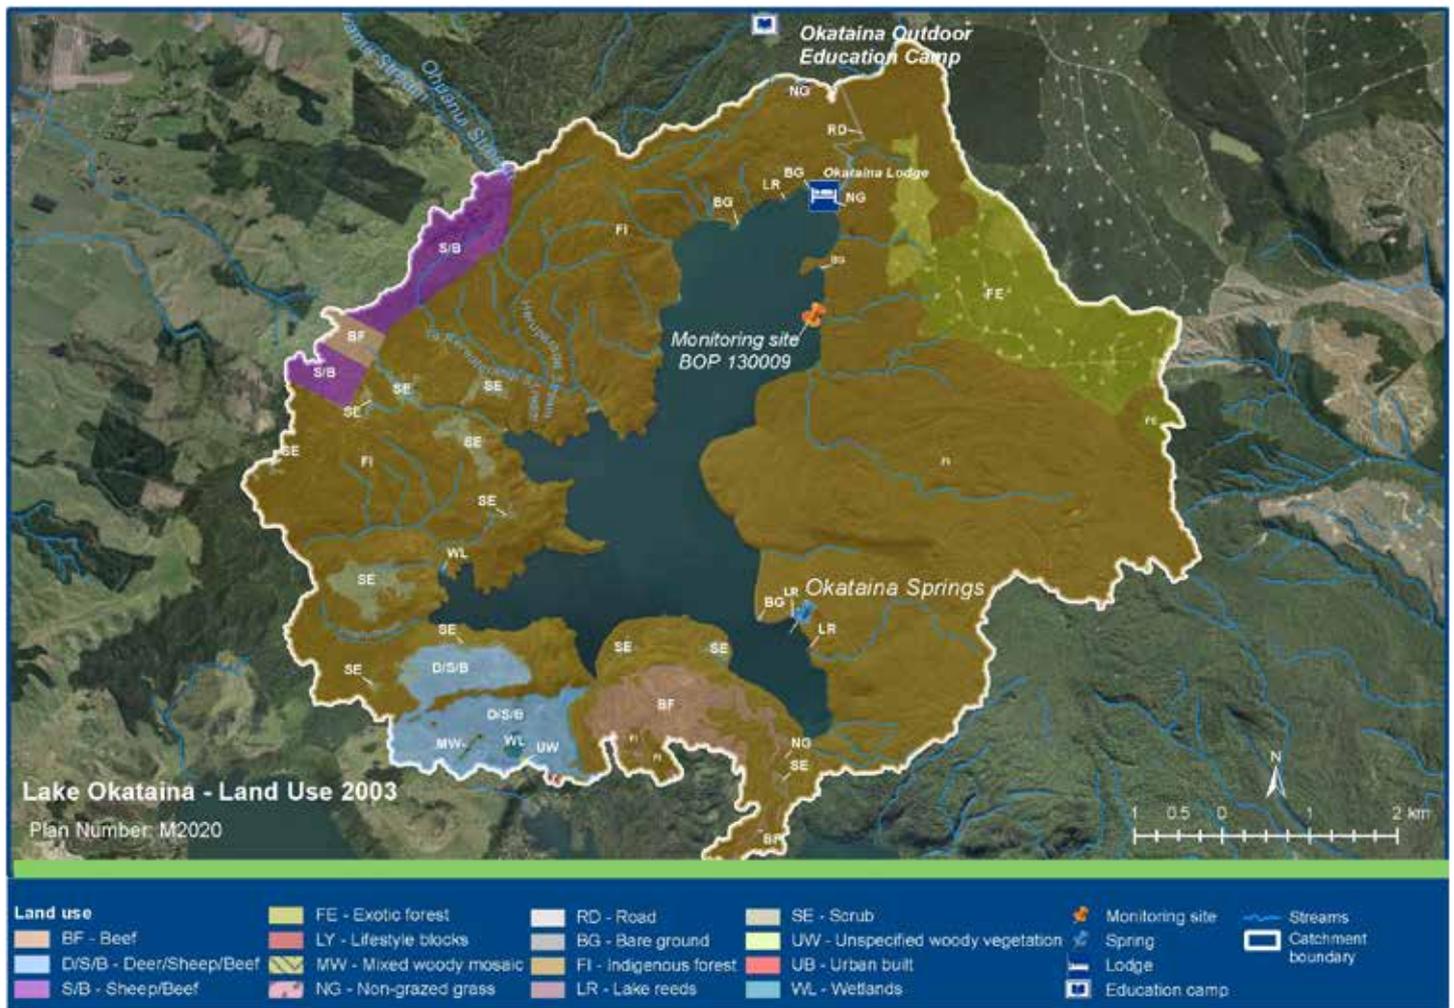
Map: Lake Ōkātina surface catchment (2006) and land-use (2003) indicative map
