A Bay of Plenty Regional Council, Rotorua District Council and Te Arawa Lakes Trust joint project

Draft Lake Ōkātina Action Plan

- for better water quality

September 2012

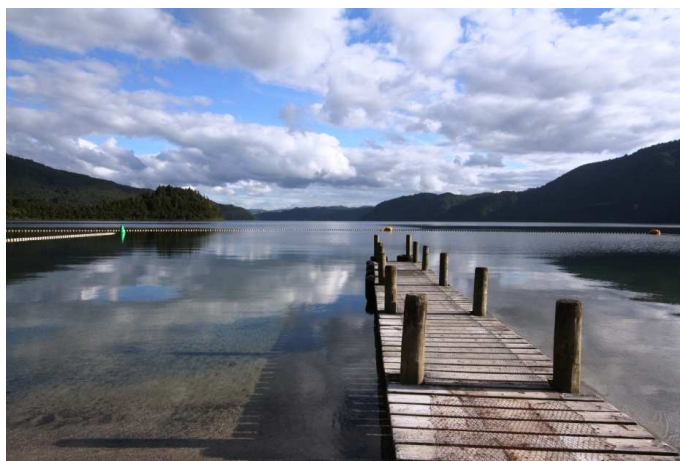
Figure 4. Lake Ōkātina at Tauranganui Bay with weed cordon

There is also some concern that the underwater ecology is threatened by invasive aquatic weeds, such as hornwort. The hornwort infestation discovered in the lake several years ago continues to be managed.

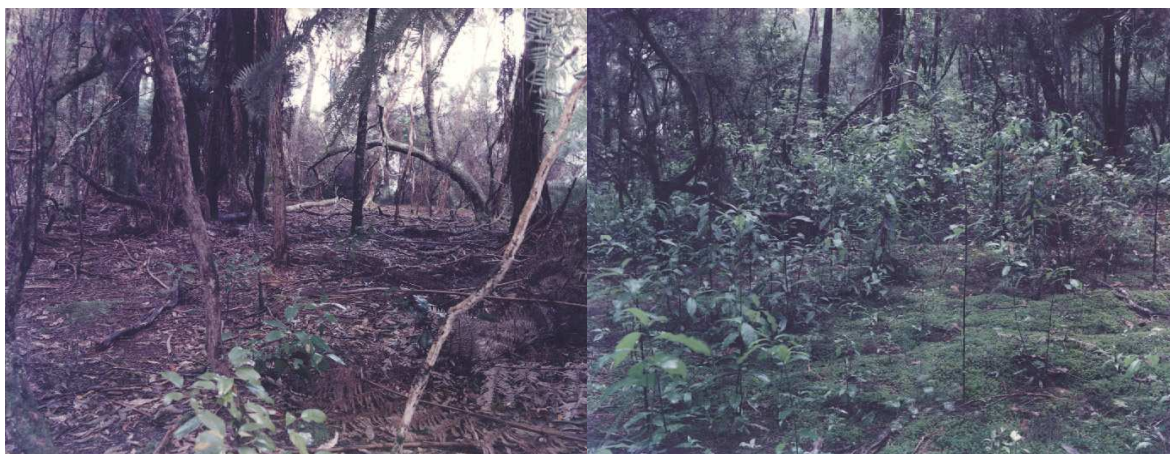
Figure 6. Differences in native bush when animal pests are excluded

The community is concerned about damage to native bush from pests. Understory vegetation is important for the forest ecosystem. The photos show the difference 10 years after the animal pest exclusion area (near Oruaruoa) was installed – the left photo shows outside of the pest animal excluding area, and the right photo shows inside of the pest animal excluding area.

We don't know to what degree the water quality is affected by pest animals degrading the native bush. The community has observed a significant impact on the native bush and scientists recognise that it is an area that requires further investigation.
