# **Consent Holder Annual Report on Okere Gates (Consent 65979) and Ohau Weir (Consent 65980) – 1 June 2014**

Operations Publication 2014/02  
ISSN: 1176-5550 (Print)  
ISSN: 1179-9587 (Online)

June 2014

Prepared by: Graeme O'Rourke  
Principal Engineering Officer/Surveyor

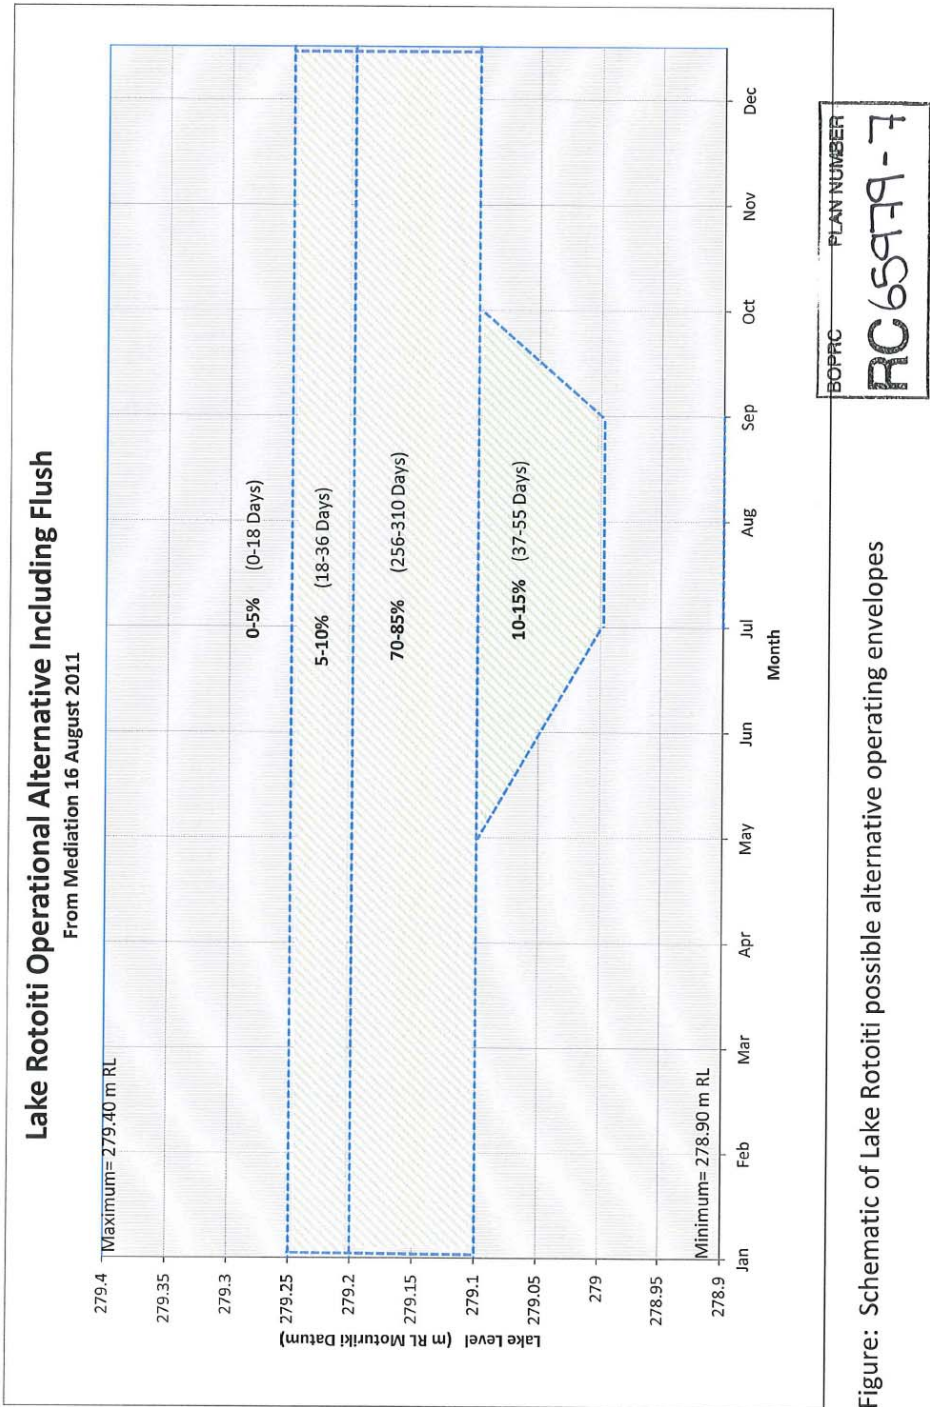
Figure 1 Lake Rotoiti operational envelope – target distributions.

Lake level distributions are determined by consent number 65979 Condition 7.4(a)-(c) (*Operational Limits*) and are best expressed in the graphical envelope shown in Figure 1 below.

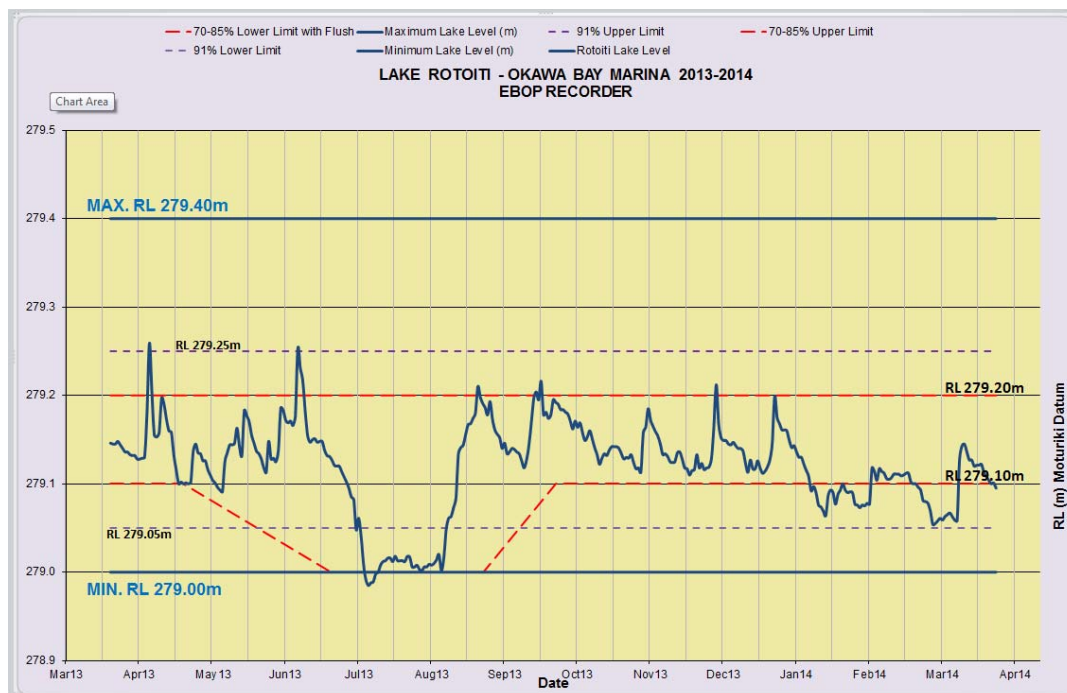
Figure 2 Lake Rotoiti levels measured at Okawa Bay Marina from 1 April 2013 to 31 March 2014.

Figure 2 below shows the 12 month trace of levels for Lake Rotoiti from 1 April 2013 to 31 March 2014.

- The annual drawdown of Lake Rotoiti programmed between 1 May and 30 September commenced on 8 July 2013 and concluded 21 August 2013 (45 days or 12% of year). Consented time allowance is 36 to 55 days per year or 10-15% per annum.
- The 'target' lake level minimum of RL 279.00 m was maintained for 30 days from 15 July 2014 to 15 August 2014 following low rainfall for this period. This window of time allowed communities opportunity to observe the effects of the lower lake level for assessment and future consideration.
- Significant rain in the final week of August 2014 resulted in a rapid recovery of lake levels to back inside the main operating range of RL 279.10 m to 279.20 m.
- Lake levels fell below the 'main operating range' of RL 279.10 m for 44 days from January 2014 to March 2014 as drought conditions persisted across the North Island.

Lake level distributions over the various ranges were generally on target with a satisfactory result of 72.9% in the 'main operating range' of RL 279.10 m to 279.20 m. Target distribution for this range is 70-85%. There were only five occurrences or 11 days for this 12 month period when lake levels exceeded RL 279.20 m.

The drawdown of Lake Rotoiti (<RL 279.10 m) commenced on 8 July 2013 and concluded 21 August 2013 (45 days or 12.3% of 365 days). Target distribution for the drawdown period is 10-15%.

There were five days during the bottom of the 'annual flush' when lake levels 'dipped' a few millimetres below the recognised minimum level of RL 279.00 m following continued low rainfall and inflows. However, for all practical purposes, it is deemed that Lake Rotoiti levels were successfully controlled within the minimum and maximum levels set out in Condition 7.4(a) of the consent.

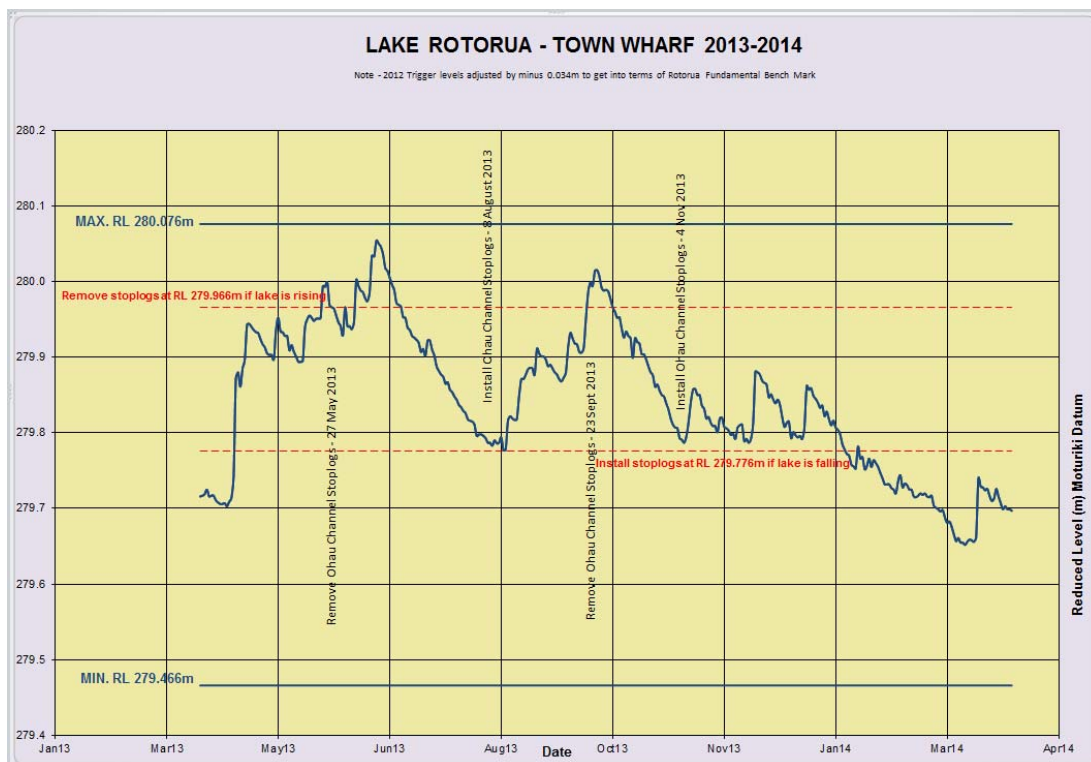
Figure 3 Lake Rotorua levels measured at Town Wharf from 1 April 2013 to 31 March 2014.

Figure 3 below shows the 12 month lake level trace for Lake Rotorua from 1 April 2013 to 31 March 2014.

- Four stop log operations during the 12 month period to store/release lake water in response falling or rising lake levels.
- Lake levels did not exceed the maximum level of RL 280.076 m.
- Lake levels did not drop below the minimum level of RL 279.466 m.

For the 12 month period, Lake Rotorua levels remained below the maximum level of RL 280.076 m for 100% of the time or 365 days. In the previous two years, maximum lake levels had been exceeded several times following significant rain events causing flood related issues around lake margins and down the Ōhau Channel through Mourea. A photographic record is now maintained to monitor the relationship of Ōhau Channel levels between Lake Rotorua and Lake Rotoiti for future assessment.

The winter months between June 2013 and September 2013 were particularly dry following below average rainfall for this time of year. It was unusual to see the stop logs installed during the middle of winter when typically, they are removed.

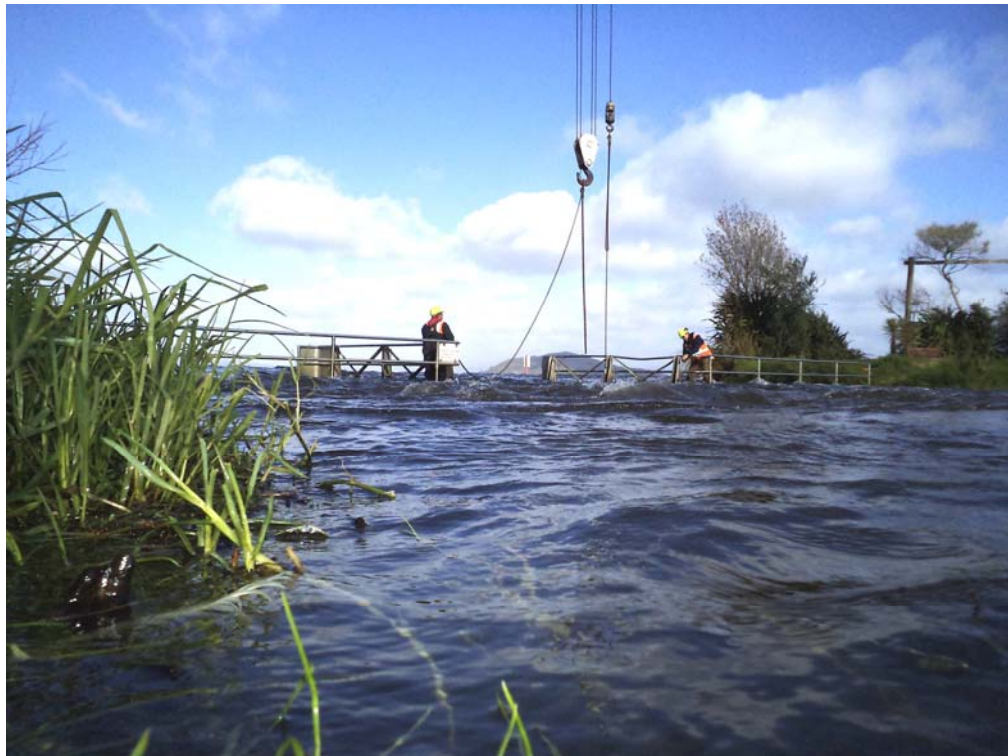
*Figure 4 Removing Ōhau Weir stop logs - 27 May 2013.*

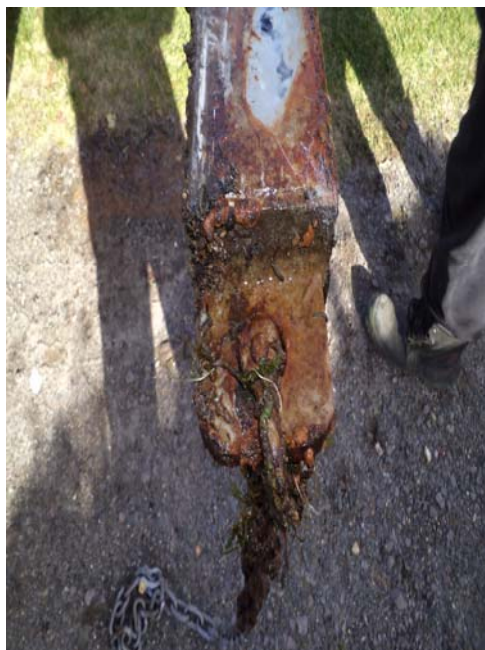
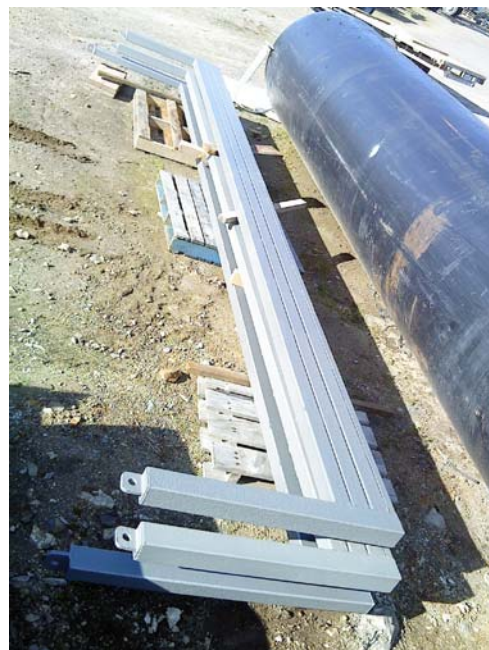
*Figures 5 & 6 Following removal, the stop logs were found to be corroded and encrusted with barnacle growth prompting early maintenance to clean, repaint and replace all fittings.*

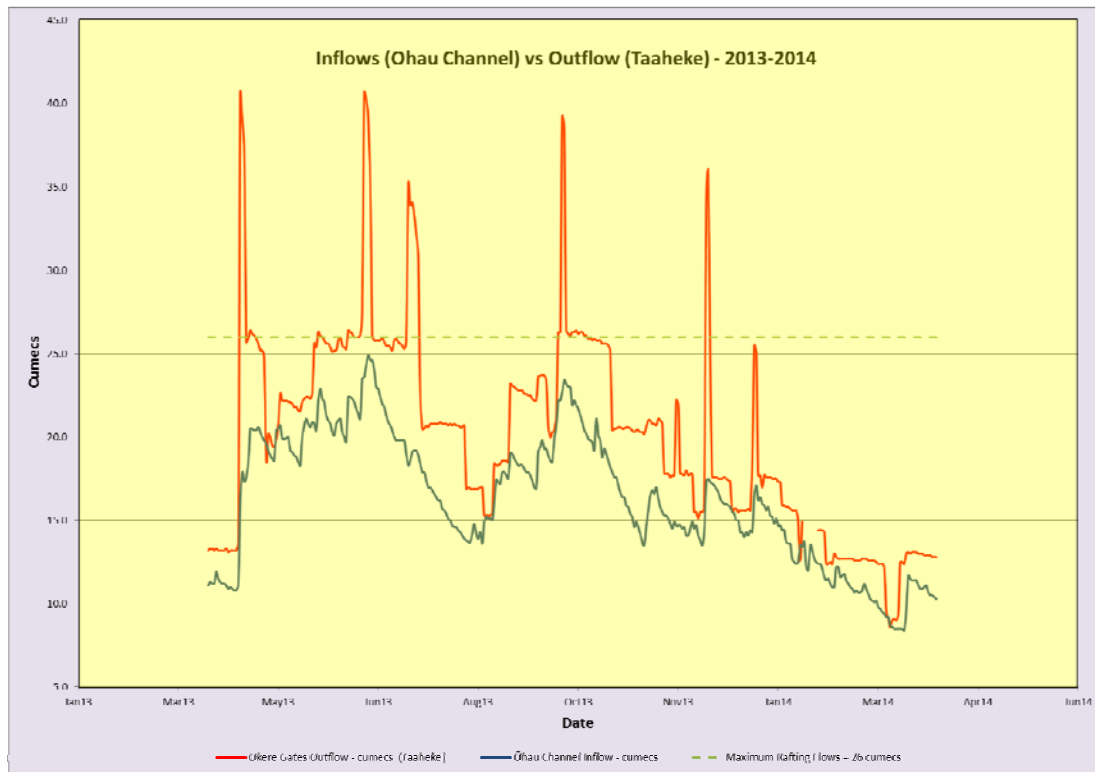
Flow rates at Taaheke and Ohau Channel are shown in Figure 6 below.

**Figure 6** Lake Rotoiti inflow - Ōhau Channel (blue) and Okere Gates outflow - Kaituna River (red) - 1 April 2012 to 31 March 2013.

The minimum Kaituna River/Okere Gate flow for this reporting period was 8.6 cumecs recorded on 8 March 2014. The minimum allowable flow is 7.9 cumecs. Ōhau Channel inflows during this time were also low at 8.4 cumecs based on NIWA's lake level recorder at Mission Bay (accuracy 8%).

The Kaituna River seven-day minimum flow was 9.982 cumecs while the Ōhau Channel seven-day minimum flow was 8.472 cumecs (extracted from the HydroTel record).

Okere Gates outflows were greater than Ōhau Channel inflows for 100% of the time except for an hour on 8 March 2014 when Ōhau Channel inflow exceeded Okere Gate outflow by 0.1 cumecs after the gates were adjusted down in order to preserve lake levels. The gates were immediately adjusted once updates were received to then restore the outflow>inflow equation.

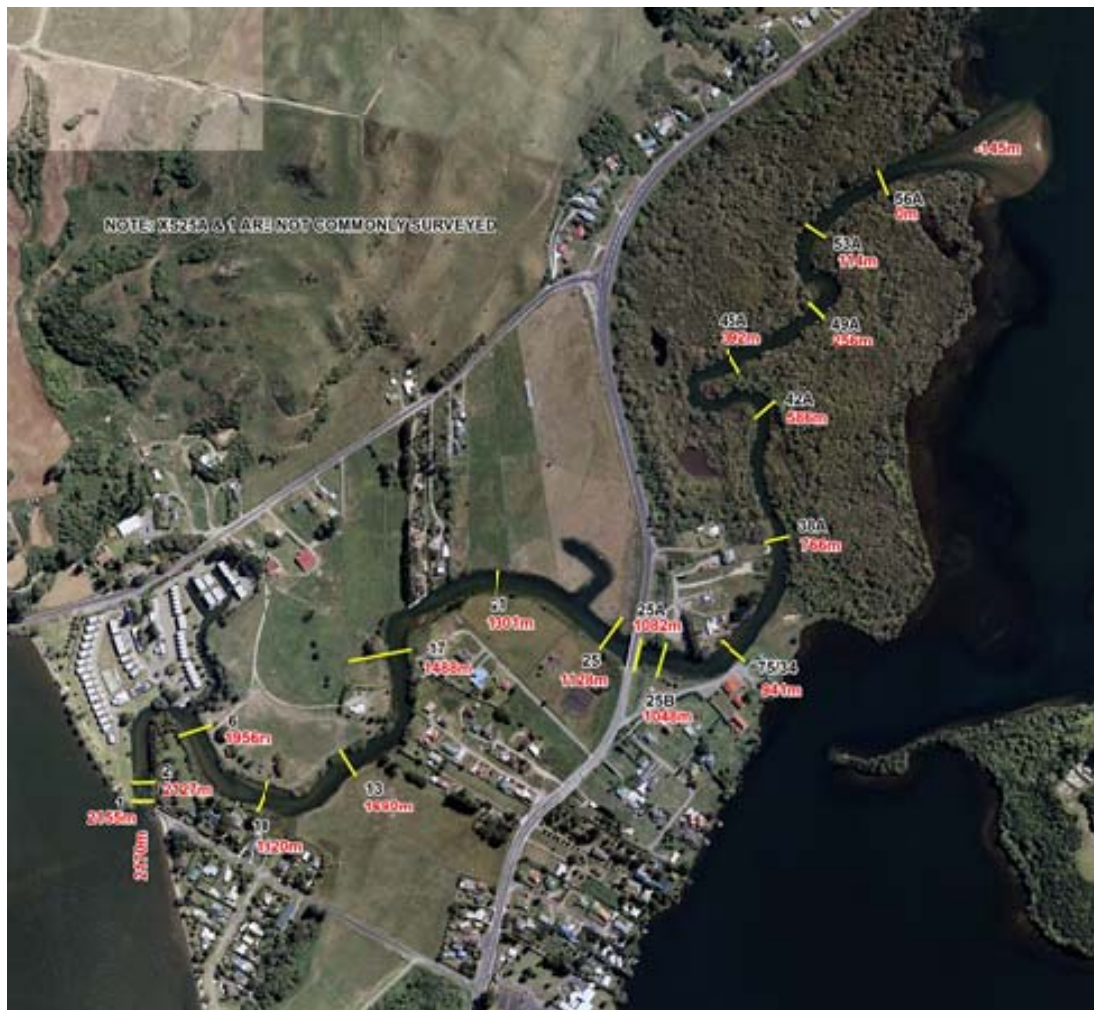
Ōhau Channel cross sections are undertaken annually at locations shown in Figure 7 to monitor bed levels prior to and after channel flush each year.

*Figure 7 Ohau Channel cross section locations.*

Several years of survey data collection indicate that the Ōhau Channel is reasonably stable with no significant change occurring since introducing the annual flush programme in 2012.

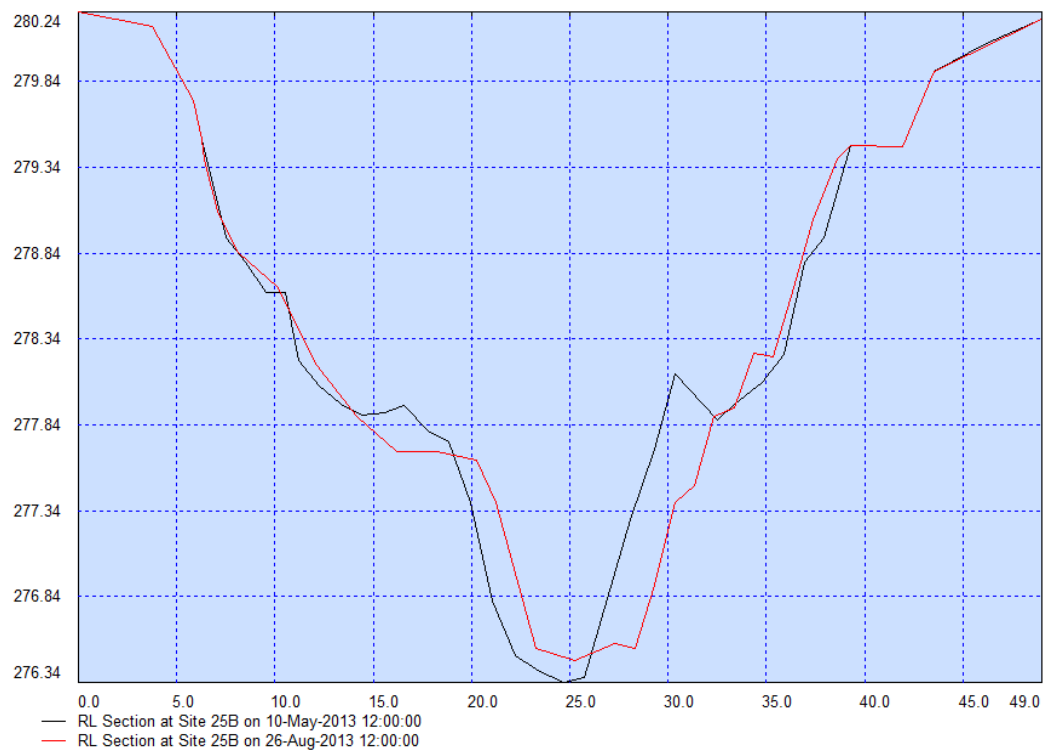
**Figure 8** *Cross section number 25B (below bridge) – pre-flush 11 May 2013 and post-flush 26 August 2013.*

The intent of the lake level drawdown or flush is to potentially increase channel velocities to mobilize sediments to increase capacity therefor reducing flood risk.

At this stage, this remains the best approach to potentially mobilize bed load and maintain sufficient gradient in the Ōhau Channel.

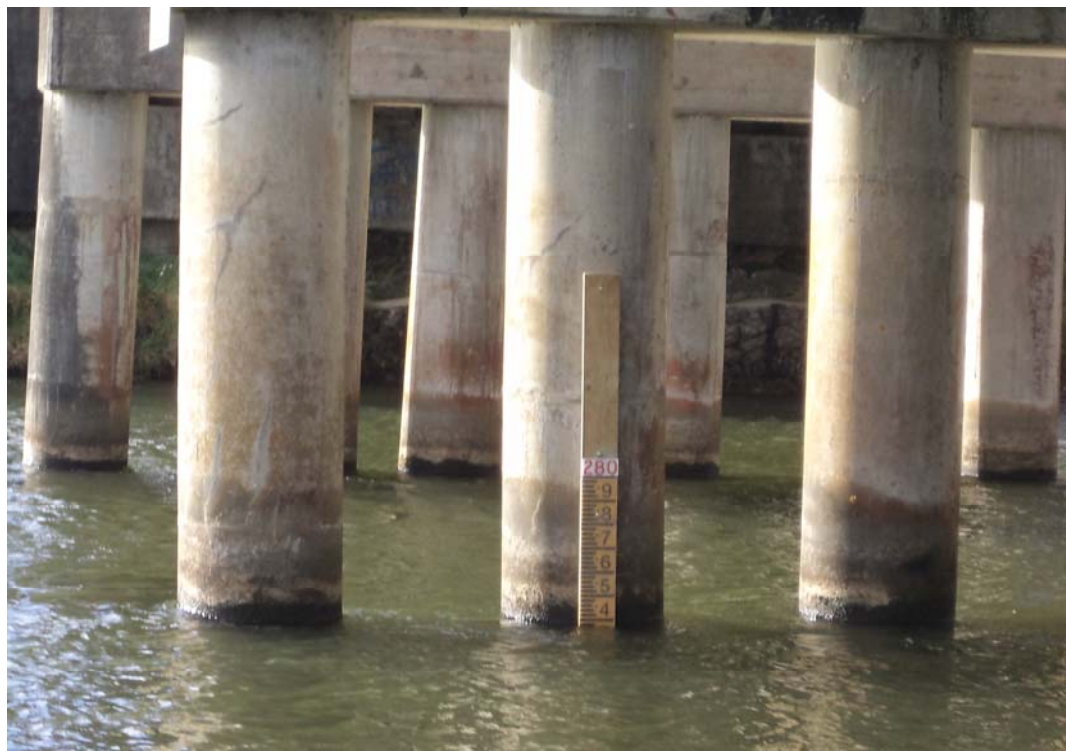
A staff gauge shown in Figure 9 below has been installed on the Ōhau Channel State Highway 33 Bridge to determine the relationship between levels on Lake Rotorua and Lake Rotoiti, particularly during times of flooding.

**Figure 9** *Ohau Channel/State Highway 33 staff gauge located on pillars of State Highway 33 Bridge at Mourea.*
