Water flow between Ohau Channel and Lake Rotoiti following implementation of a diversion wall

CBER Contract Report 96

Prepared for Environment Bay of Plenty

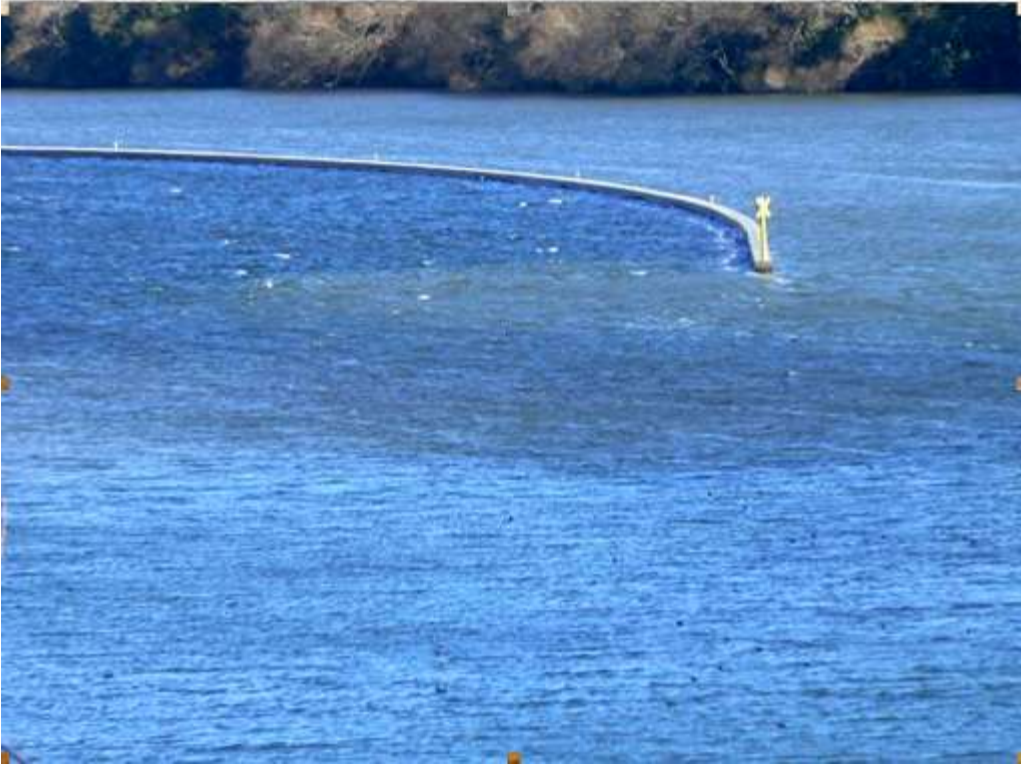
Figure 8. Photo of the end of Ohau Channel Diversion wall taken 13:40 hr on 24 July 2008. Note relatively turbid water from the diversion channel (left-hand side of photo) flowing into relatively clear water of Lake Rotoiti. Photo courtesy of N. Miller.

Our measurements have been supplemented with five cases of visual evidence of the plume. The first is a photo of the south-east end of the Ohau Channel at 13:40 hr on 24 July (Figure 8). The second is a satellite image taken on 17 November 2008 (Figure 9). The photo on 24 July shows relatively turbid water from the Ohau Channel tending to spread laterally once it flows past the end of the diversion wall. At 14:00 hr on this day the wind speed was 7.7 m s^{-1} and wind direction was south-west at Rotorua Airport. The remote sensing image was from 17 November 2008. It shows a marked difference in water clarity between the turbid diversion channel water and the clear waters of Lake Rotoiti (Figure 9). The water from Lake Rotoiti can be discerned well past the end of the diversion wall and into the Okere Arm end of the lake. Three other aerial photos from 16 December 2008 are shown to provide additional perspective on the diversion wall (Figures 10, 11 and 12).

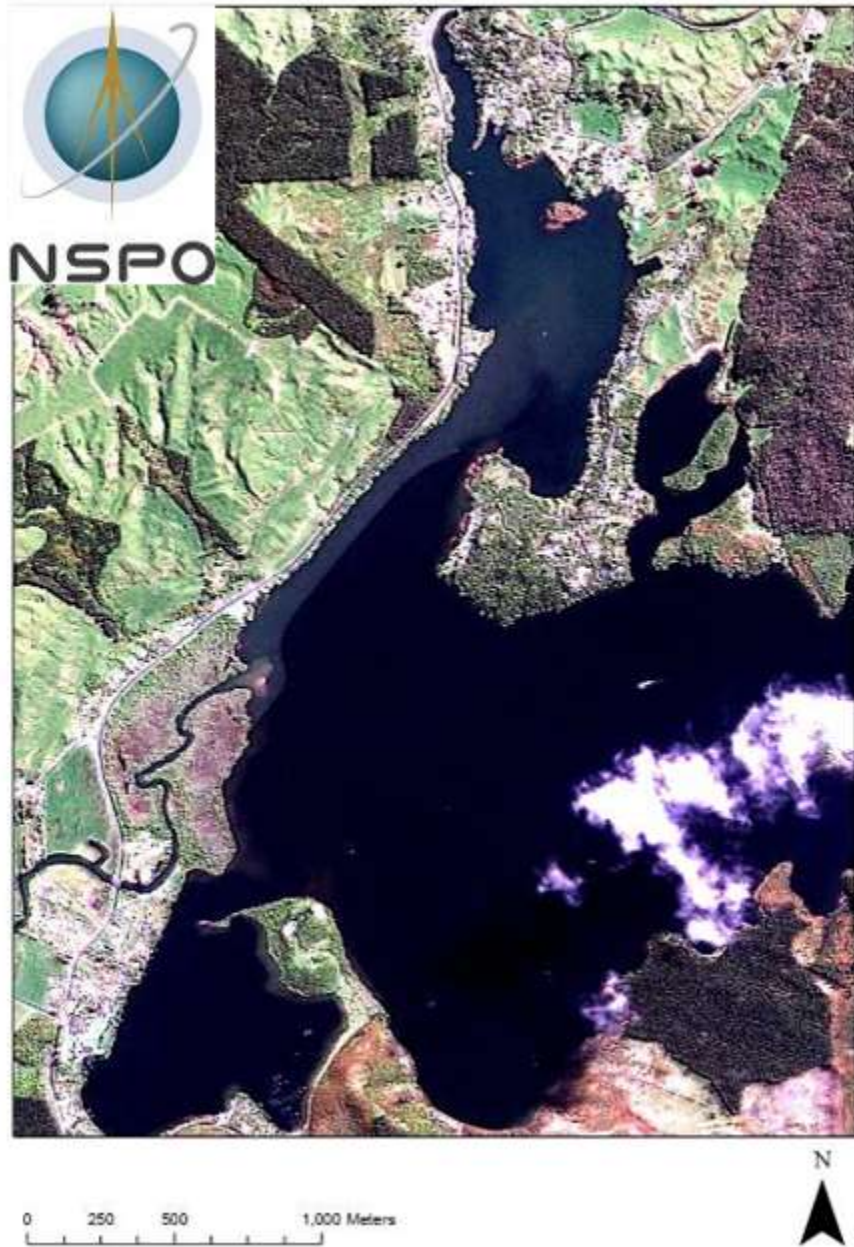
Figure 9. Remote sensing image of Ohau Channel, Okawa Bay, Kaituna exit and western basin on Lake Rotoiti. Photo taken 17 November 2008. Image made available through agreement entered into for the license from National Space Program Office of the National Applied Research Laboratories for the limited use of ROCST-2 satellite image and data by the University of Waikato, and supported through the Global Lake Ecological Observatory Network (GLEON). The horizontal resolution is 2 m and the image has been pan-sharpened from a true colour image through assistance from Mat Allan (University of Waikato).

The satellite image (Figure 9), shows turbid water within the diversion channel moving past the end of the diversion wall and into the Okere Arm. This is in contrast to the clear waters of Lake Rotoiti and is visual evidence that the diverted water was flowing towards Kaituna River at this time. Overflow conditions were most likely to have been prevalent in November (Gibbs *et al.* 2003; Hamilton *et al.* 2005a), at the time of the satellite photo.

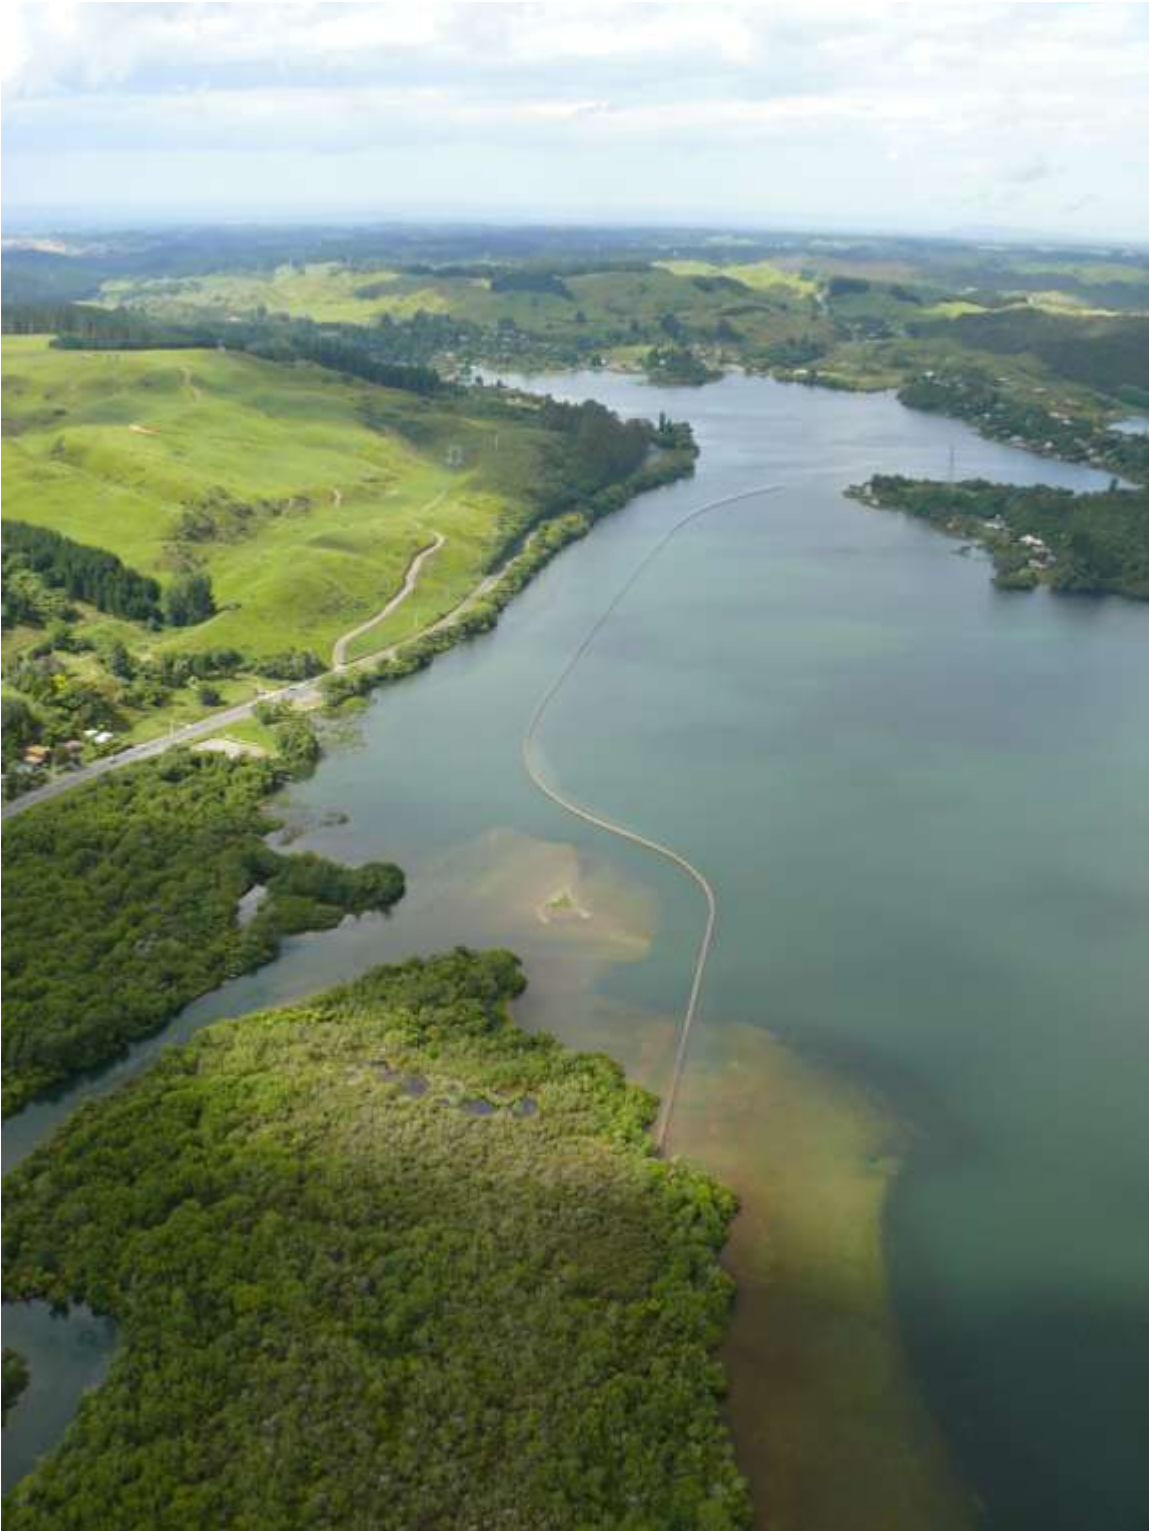
Figure 10. Photo of the Ohau Channel diversion wall showing the Okere Arm towards the outlet of Lake Rotoiti (upper left). Photo: Environment Bay of Plenty.

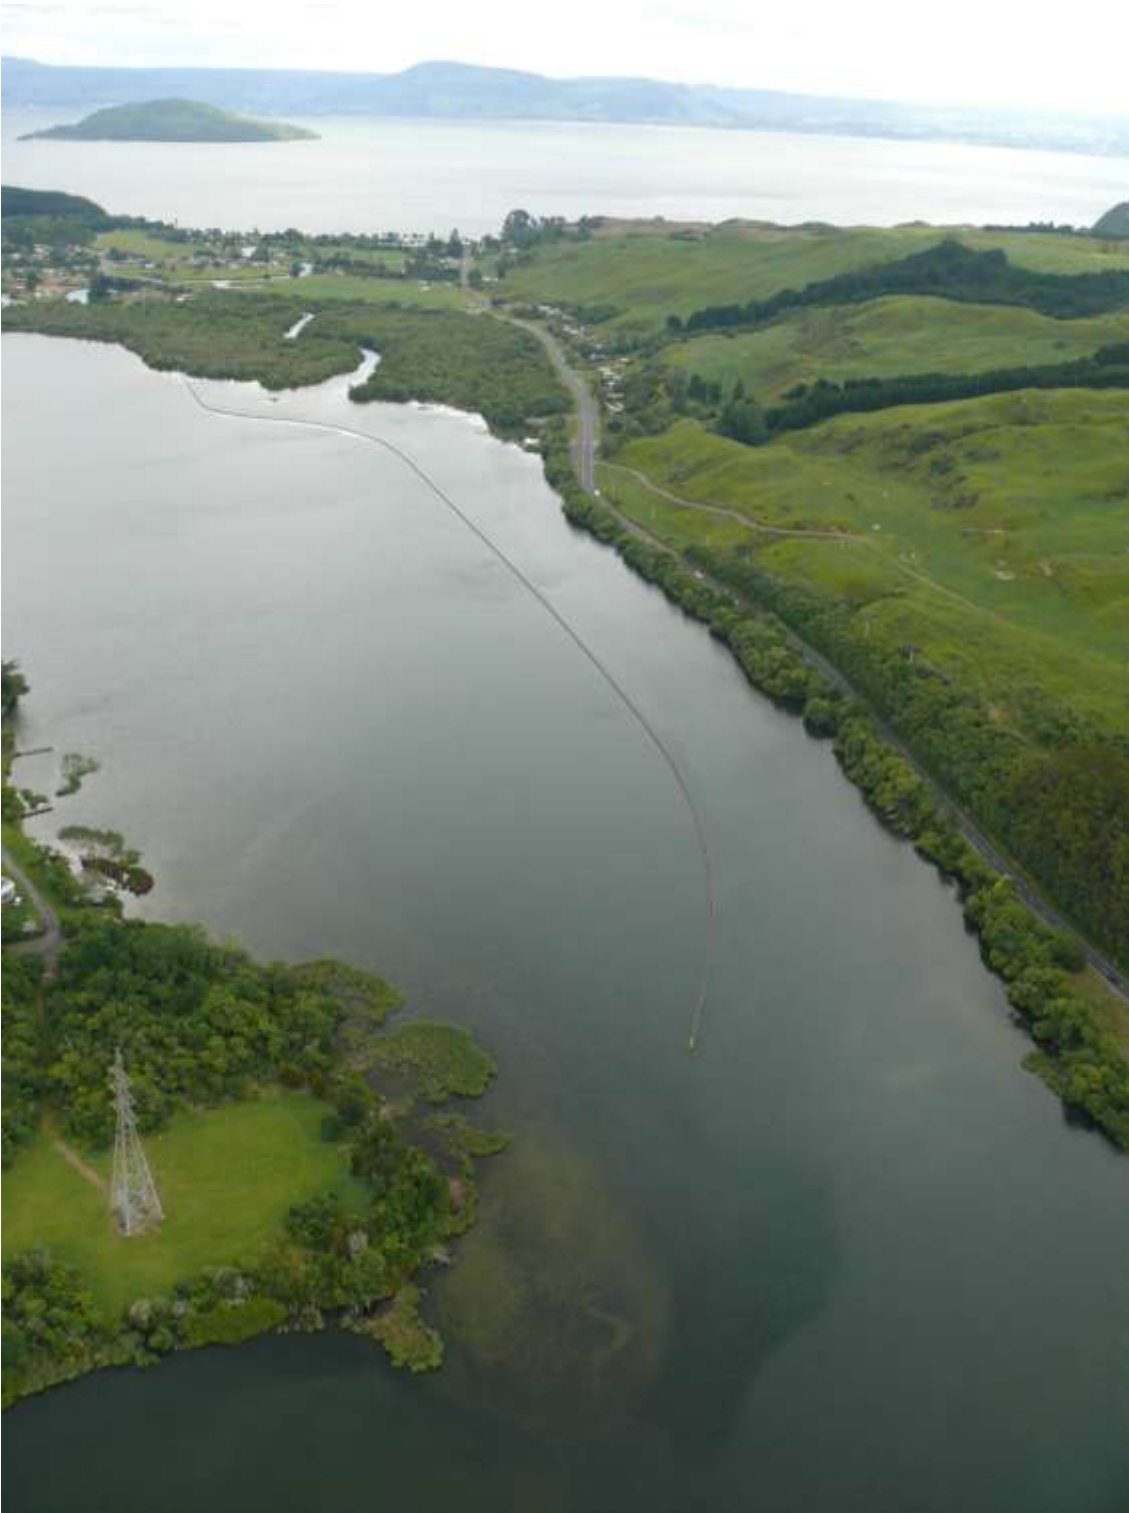
Figure 11. Photo of the Ohau Channel diversion wall, also showing Lake Rotorua (top waterbody) and including Mokoia Island (upper left). Note the variation in water appearance between in the photo foreground arising from mixing between water from the Ohau Channel from Rotoiti. Photo: Environment Bay of Plenty.

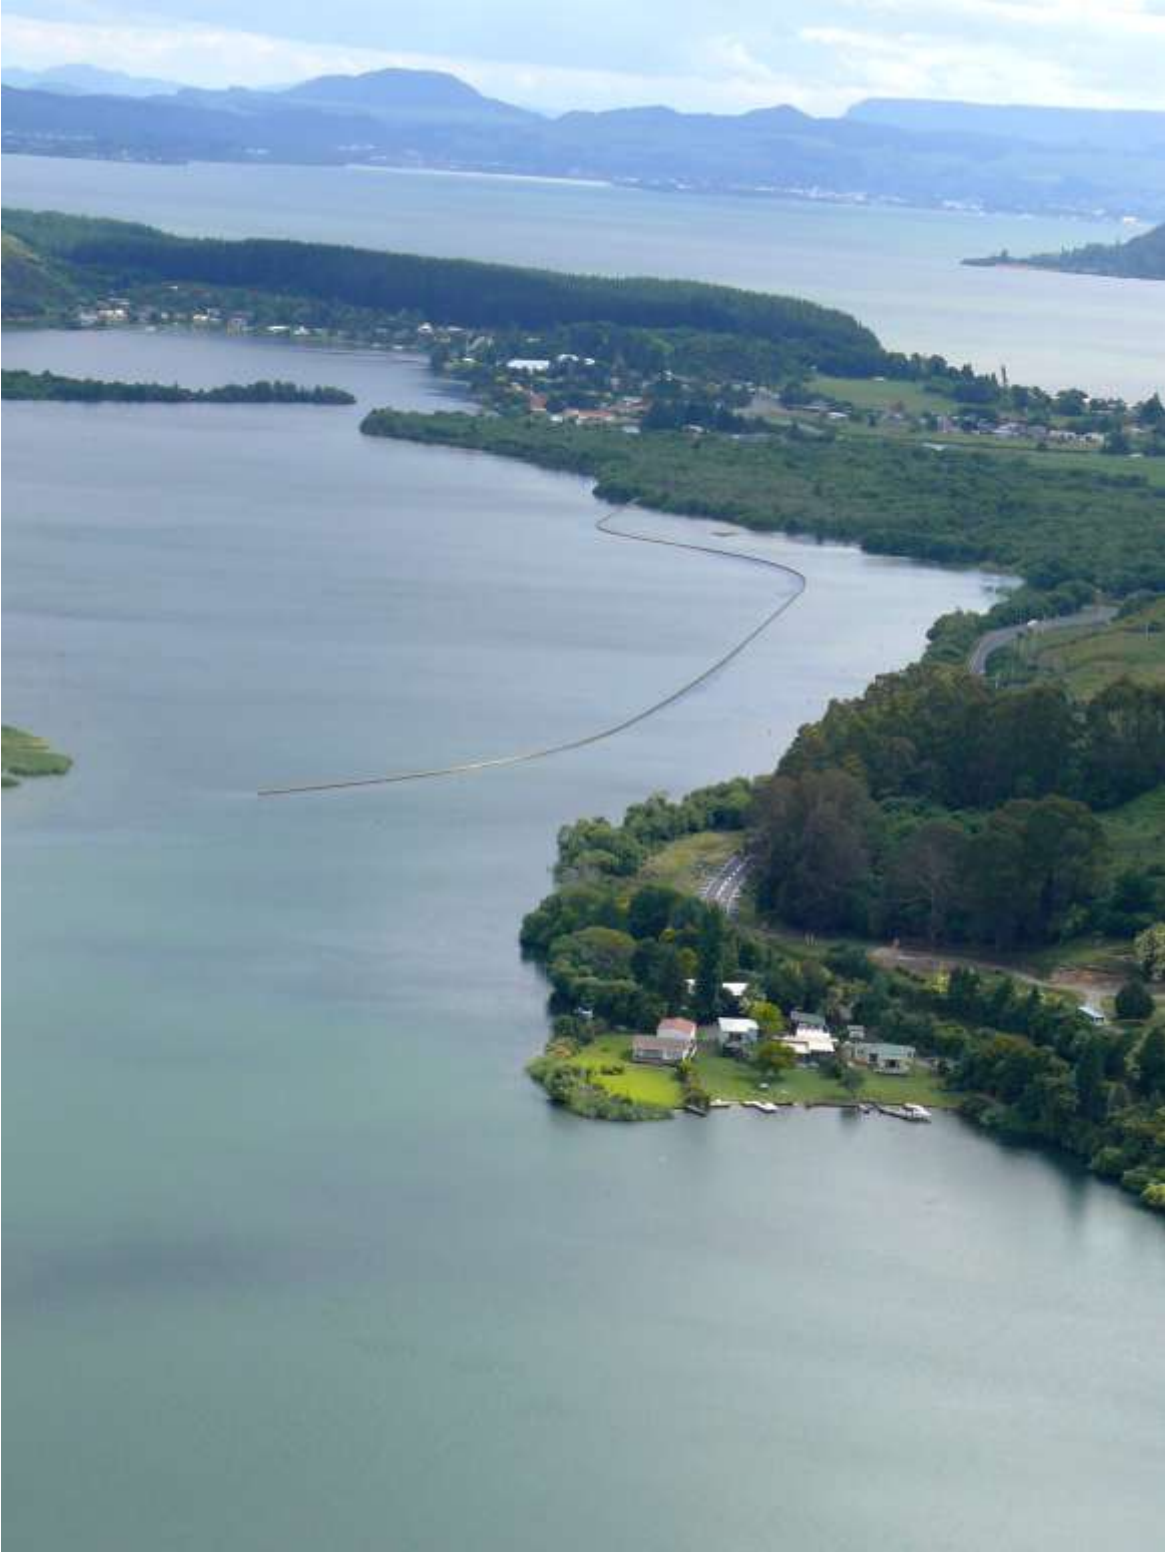
Figure 12. Photo of the Ohau Channel diversion wall, also showing Lake Rotorua (top waterbody). Photo: Environment Bay of Plenty.
