Long-Term Rehabilitation of Delavan Lake, Wisconsin, USA: Importance of Biological Interactions

Dale Robertson

U.S. Geological Survey, Wisconsin Water Science Center

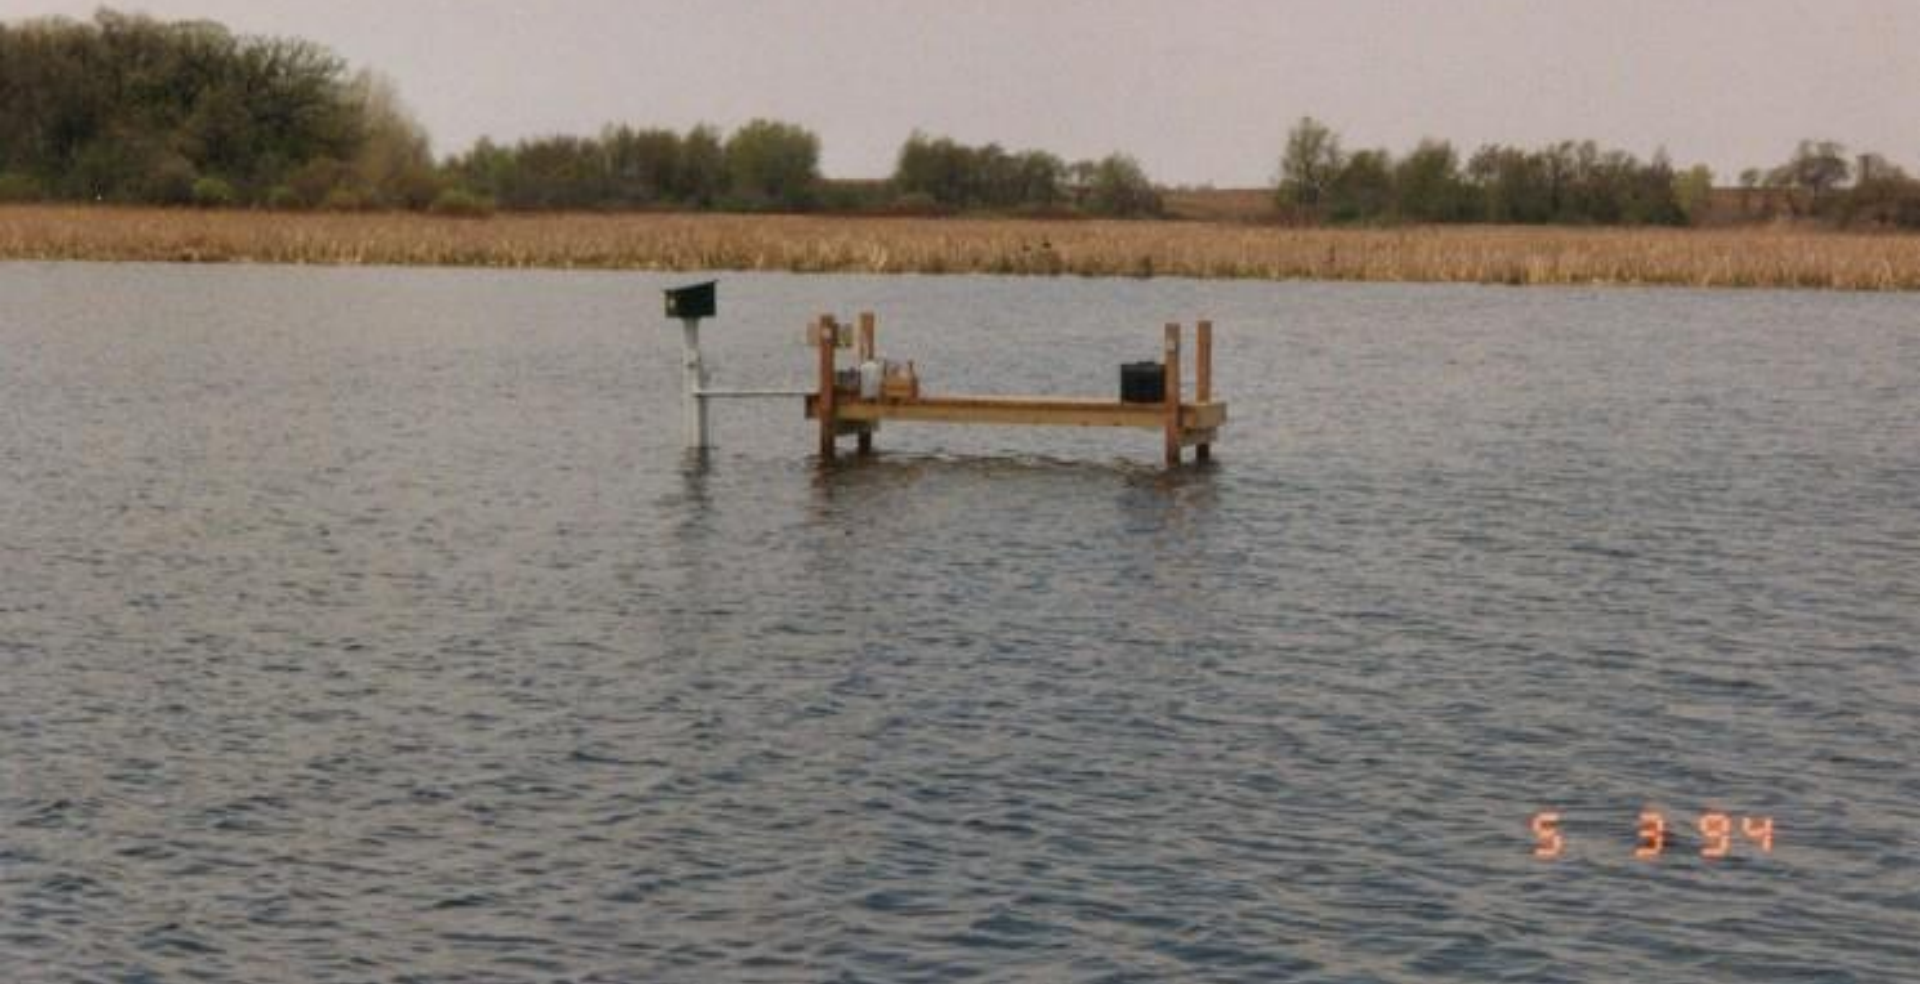
Sampling Platform to document dissolved oxygen and pH conditions in the Inlet
