**The ecological condition of the Rotorua
Lakes using LakeSPI**

**NIWA Client Report: HAM2008-149
September 2008**

The ecological condition of the Rotorua Lakes using LakeSPI

Environment Bay of Plenty

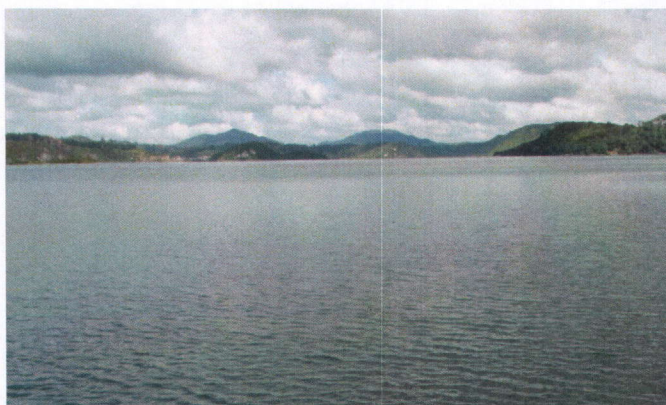
3.1 Lake Rotomahana

Lake condition: Good

Stability: Stable with signs of decline.

State	Year	LakeSPI Index (%)	Native Condition Index (%)	Invasive Condition Index (%)
Pristine		94	90	0
	1988	72	64	13
Historical data	2002	73	61	7
	2005	70	66	19
Present day	2008	66	63	24

Lake Rotomahana, while still the highest ranked lake in the Rotorua region, is showing signs of declining condition as indicated by the most recent LakeSPI assessment. This is due to the recent invasion of the lake by two of New Zealand's worst aquatic plant species, *Egeria densa* and *Ceratophyllum demersum* (hornwort). Discovered for the first time in April 2007, *Egeria* was found to be established in two areas of the lake, at the north-eastern end and in the southern embayment, while *Ceratophyllum* fragments were found growing amongst native plants in the southern embayment (Clayton & de Winton, 2007; Scholes and Bloxham, 2008). Since then both species have continued to spread with *Egeria* now present at 2 of the 5 LakeSPI baseline sites forming bands of weed growth down to a depth of 9m. The maximum depth of aquatic plant growth at these 2 sites is 12m. As both *Egeria* and hornwort increasingly continue to impact negatively on the diversity and quality of indigenous plant communities we can expect to see the Native Condition Index for this lake decline while the 'Invasive Condition Index' continues to increase.

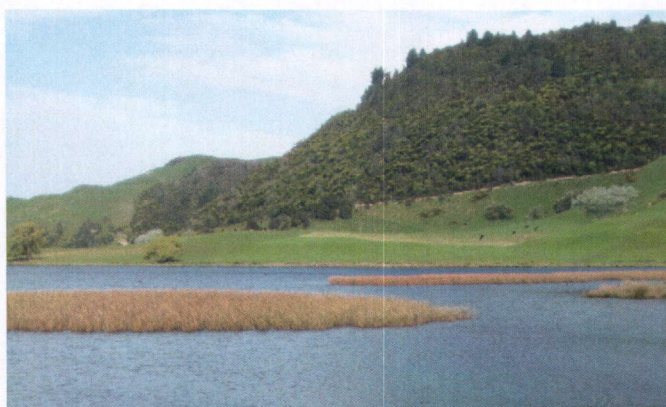
3.5 Lake Okareka

Lake condition: Average
 Stability: Declining
 Lake ranking 5th

State	Year	LakeSPI Index (%)	Native Condition Index (%)	Invasive Condition Index (%)
Pristine		94	90	0
	1980	40	49	67
Historical data	1988	44	53	66
	2001	41	50	70
	2003	34	42	77
Present day	2006	34	39	76

Lake Okareka has recorded a 10% decrease in the LakeSPI Index over the last 18 years, from 1988 to 2006, resulting from a decline in the quality of native plant communities present, indicated by the Native Condition Index, and an increase in the Invasive Condition Index over the same time frame.

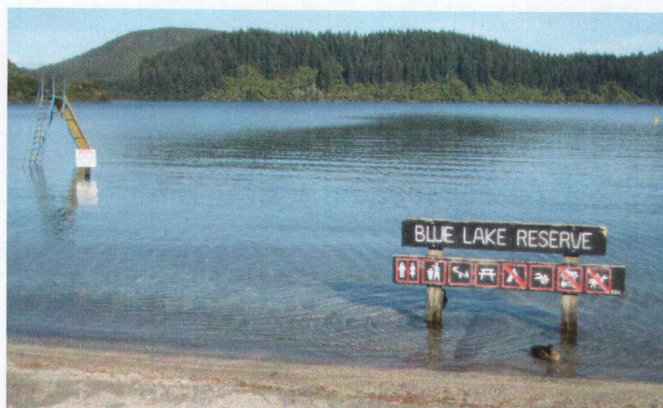
3.6 Lake Tikitapu

Lake condition: Average

Stability: Declining

State	Year	LakeSPI Index (%)	Native Condition Index (%)	Invasive Condition Index (%)
Pristine		94	90	0
	1970	70	77	33
Historical data	1988	63	75	47
	2005	46	45	50
Present day	2008	32	28	63

The LakeSPI Index shows a reduction of 31% over the last 20 years indicating that the condition of Lake Tikitapu has deteriorated faster than any of the 12 Rotorua Lakes over this same period from 1988 to 2008. Unlike the other lakes this decline is not due to the impact from new invasive species but from a significant decline in the quality and extent of native plant communities present. The mean maximum depth of native plant growth at LakeSPI survey sites has declined from 12.4m in 2005 to only 8.8m resulting in a 47% decline in the 'Native Condition Index' over the last 3 years. This notable reduction in native condition is most likely related to water quality, in particular water clarity near the maximum depth limit of vegetation growth. The presence of a sustained turbid water layer with high chlorophyll *a* levels has been reported above the thermocline (David Hamilton, Waikato University, pers comm.). The increase in Invasive Condition scores over this same time frame has occurred not on account of any new invasive plant introductions but due to the existing invasive vegetation now having a greater relative impact on overall vegetation status.

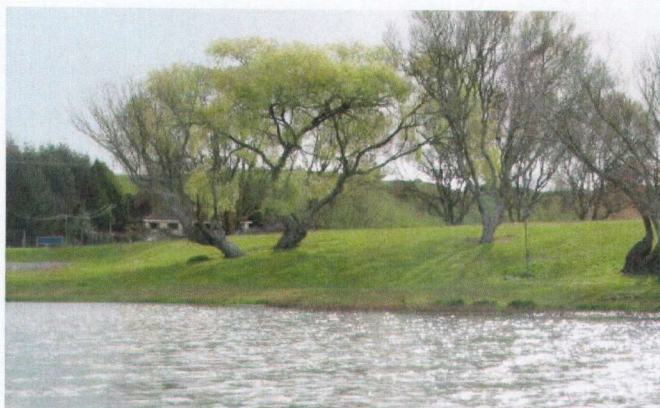
3.10 Lake Okaro

Lake condition: Poor
 Stability: Stable
 Lake ranking 10th

State	Year	LakeSPI Index (%)	Native Condition Index (%)	Invasive Condition Index (%)
Pristine		94	89	0
Historical data	1982	31	29	67
	2003	19	6	76
Present day	2006	19	6	52

Elodea is the only invasive species reported in this lake. It is possible other invasive species have been introduced but were not able to establish or thrive. The hypereutrophic nature of this lake presents an unfavourable habitat for submerged vegetation. This is reflected in the highly variable cover and depth range of *Elodea*, both seasonally and annually. It is also likely to explain root lyses (root death and detachment) in *Elodea* beds from periods of oxygen stress and anoxia. On several occasions we have observed rooted shallow water *Elodea* beds, while at around 2m depth and deeper all of the *Elodea* appears as non-rooted 'drift'. This may well coincide with periods of shallow stratification with severe anoxia below the thermocline resulting in root death and shoot detachment.

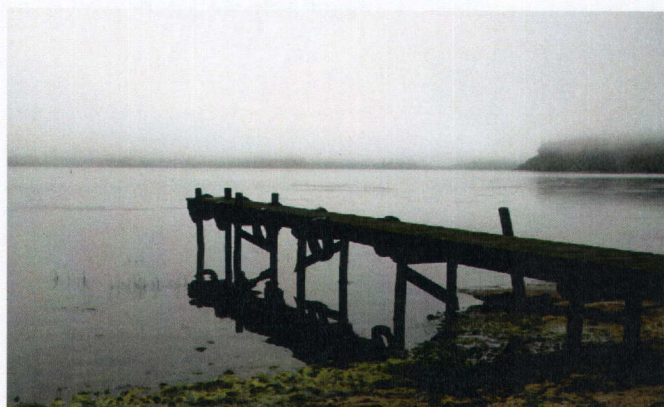
3.11 Lake Rotoehu

Lake condition: Poor

Stability: Declining

State	Year	LakeSPI Index (%)	Native Condition Index (%)	Invasive Condition Index (%)
Pristine		89	88	0
	1988	33	33	73
Historical data	2003	34	34	64
	2006	22	32	82
Present day	2008	18	26	85

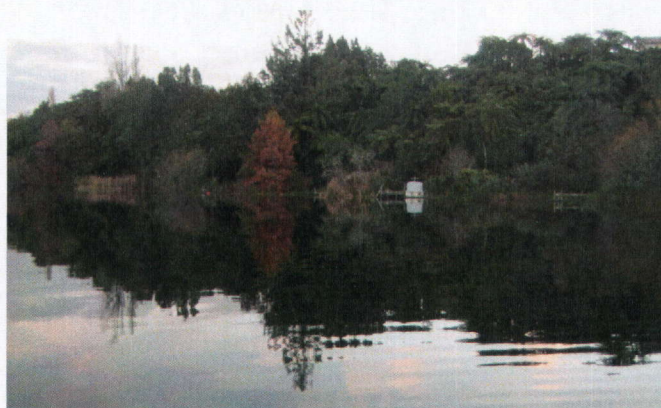
3.12 Lake Rotoiti

Lake condition: Poor

Stability: Stable

State	Year	LakeSPI Index (%)	Native Condition Index (%)	Invasive Condition Index (%)
Pristine		94	90	0
	1981	26	33	82
Historical data	1988	26	33	85
	2001	20	24	90
	2003	18	22	90
Present day	2006	18	18	90

Lake Rotoiti has consistently had one of the highest Invasive Condition Index scores and during the most recent 2006 survey it continued to have the lowest LakeSPI Index so far recorded for any of the 12 lakes in this region. It is interesting to note the similarity of LakeSPI scores, Native Condition Index and Invasive Condition Index between Lakes Rotoiti (18, 18, 90) and Rotorua (22, 21, 78), 2006 surveys. Lake Rotoiti has a complex morphometry with areas along the northern shoreline that are too steep to support submerged vegetation making them unsuitable for LakeSPI. The western end of Rotoiti has been predominantly influenced from Lake Rotorua inflows and there has been a progressive decline in submerged vegetation in several arms of Lake Rotoiti such as Okawa Bay, Wairau Bay and Te Weta Bay. Sheltered areas with low water quality are now often dominated by loose filamentous algae, attached benthic blue-green algal mats and planktonic blue-green algal blooms. The LakeSPI scores indicate poor water quality in this lake.
